CK-2096

FLORENCE LAKE 13.11km

2015 Inspection

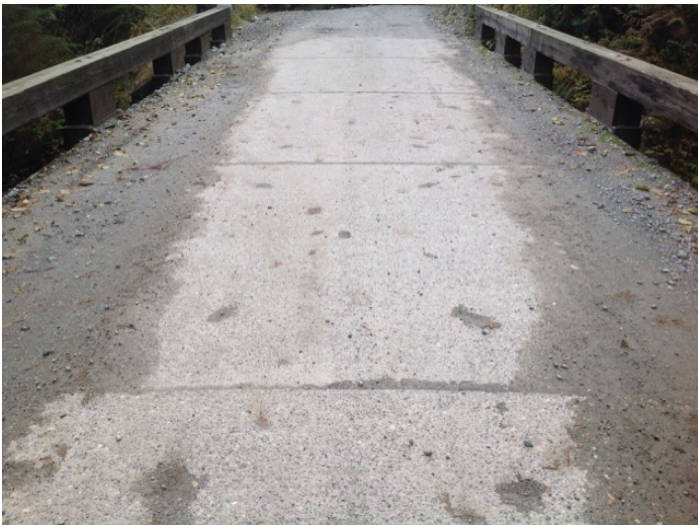
Overall Deck Condition Fair
