CK-2103

GARNET CREEK 8.8km

2015 Inspection

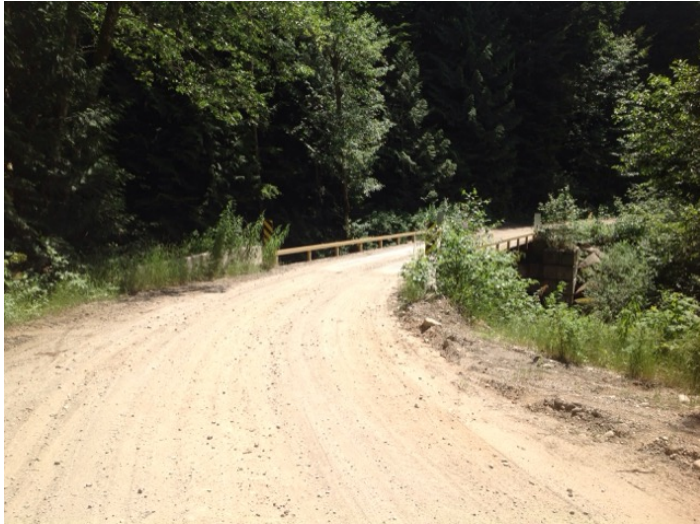
Approach from Right Bank when facing downstream

Alignment Fair

Road Surface Fair

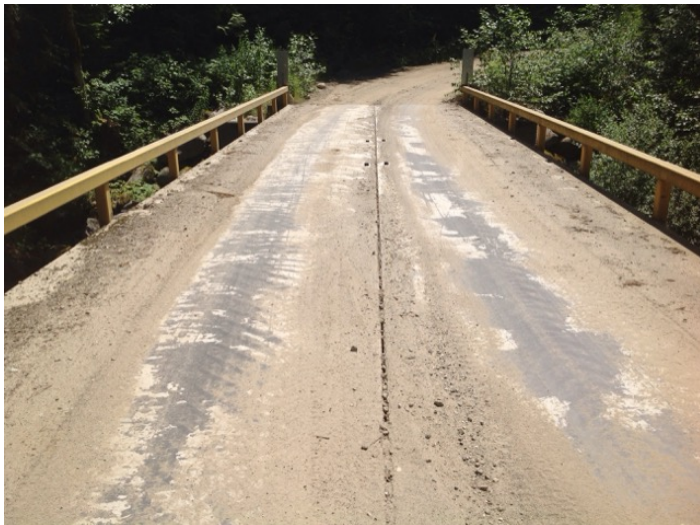
| Steel Deck Plate | Good | anti skid wearing |
| Overall Deck Condition | Fair | |

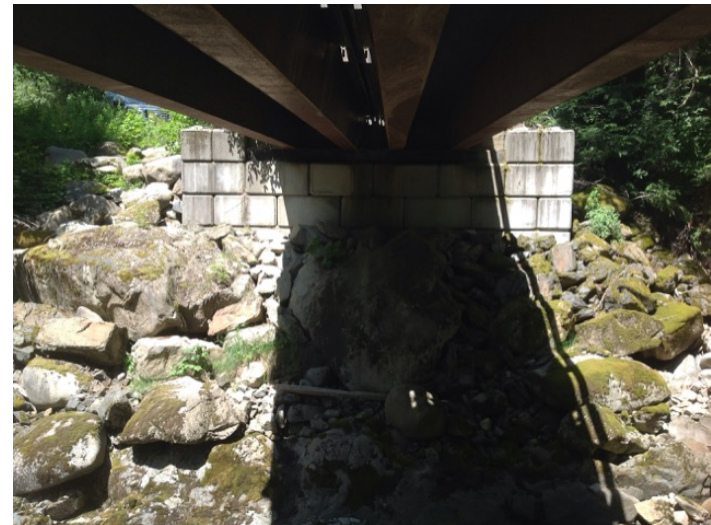
Right Bank Abutment when facing downstream

Concrete Good lock blocks

Caps or Sills Good treated timber sills
