CK-2104

HARRISON EAST 6.8km

2015 Inspection

| Crossing Name | Slollicum Creek |

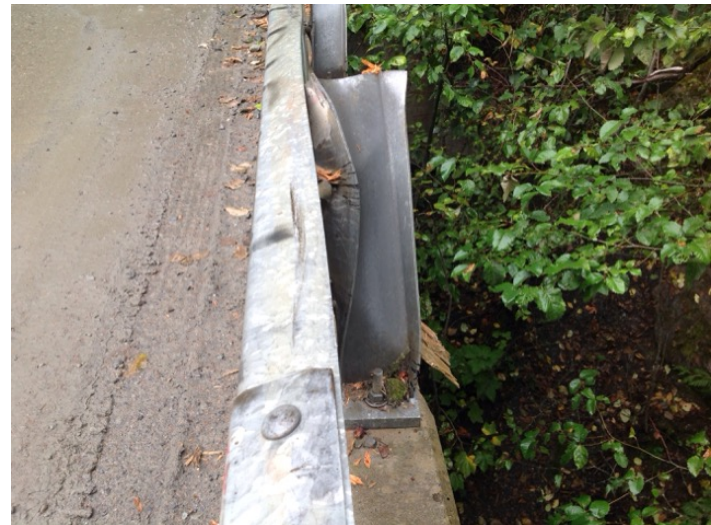
| Curb Rail/Blocks/Posts | Fair | some recent damage to steel risers |

damaged steel posts
