CK-2106

HARRISON EAST 15.4km

2015 Inspection

| Crossing Name | Bear Creek |

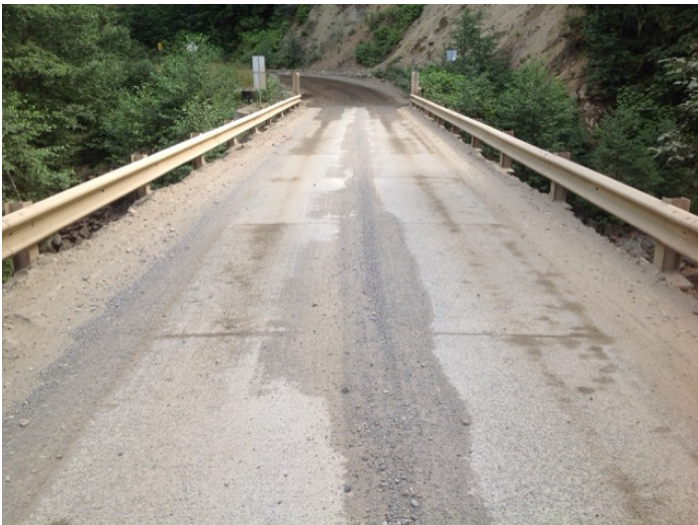
| Concrete Deck | Good | |
| Overall Deck Condition | Good | |

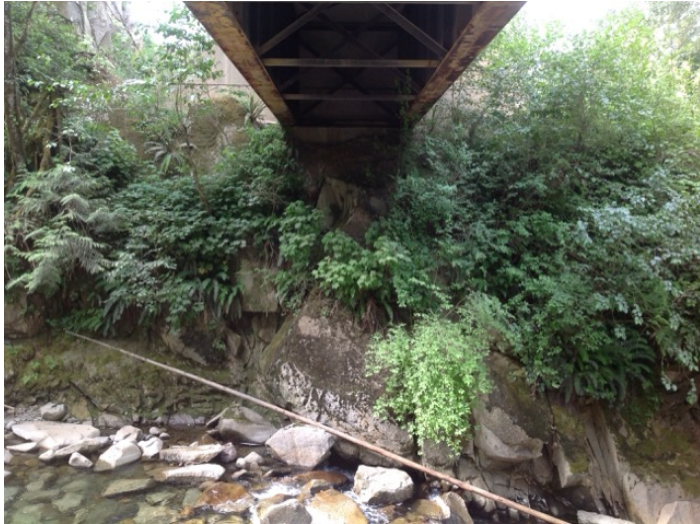
Left Bank Abutment when facing downstream

CIP left bank

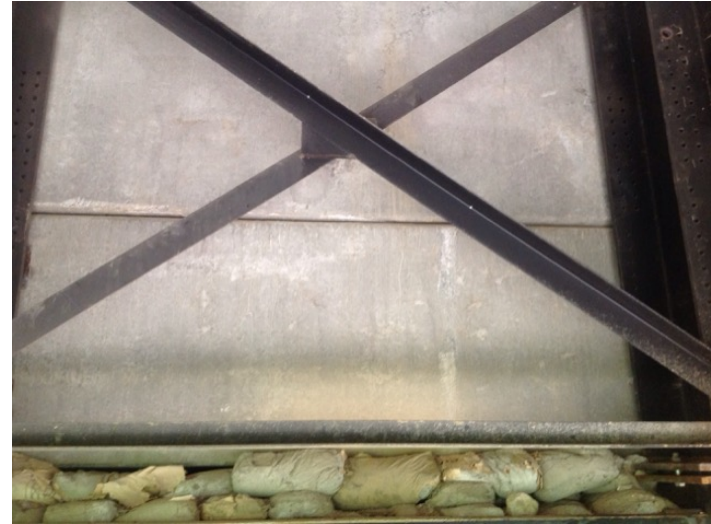
double ballast wall - stacked

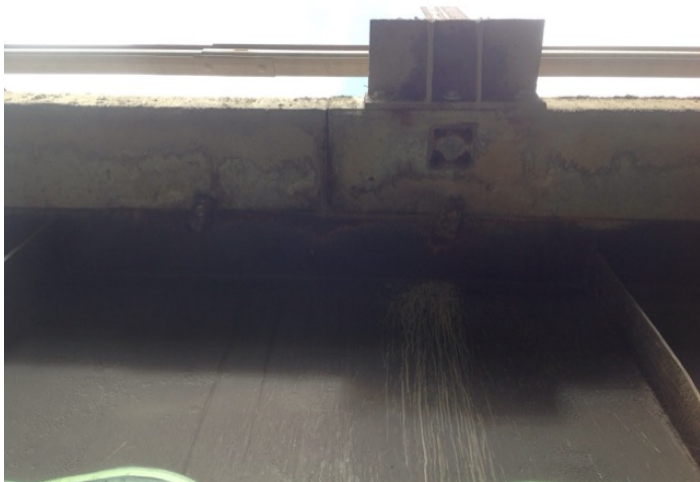
deck clips

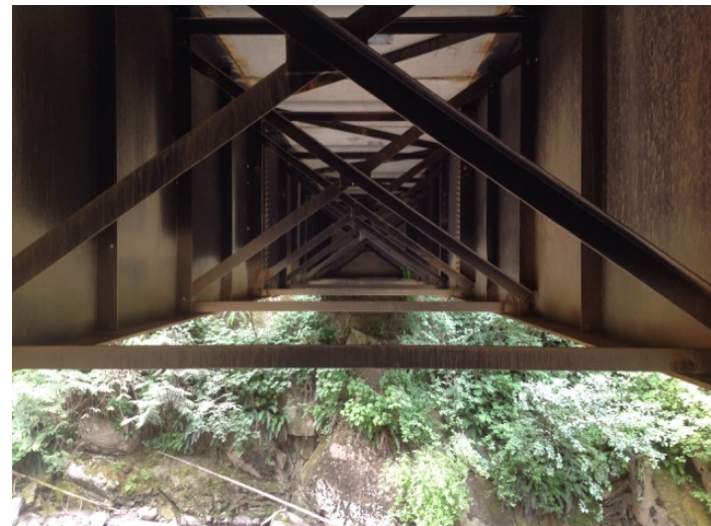
superstructure

Girders Fair painted deep (3m+) girders - minor corrosion

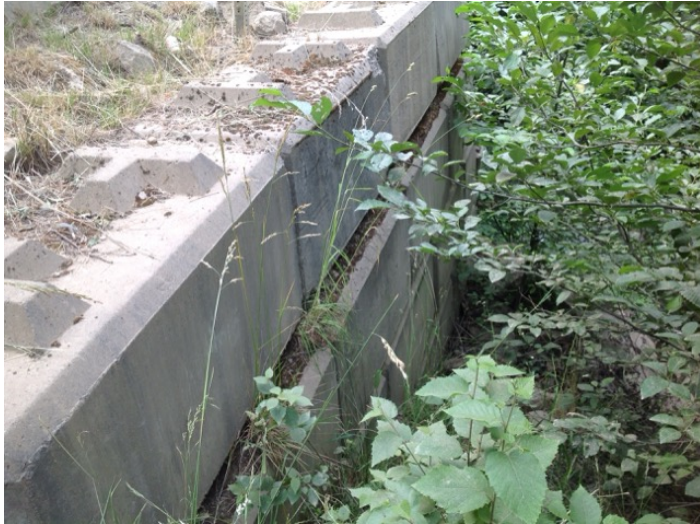
downstream right bank

right downstream wall battered

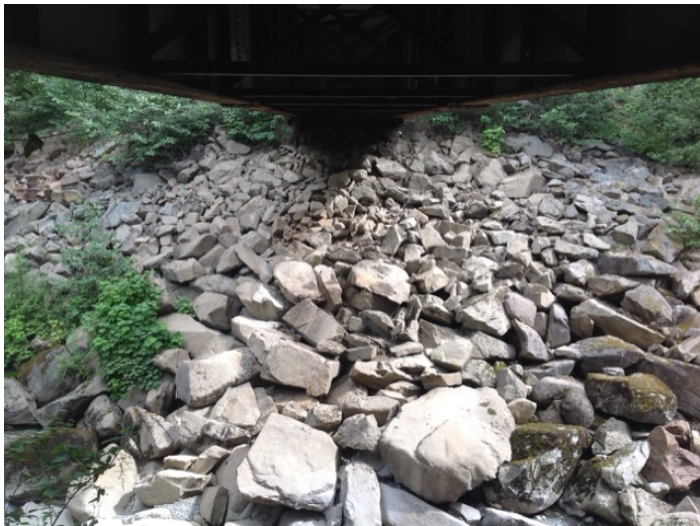
Right Bank Abutment when facing downstream

plates and rubber pads right bank
