CK-2107

HARRISON EAST 24.8km

2015 Inspection

| Crossing Name | Cogburn Creek |

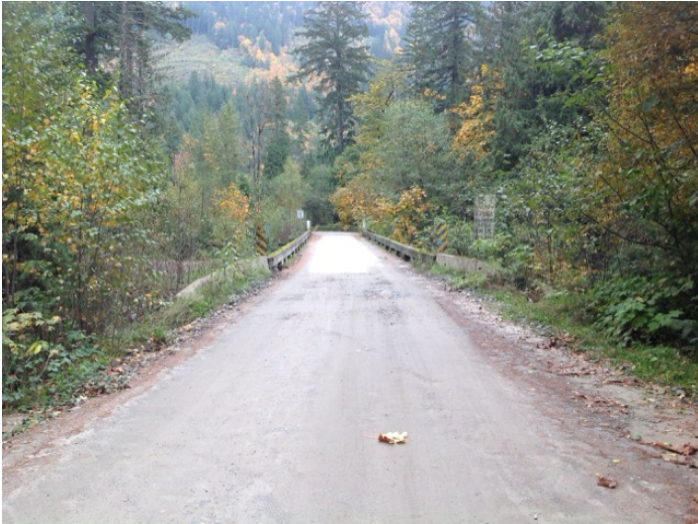
Approach from Right Bank when facing downstream

Brushing Required Y minor

| 1 | Medium | brush approaches |

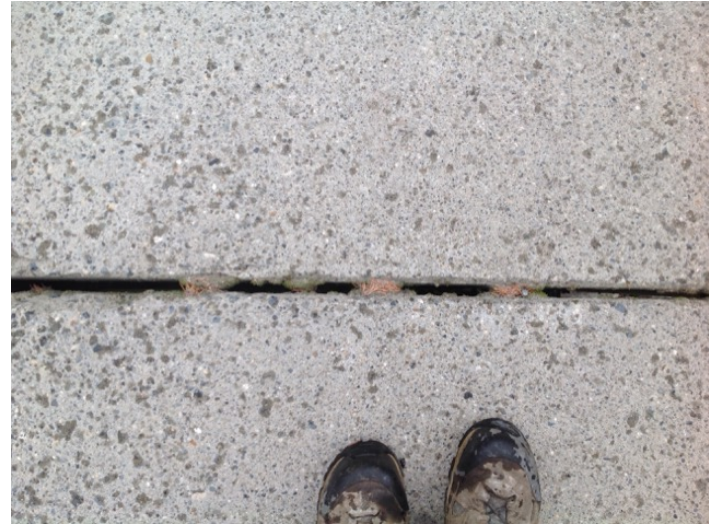
compression seal missing

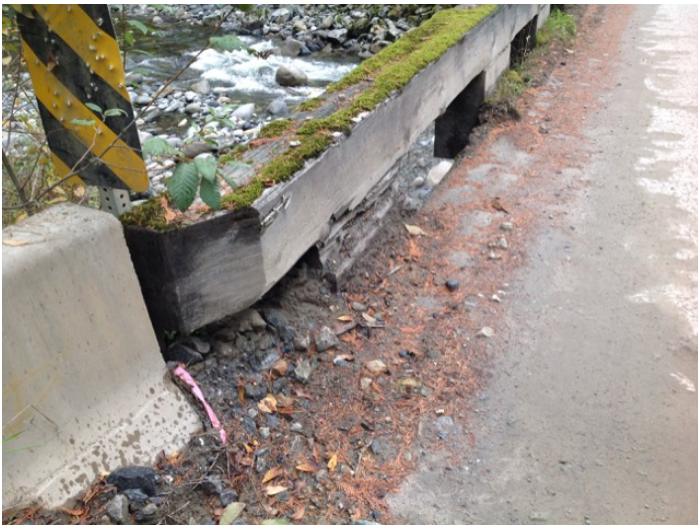
| Curb Rail/Blocks/Posts | Poor | rotten risers and blocks |
| Overall Deck Condition | Poor | due to rotten risers and blocks |

damaged riser

Replace guardrail, risers and blocks; and brush approaches. Present load rating of L150 or 136 tonnes to continue.

| 2 | Medium | replace guardrail system |

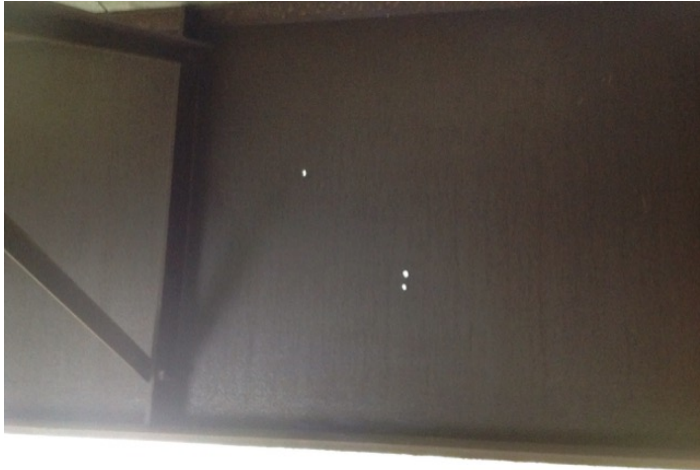
bullet holes through web of upstream girder

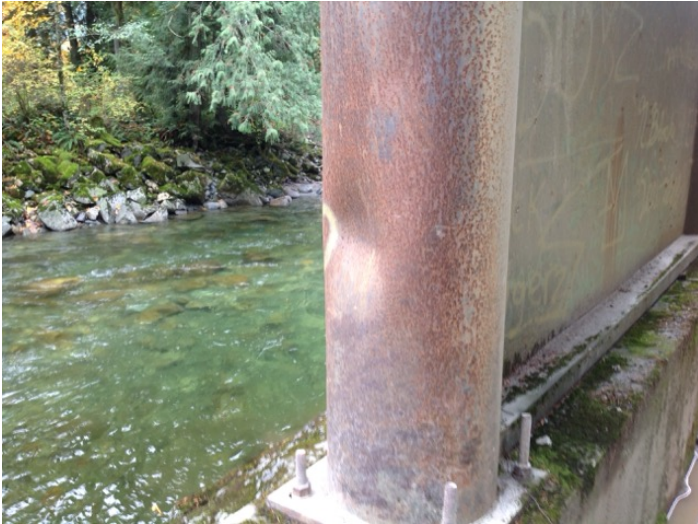
damage to upstream pier pipe column
