CK-2109

HARRISON EAST 35.3km

2015 Inspection

| Crossing Name | Hornet Creek |

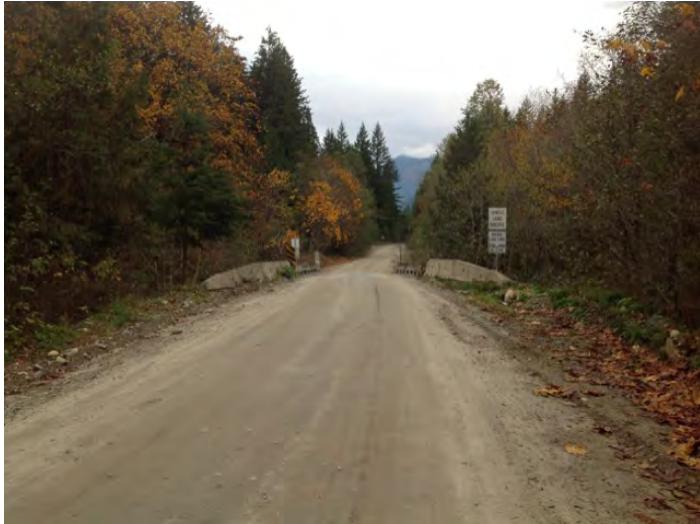
Approach from Left Bank when facing downstream

Delineator Missing  
Left ☐ 0 ☒ 1 ☐ 2

Replace missing delineators; monitor deck panels for movement. Structure is tentatively planned for replacement in the summer of 2016. Present load rating of L150 or 136 tonnes to continue.

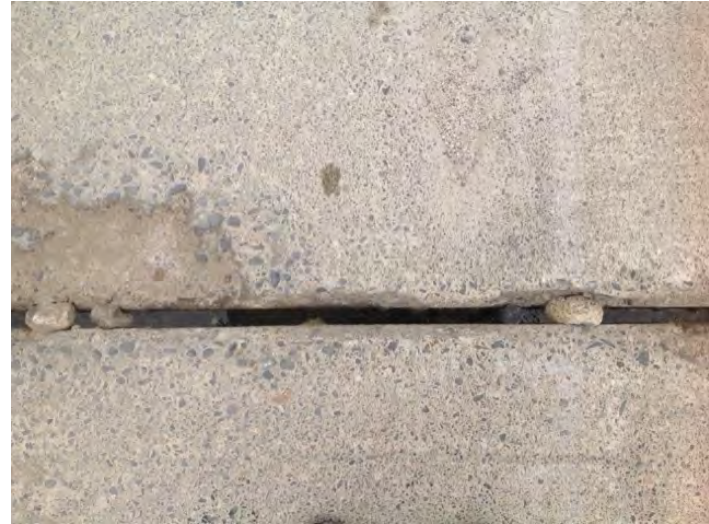
| Deck Joints | Fair | some damage at panel joints |

missing all deck joint seals

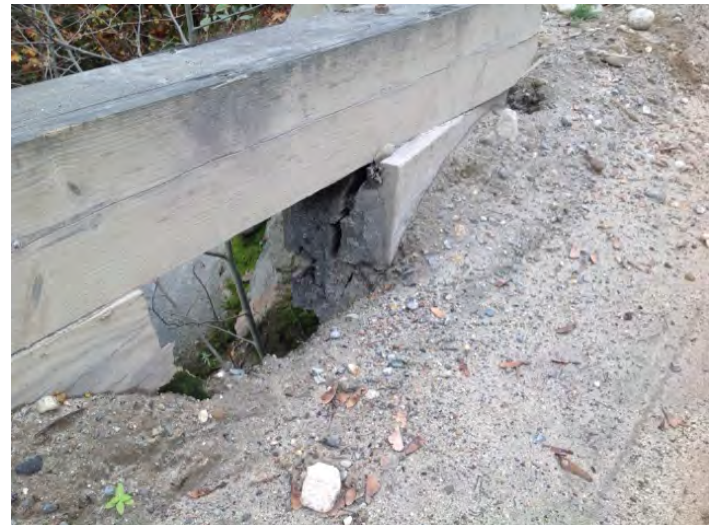
| Curb Rail/Blocks/Posts | Fair | some risers and blocks in poor shape |

damaged riser and block

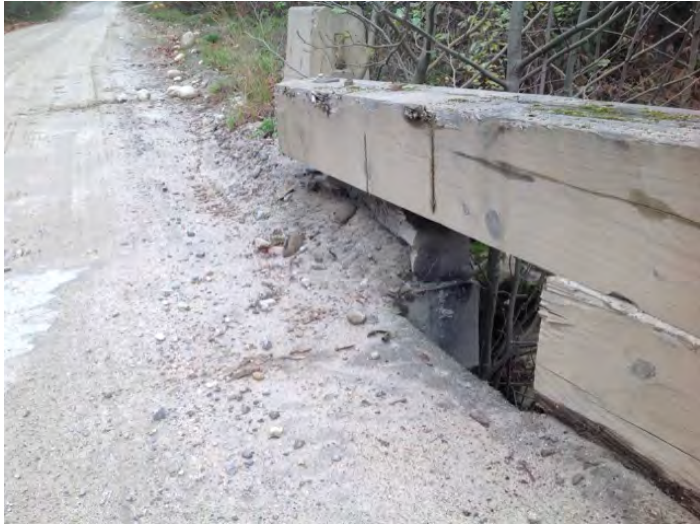
damaged riser

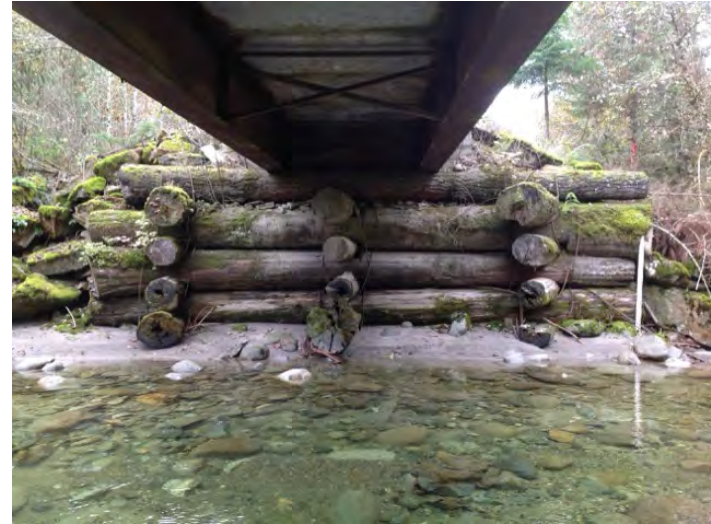
Left Bank Abutment when facing downstream

Riprap Poor none in front of crib

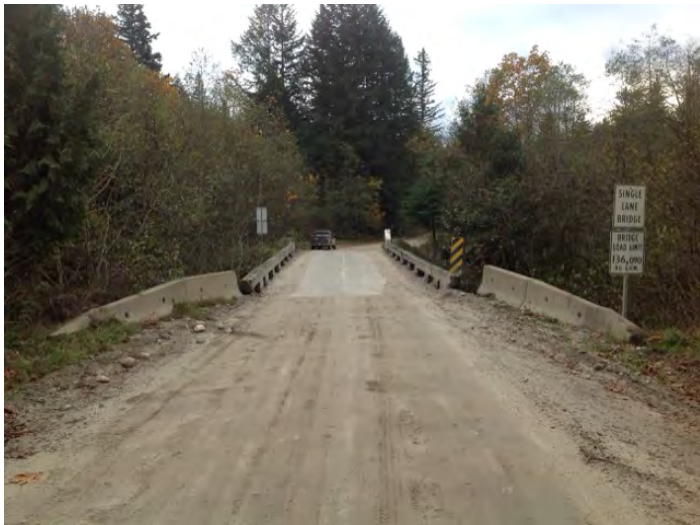
Approach from Right Bank when facing downstream

Delineator Missing  
Right ☐ 0 ☒ 1 ☐ 2

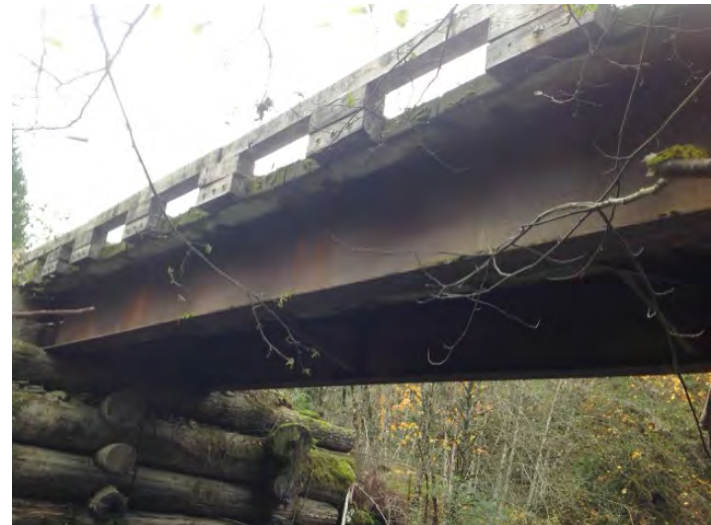
| Deck to Girder Bolts | Fair | some deck clips missing while others are loose - no movement in the panels evident |

missing and loose deck clips

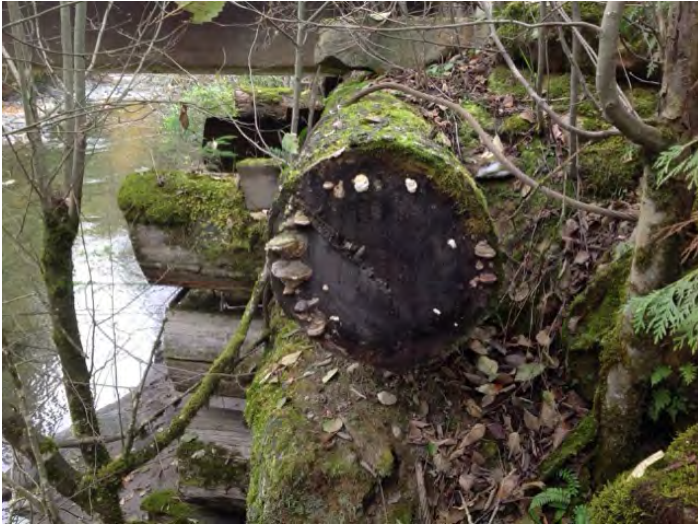
Douglas Fir logs appear to have been placed 7-8 years ago

Douglas Fir sills starting to deteriorate
