CK-2110

HARRISON EAST 38.5km

2015 Inspection

| Crossing Name | Clear Creek (structure # 29) |

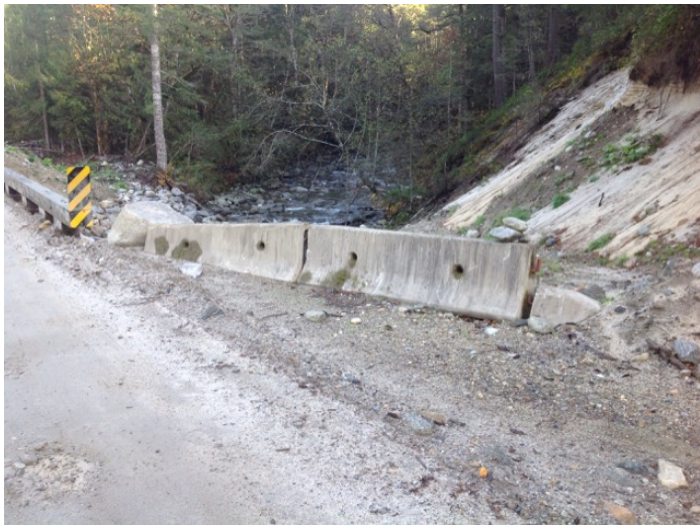
Fender Condition Fair backwards

concrete barriers on left bank are backwards

Monitor first deck panel on left approach as the ballast wall is approximately 50mm below deck panel and will be subject to grader damage. Concrete barriers are placed backwards on left upstream approach and are not linked together - repair. Present load rating of L150 or 136 tonnes to continue.

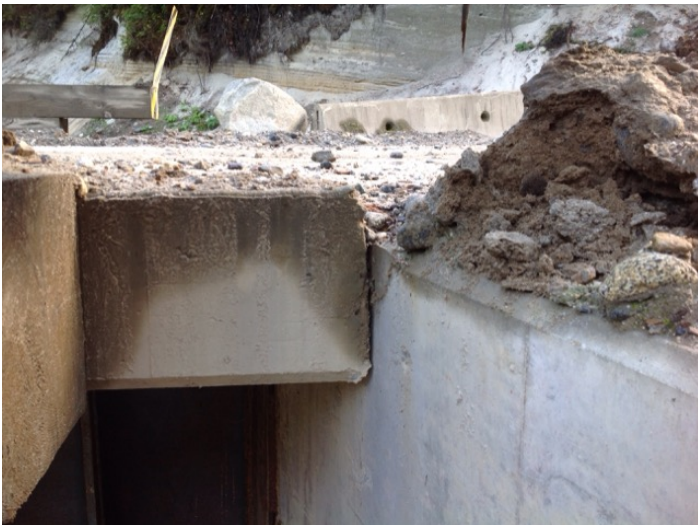
Ballast Wall Fair left bank wall hung 50mm lower than deck panel

left bank ballast wall hung 50mm lower than deck panel - probe to grader damage

| Item | Monitor Description | Frequency |
|---|---|---|
| 1 | deck panel damage at left approach | Routine Inspection |
