CK-2111

HARRISON EAST 48.9km

2015 Inspection

| Crossing Name | Big Silver River |

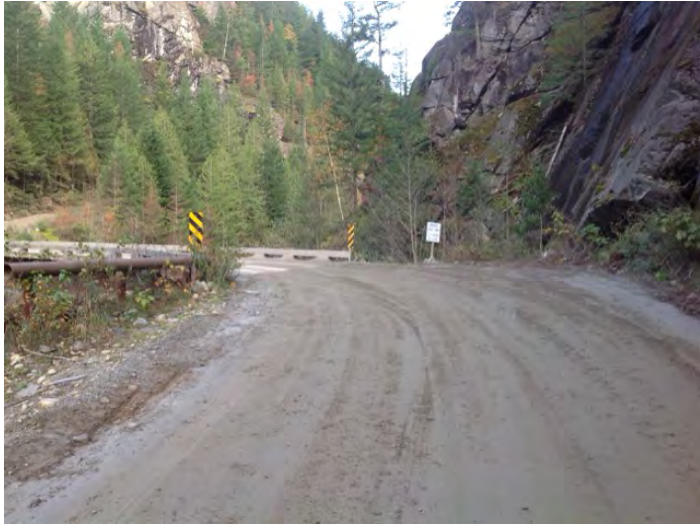
Approach from Left Bank when facing downstream

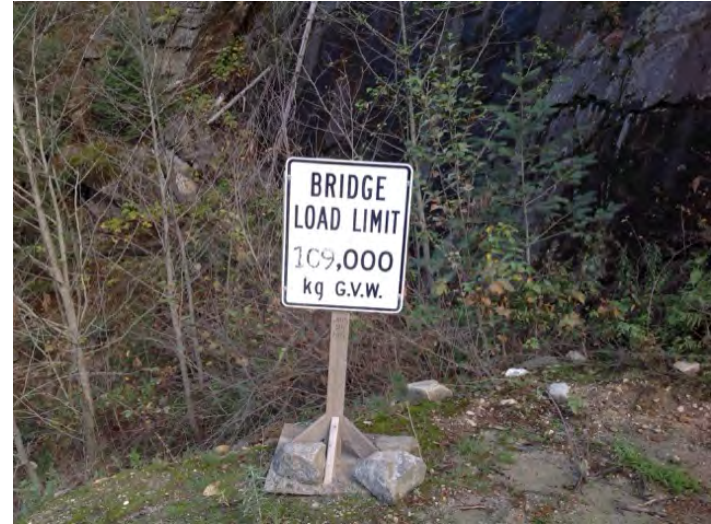
load rating sign

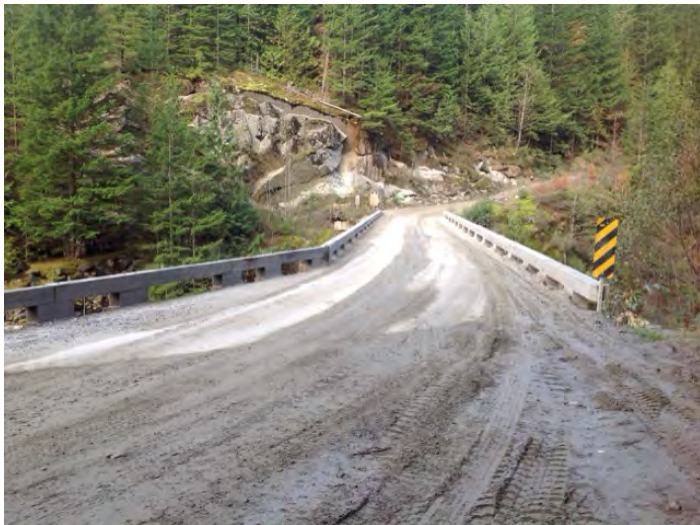
Approach from Left Bank when facing downstream

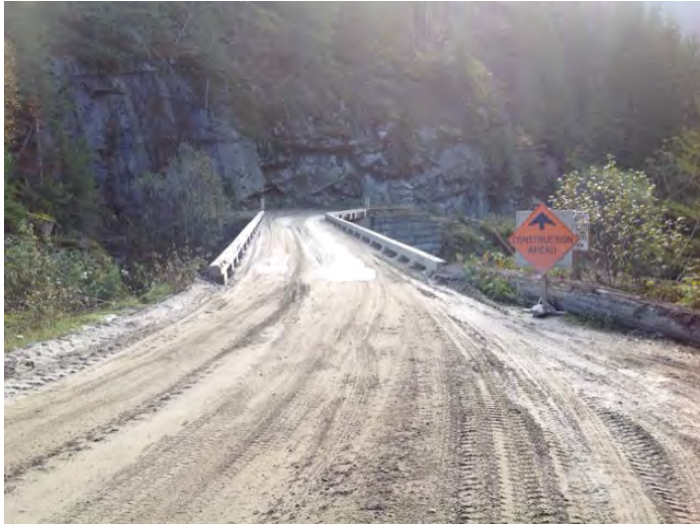
Approach from Right Bank when facing downstream

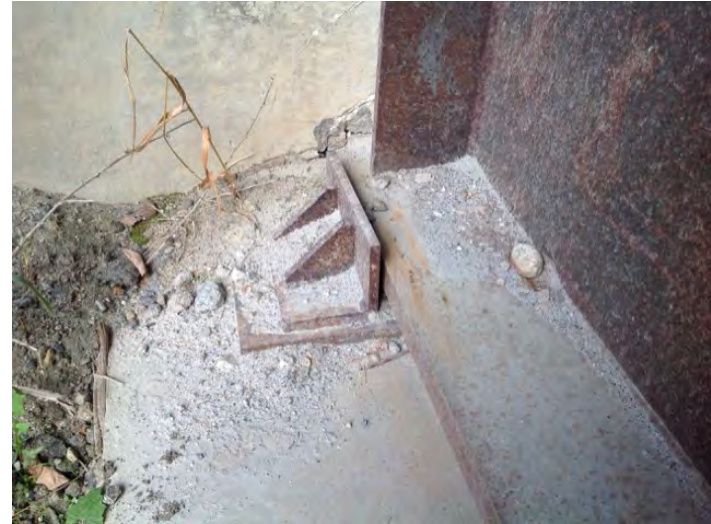
right bank girder bearing keepers - typical

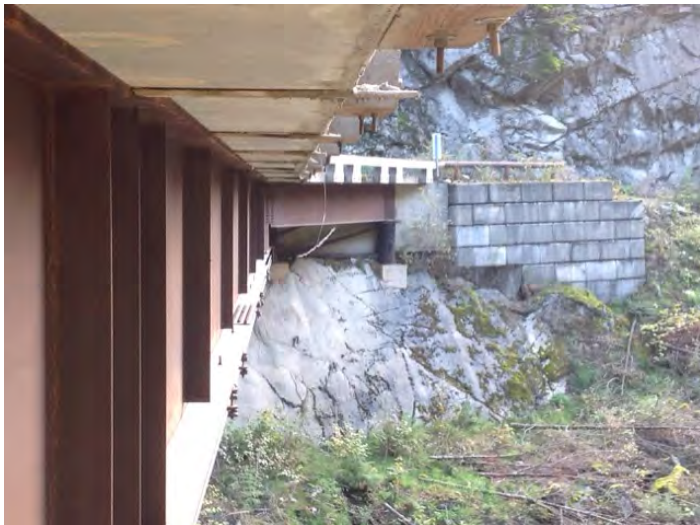
downstream left bank girder flare

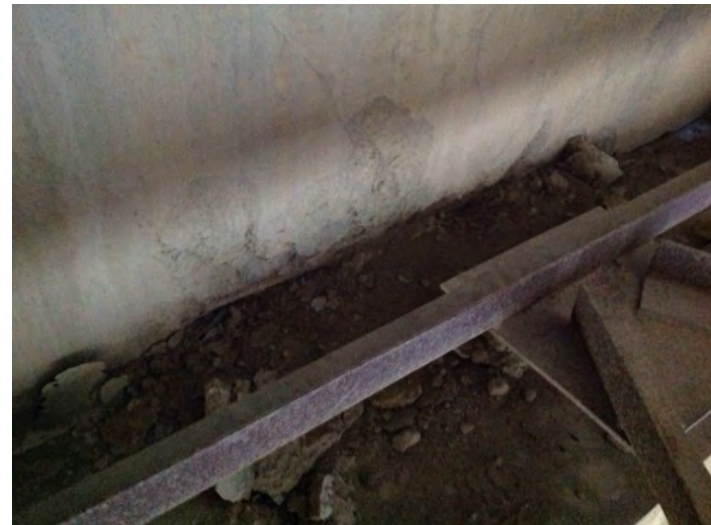
right bank has damage with rebar exposed on streamside

right bank ballast wall damage - rebar exposed

Replace missing delineators and replace missing fenders. Monitor the right approach ballast wall condition and the bearing bolts on the left approach. Present load rating of L120 or 109 tonnes to continue.

| 2 | right ballast wall condition | Routine Inspection |

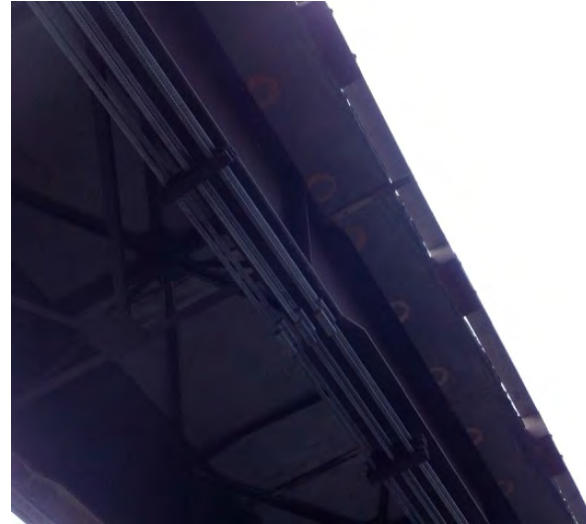
markings under deck panels - for fibre optics hangers?

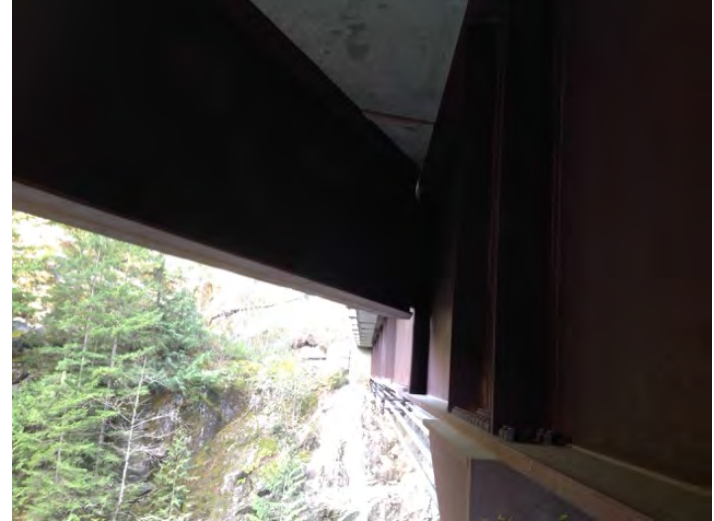
left bank girder flare

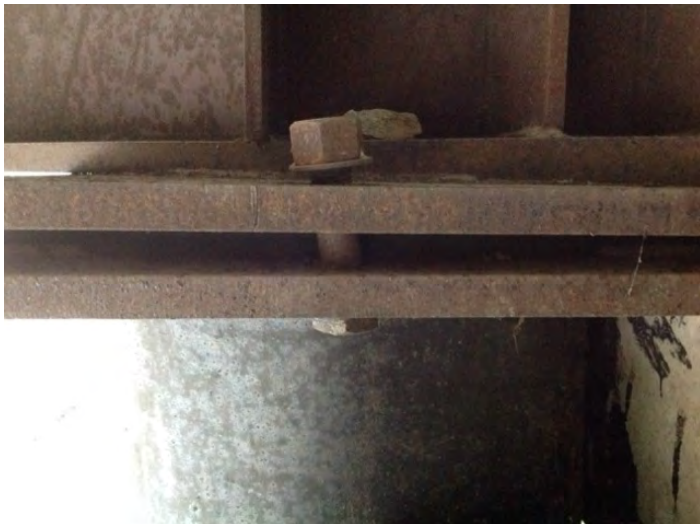
bearing bolts on left bank bending

upstream left bank bearing bolt

| 1 | bearing bolts | Routine Inspection |

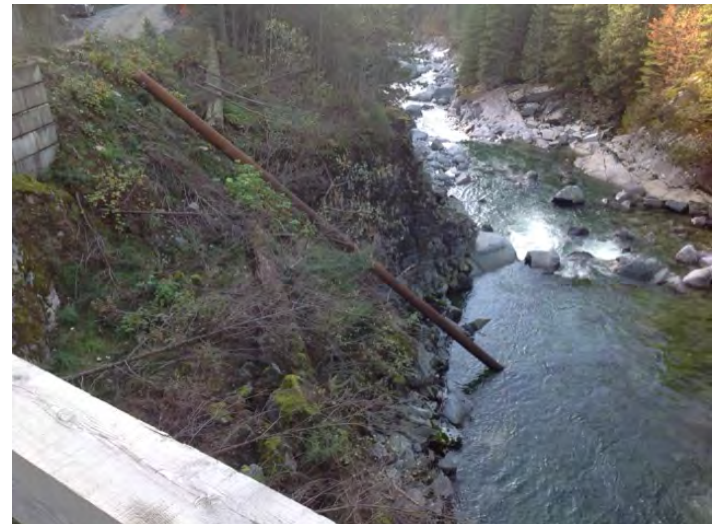
pipe in water on downstream side of bridge
