CK-2113

HARRISON EAST 53.5km

2015 Inspection

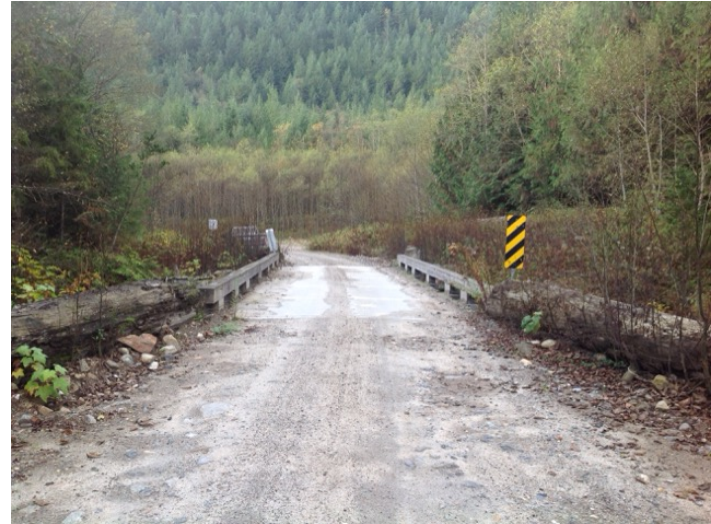
Approach from Left Bank when facing downstream

Delineator Missing  
Left ☐ 0 ☐ 1 ☒ 2Delineator Missing  
Right ☒ 0 ☐ 1 ☐ 2

Replace missing delineators. Present load rating of L150 or 136 tonnes to continue.

| Repair Item | Priority | Repair Description |
|---|---|---|
| 1 | Medium | replace missing delineators |

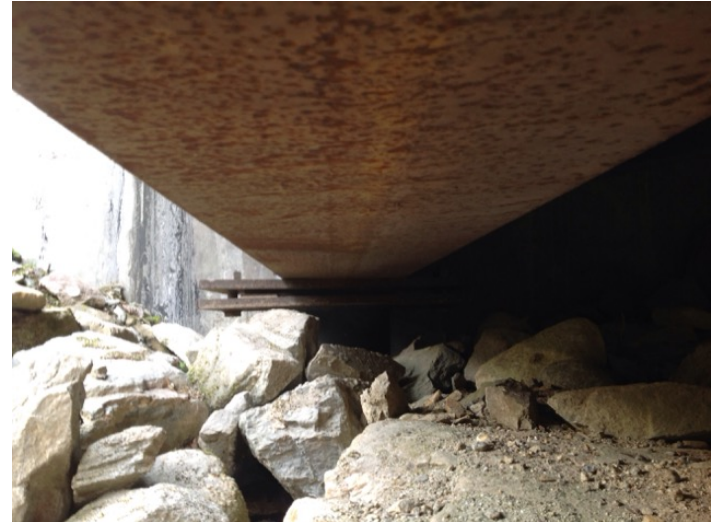
Bearings Fair

right downstream bearing slightly off center
