CK-2127

TALC CREEK 0.6km

2015 Inspection

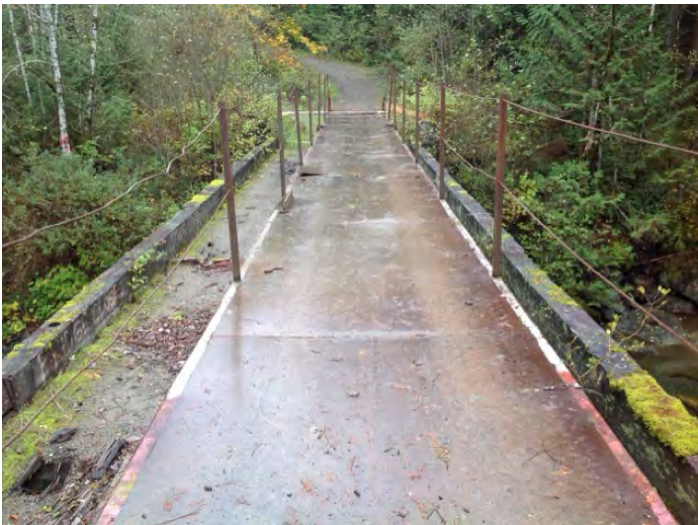
Comments    main bridge to remain at 0 tonnes due to rotten deck  
walk bridge bears directly on deck  
require structural drawings of walk bridge for load rating  
site has been surveyed

walk bridge

We don't have any information on the walk bridge, send record drawings, structural drawings and the crossing assurance statement to CEG for review. Limit loading to 1 tonnes and inspect prior to use. Replace structure soon.

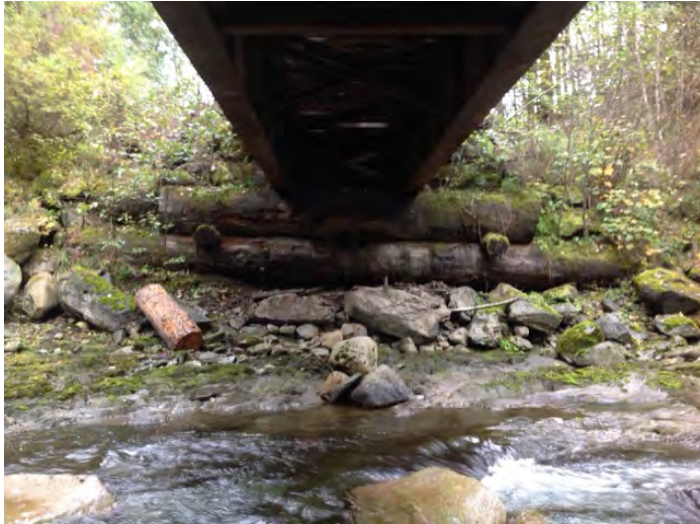
Left Bank Abutment when facing downstream

Hardware Poor rotten

Riprap Poor none in front of crib

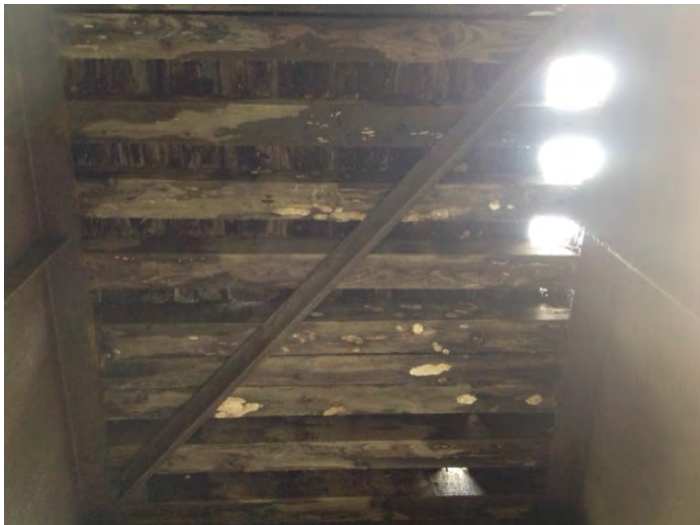
| Running Planks | Poor | rotten |
| Ties | Poor | rotting |
| Nails | Poor | protruding |
| Overall Deck Condition | Poor | rotten deck |
