CK-2128

STS'AILES 5.9km

2015 Inspection

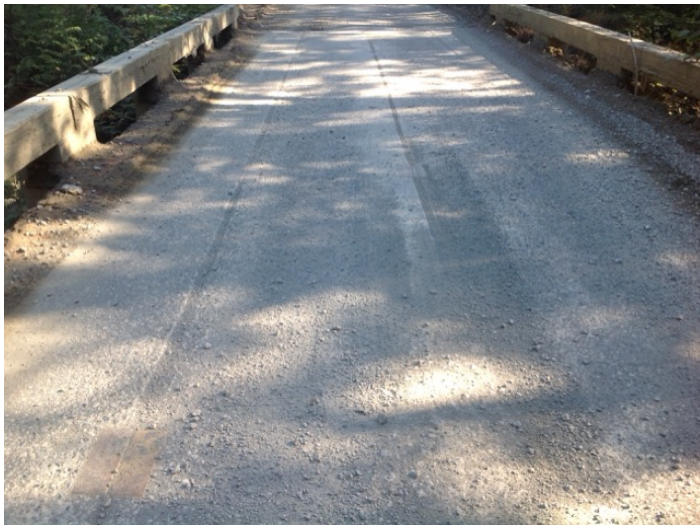
Overall Deck Condition Fair

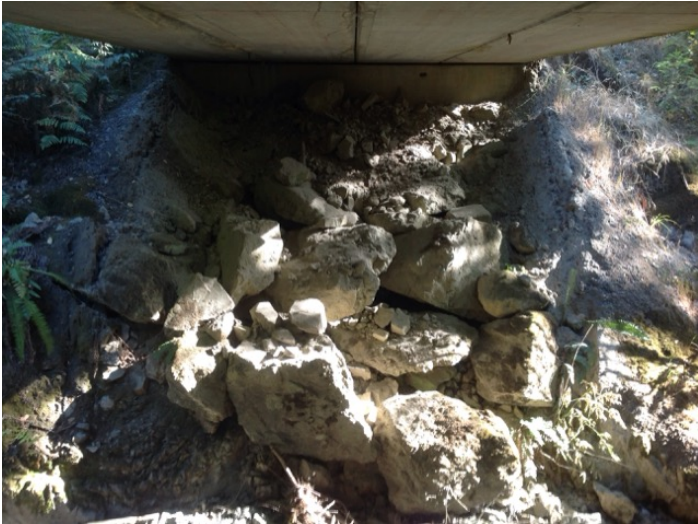
Left Bank Abutment when facing downstream

Riprap Fair scoured left bank but bedrock noted

Monitor left bank riprap. Present load rating of L75 or 68 tonnes to continue.

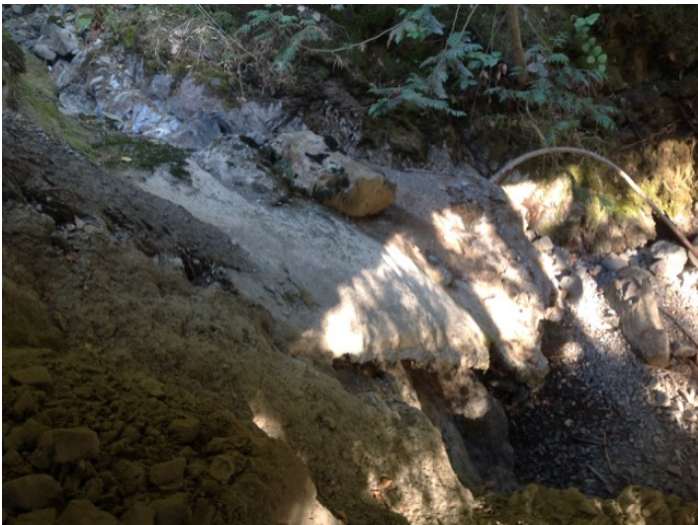
concrete on right bank
