CK-2130

STS'AILES 13.1km

2015 Inspection

| Crossing Name | Wells Creek |

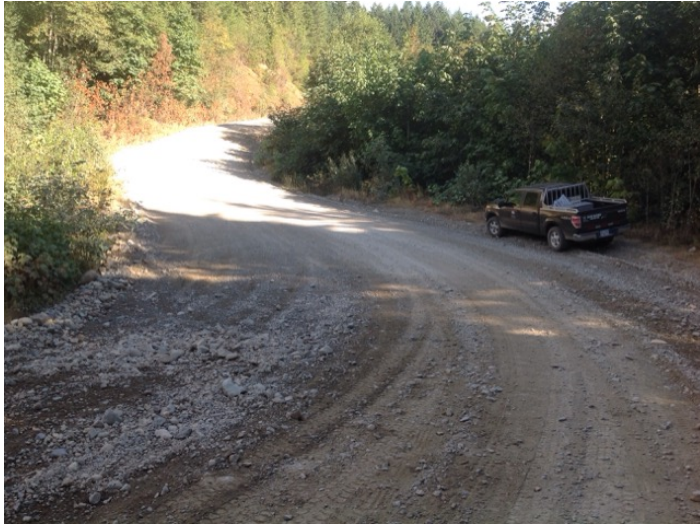
Approach from Right Bank when facing downstream

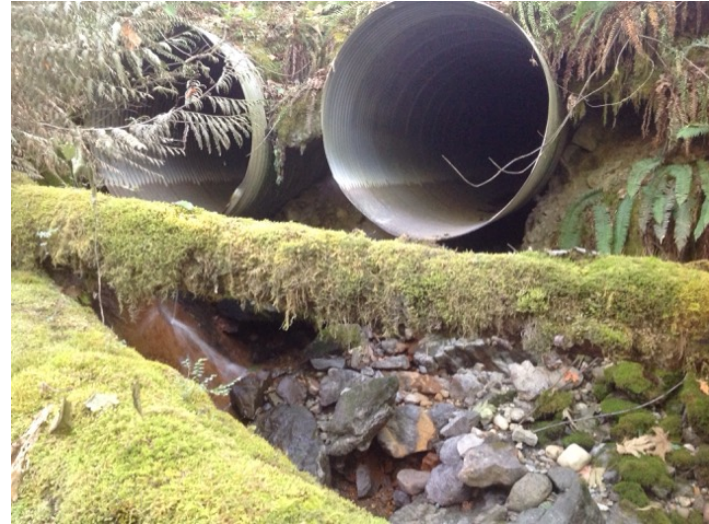
outlet

| Outlet | Fair | 1.5m drop onto bedrock |

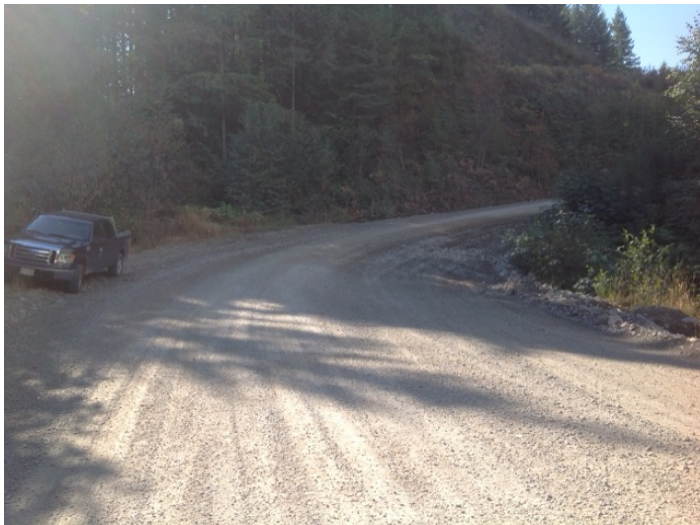
Approach from Left Bank when facing downstream

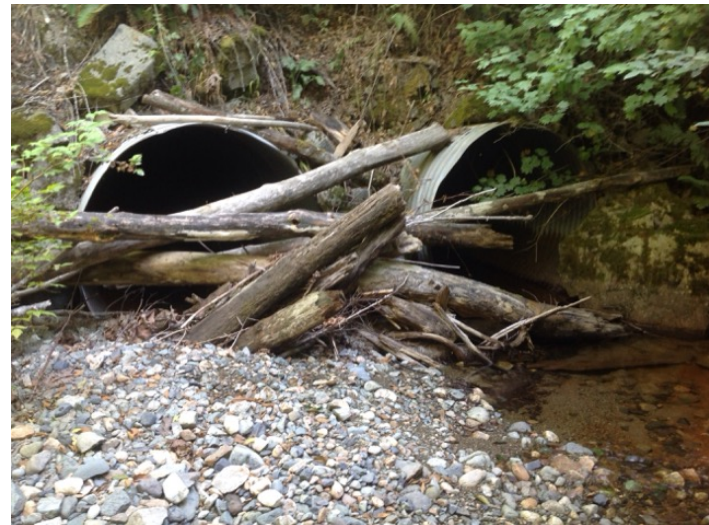
Clean inlet

| Inlet | Poor | debris accumulations |

Clean inlet. Present load rating of L150 or 136 tonnes to continue.

| Item | Monitor Description | Frequency |
|---|---|---|
| 1 | debris accumulations | Routine Inspection |
