CK-2132

STS'AILES 17.4km

2015 Inspection

| Crossing Name | Simms Creek |

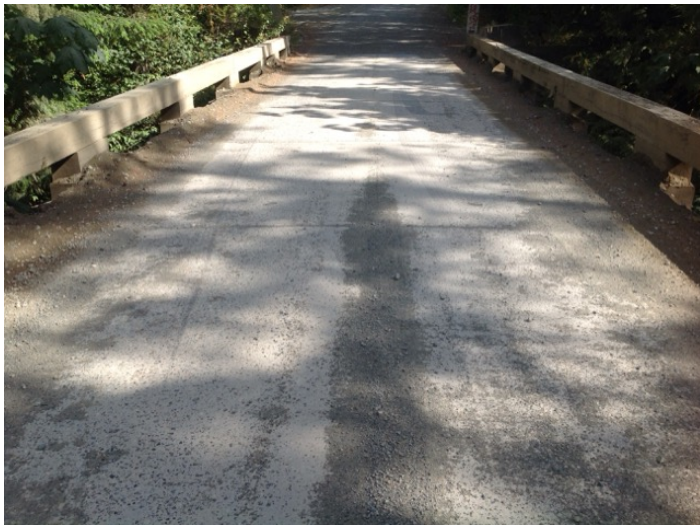
Concrete Deck Fair

Overall Deck Condition Fair

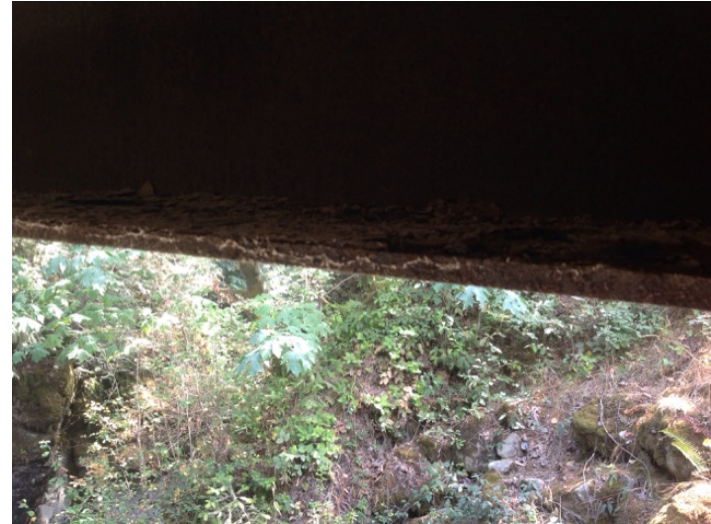
Girders Fair

surface rust

girder corrosion
