CK-2133

STS'AILES 19.4km

2015 Inspection

| Crossing Name | Walian Creek |

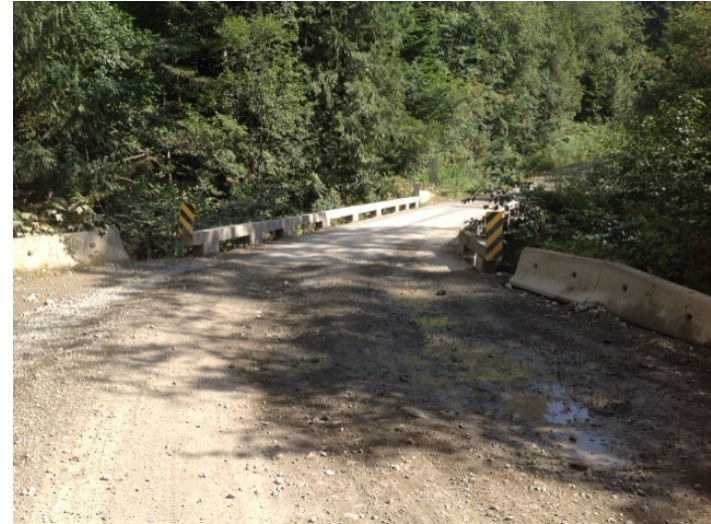
Approach from Right Bank when facing downstream

HC right approach

potholes right approach

Grade approaches. Present load rating of L150 or 136 tonnes to continue.

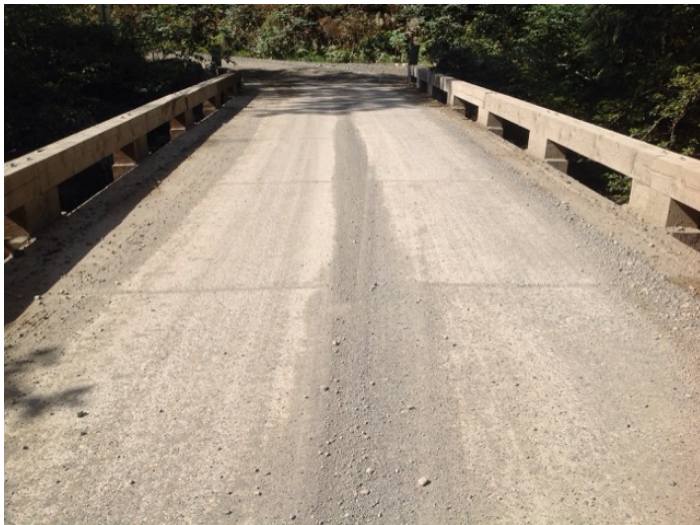
| Overall Deck Condition | Fair | |

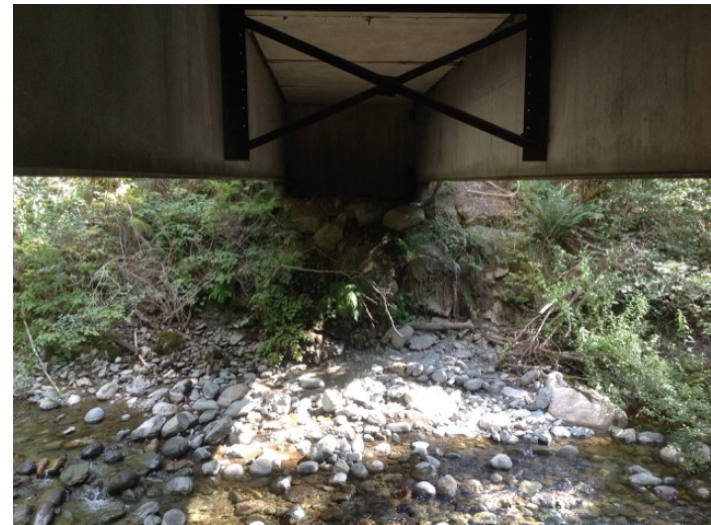
Left Bank Abutment when facing downstream

Bracing Good none on left bank due to pipe height

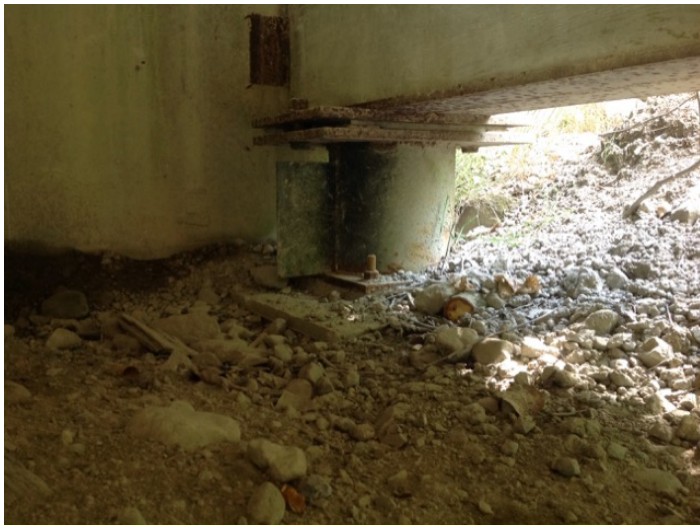
left bank pipe risers - typical
