CK-2136

STS'AILES 31.1km

2015 Inspection

| Crossing Name | Mystery Creek |

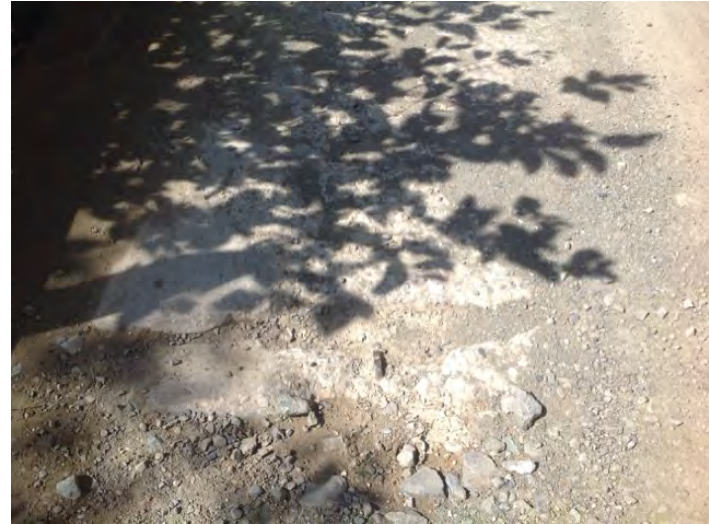
Concrete Deck Fair track damage and rebar exposed at approaches

| Repair Item | Priority | Repair Description |
|---|---|---|
| 2 | Medium | repair exposed rebar on running path of deck panels |

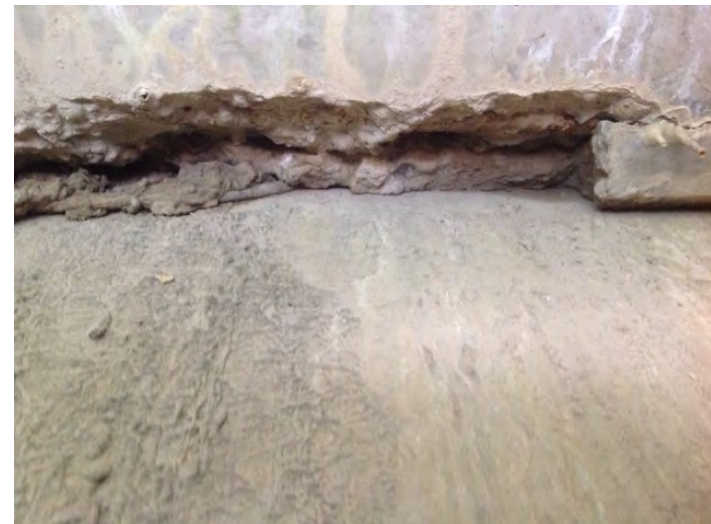
panel 1 damage underneath

Repair damage to deck panels. Brush approaches. Present load rating of CL-625 or 63 tonnes to continue. Update load rating sign.

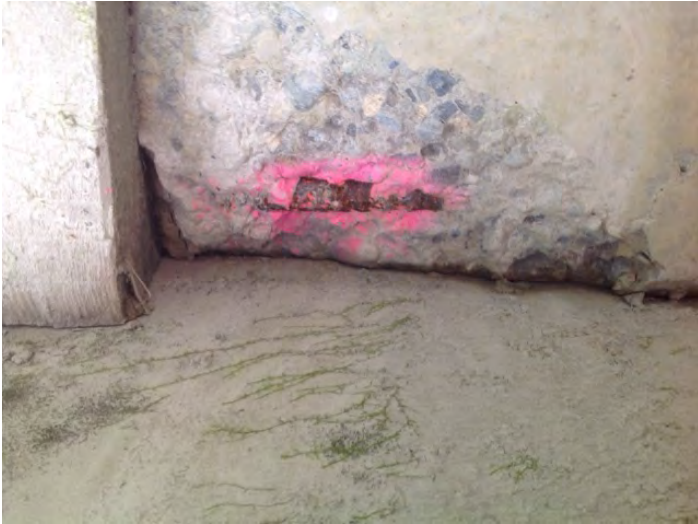
panel 1 damage

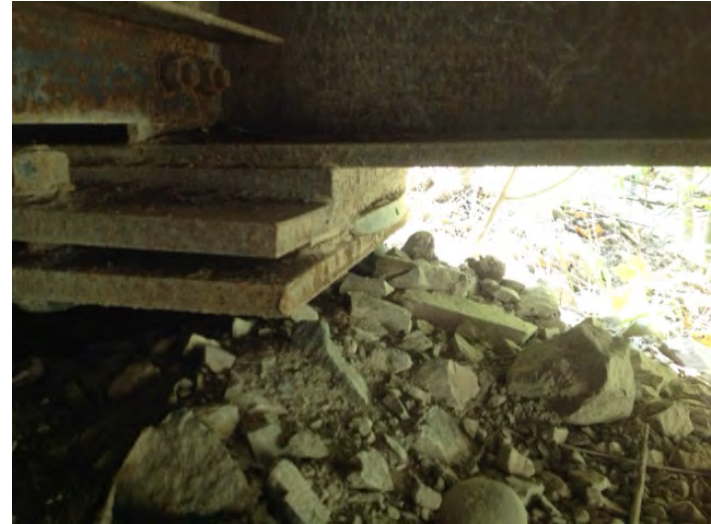
Bearings Fair

bearing plates and pads - typical

| Item | Monitor Description | Frequency |
|---|---|---|
| 1 | bearings | Routine Inspection |

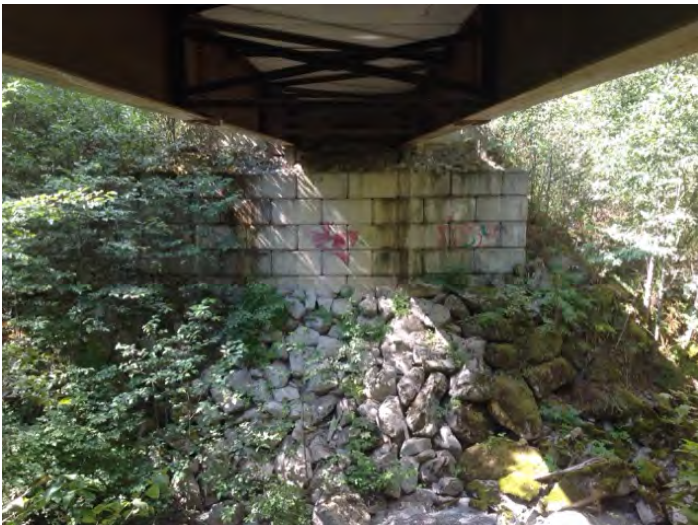
Right Bank Abutment when facing downstream

Concrete Good lock block bin wall on right bank
