CK-2152

JONES LAKE 4km

2015 Inspection

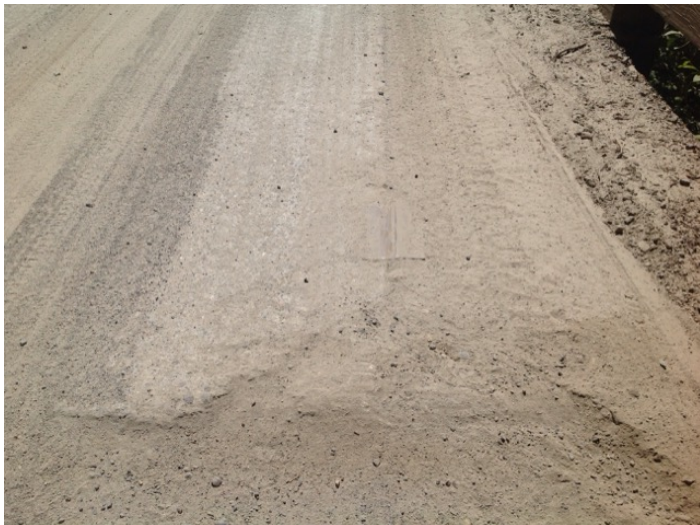
Concrete Deck Fair wear on wheel path

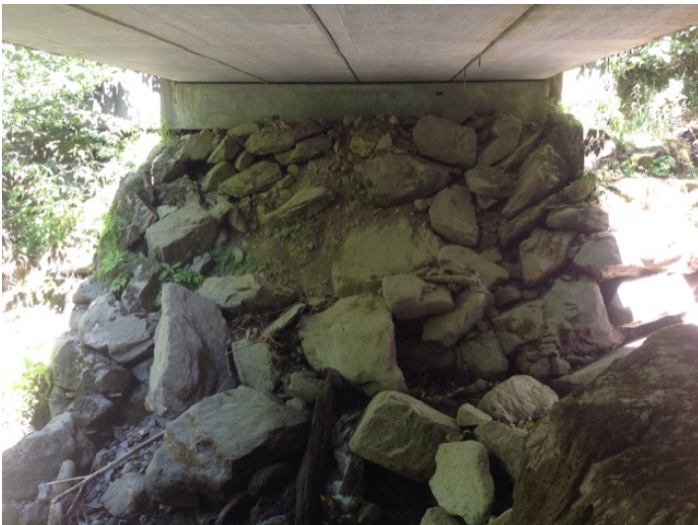
Right Bank Abutment when facing downstream

Riprap Fair eroded on right bank but abutment far enough back that it is low risk
