CK-2153

JONES LAKE 9.2km

2015 Inspection

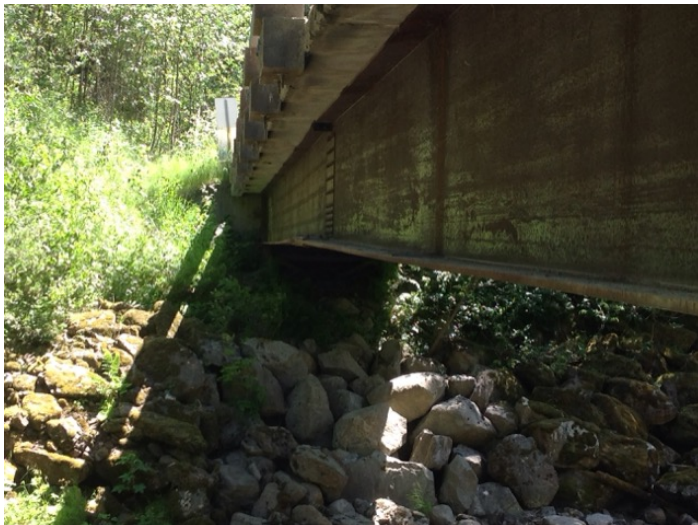
superstructure noticeably higher at splice

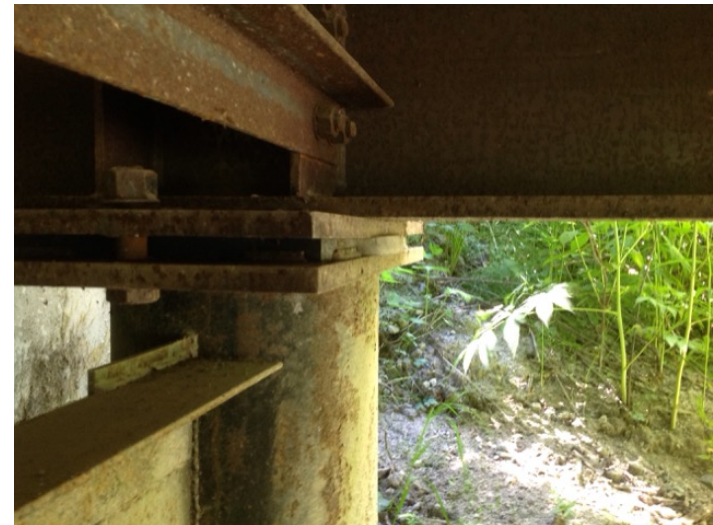
Bearings Fair

slight bulging on all bearing pads
