CK-2167

LOST CREEK 8.4km

2015 Inspection

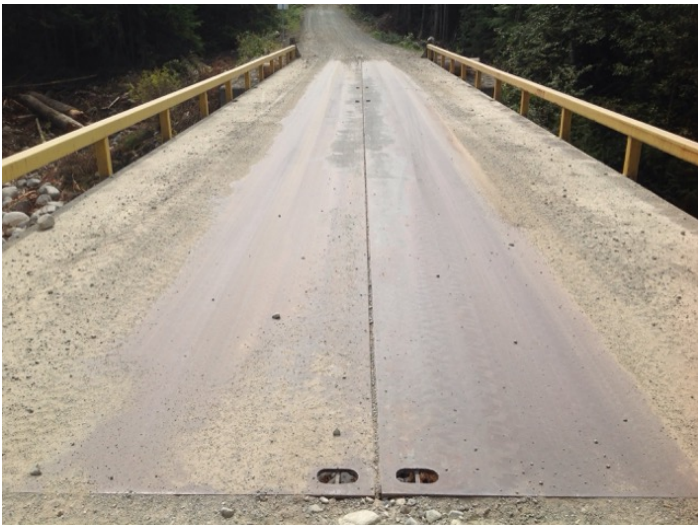
| Steel Deck Plate | Fair | anti skid all worn off |

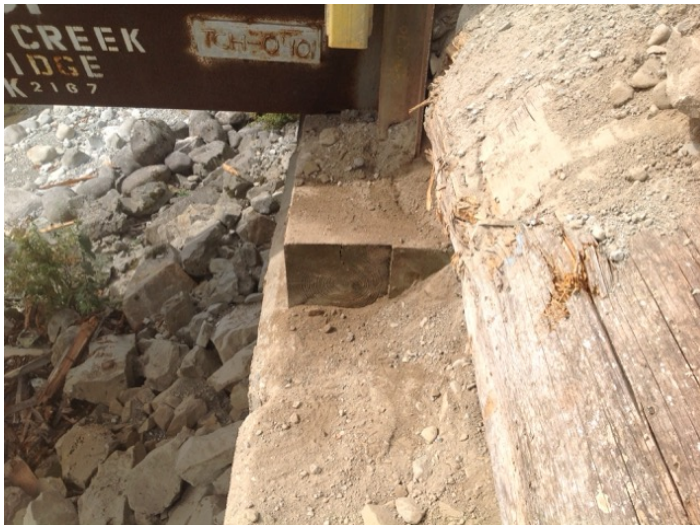
Caps or Sills Good new treated timber sills

new treated timber sills
