CK-2175

LOST-MURDO 1.2km

2015 Inspection

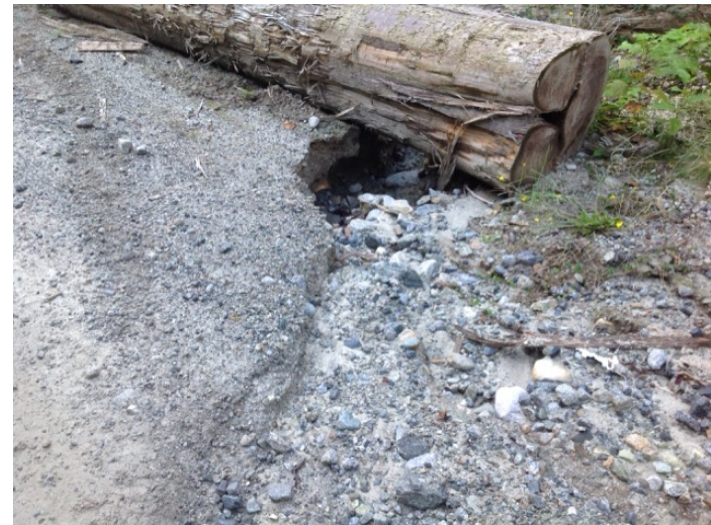
right approach down stream erosion

| 2 | High | place a water bar or cross ditch on the right approach to control erosion |

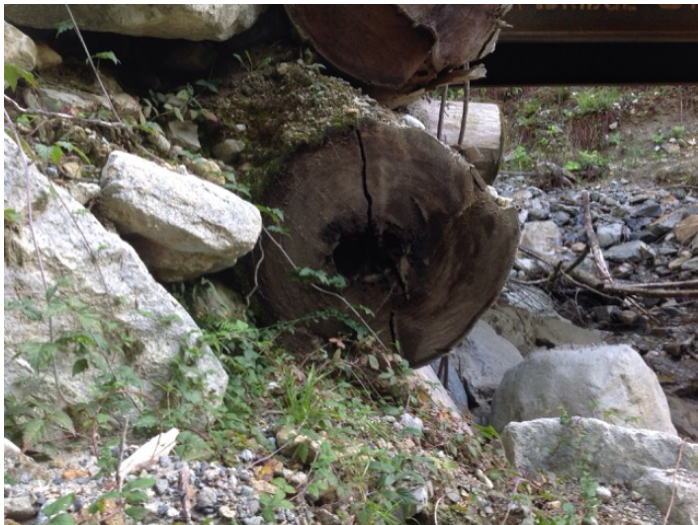
right bank abutment, 3rd crib log crack

| 1 | crack in 3rd crib log on right abutment | Routine Inspection |
