CK-2188

LOST-BLACKLOCK 0.4km

2015 Inspection

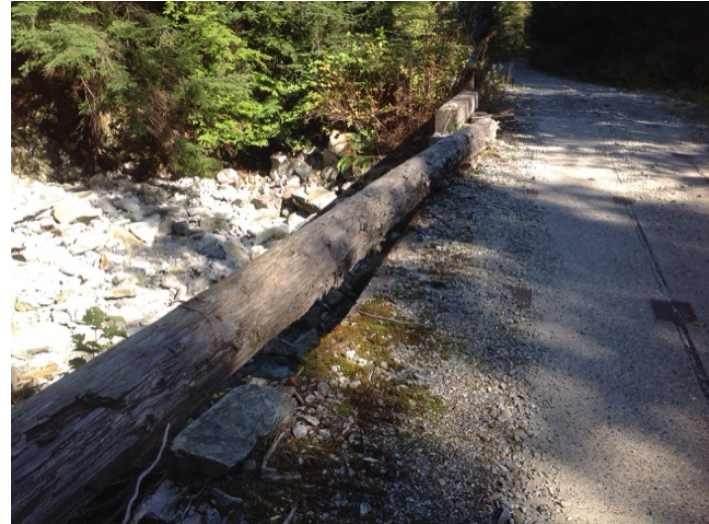
Guard Rail

| Curb Rail/Blocks/Posts | Poor | rotten |

| 1 | High | replace guardrail with activity |

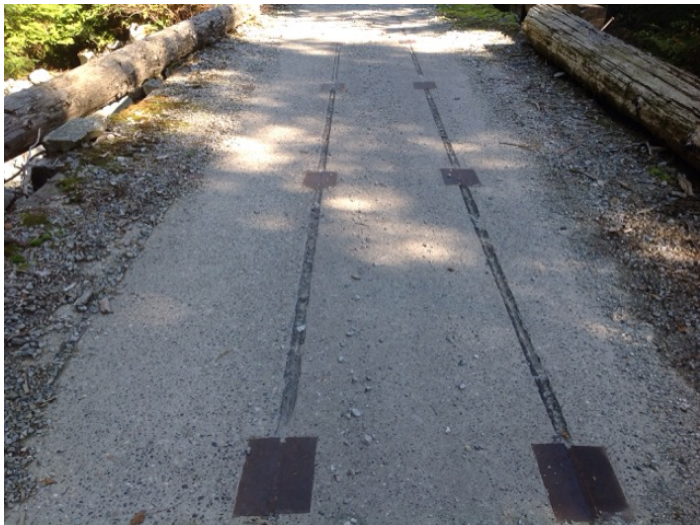
| Concrete Deck | Fair | |
| Overall Deck Condition | Poor | due to rail |
