CK-2194

MASELPANIK CREEK 0.1km

2015 Inspection

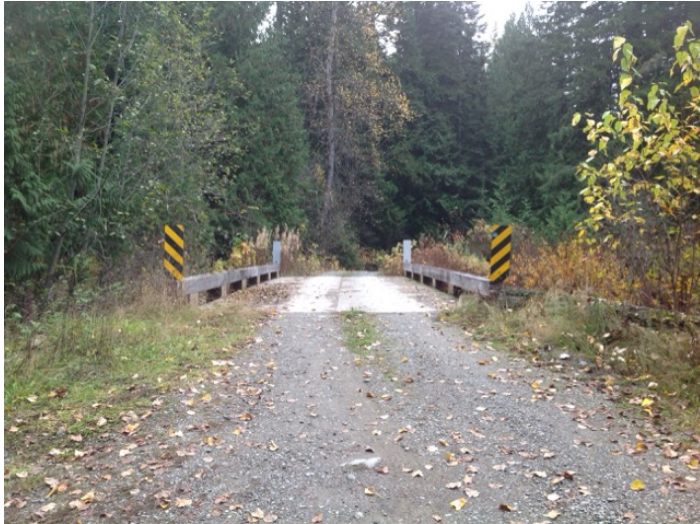
Approach from Left Bank when facing downstream

Bridge Ahead Signs  
Missing ☐ 0 ☒ 1 ☐ 2

Fender Condition Fair missing upstream right and downstream left

| 1 | Medium | post bridge ahead signs |

| 2 | Medium | replace missing fenders |

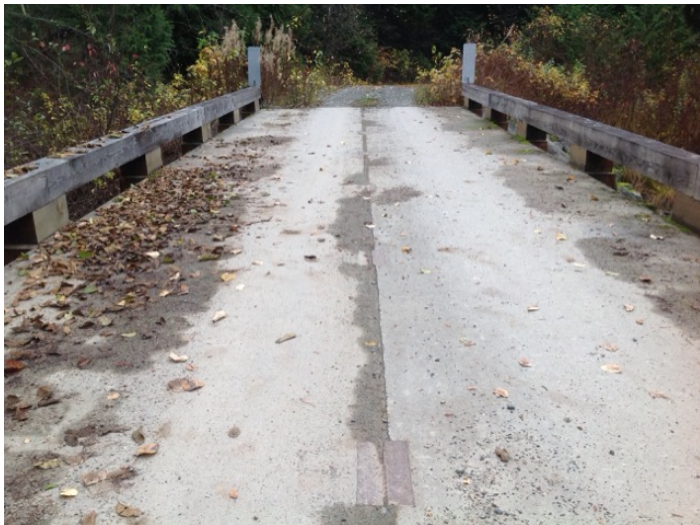
| Overall Deck Condition | Good |

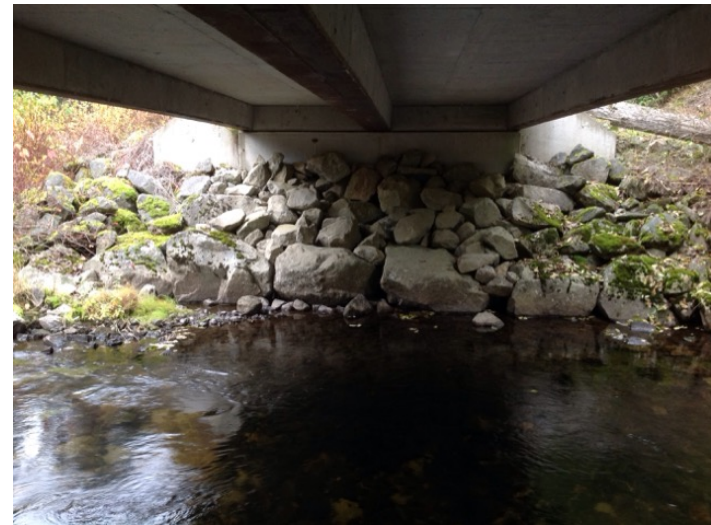
Left Bank Abutment when facing downstream

Concrete Good

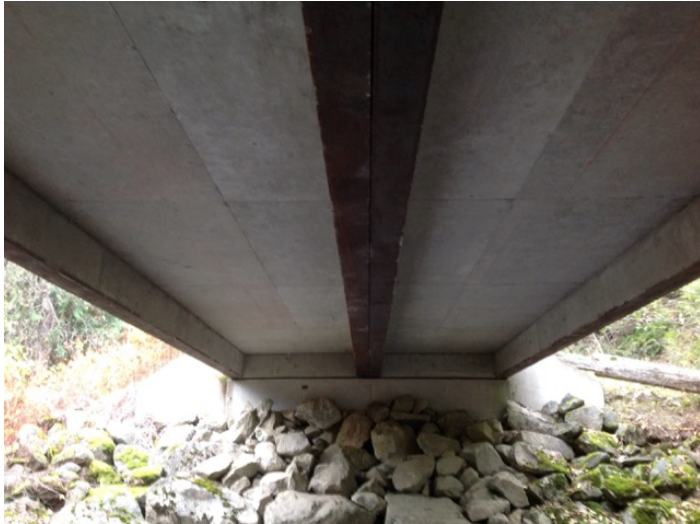
superstructure

Girders Good inverted C channel
