CK-2197

NAHATLATCH 12km

2015 Inspection

| Crossing Name | Log Creek |

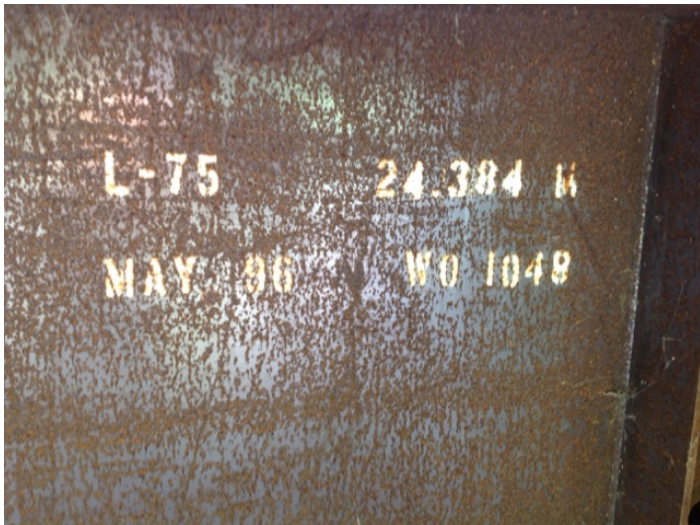
Structure ID

Serial/ID Plate 24.384m, L75, May 1996, WO1048
