CK-2198

NAHATLATCH 21.9km

2015 Inspection

| Crossing Name | Squakum Creek |

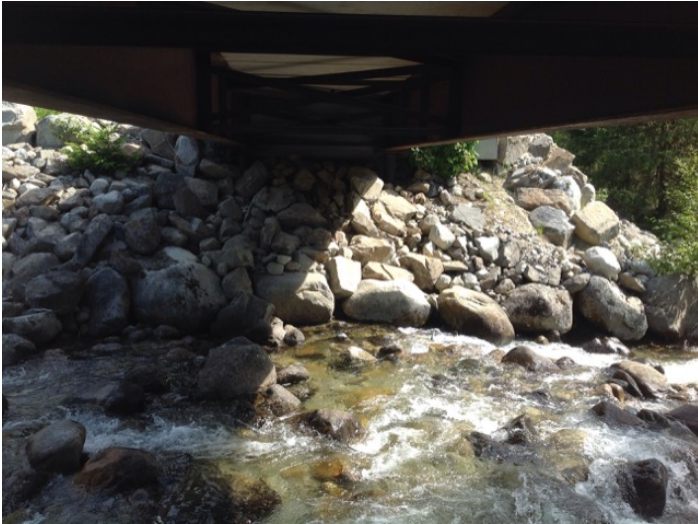
Left Bank Abutment when facing downstream

Fill Fair downstream left approach perched on rounded riprap

Riprap Fair downstream left approach rounded and slightly scoured
