CK-2207

MOWHOKAM 9.6km

2015 Inspection

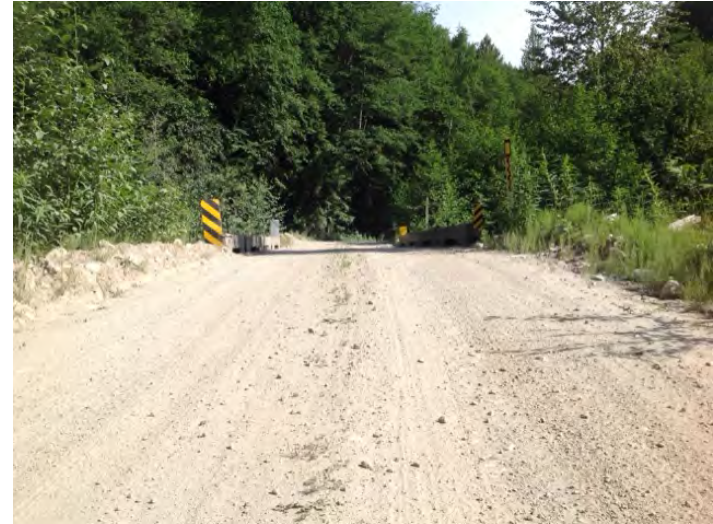
structure appears to be settling on downstream end

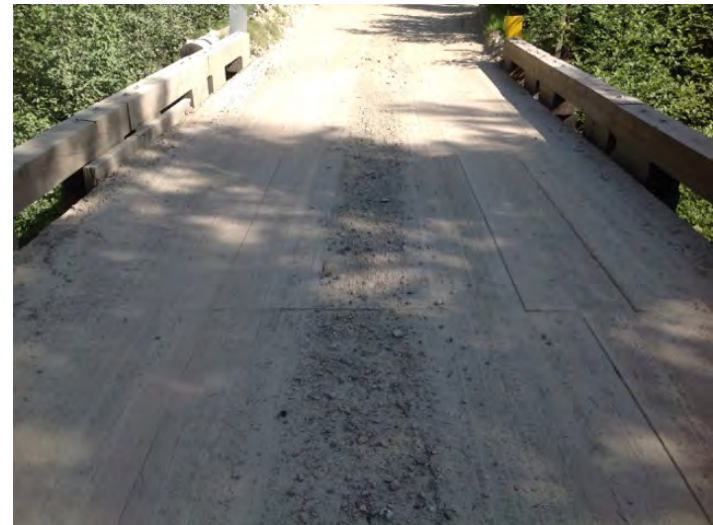
Running Planks Good new modular deck panels

modular panels

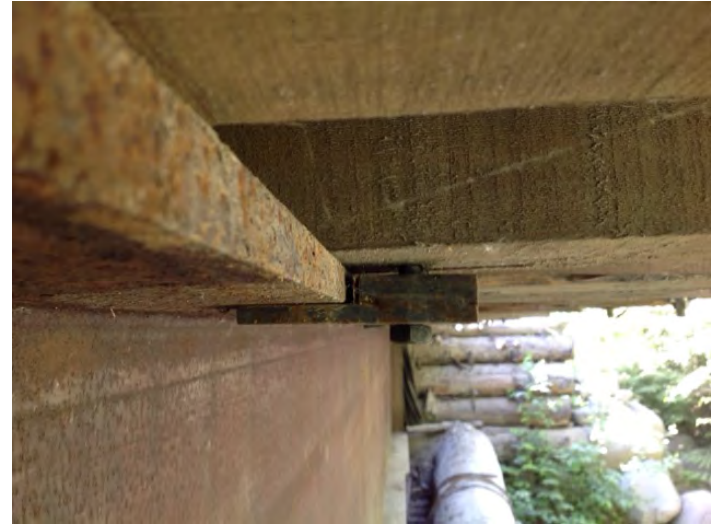
Deck to Girder Bolts Fair undersized deck clips but functional

deck clips not correct size but functional for now

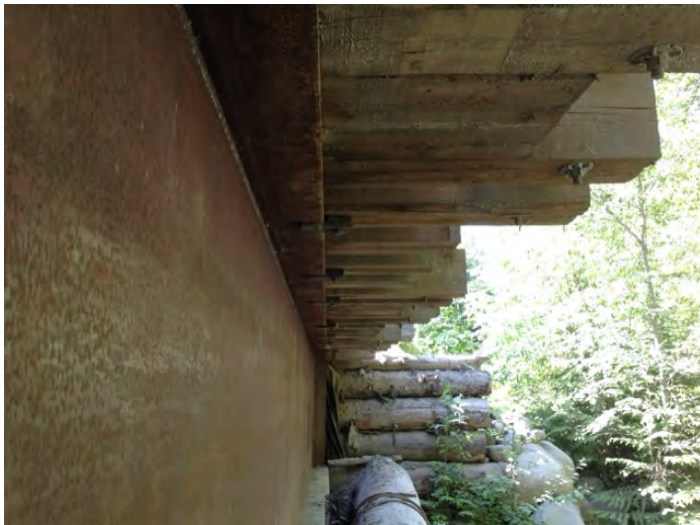
deck clips

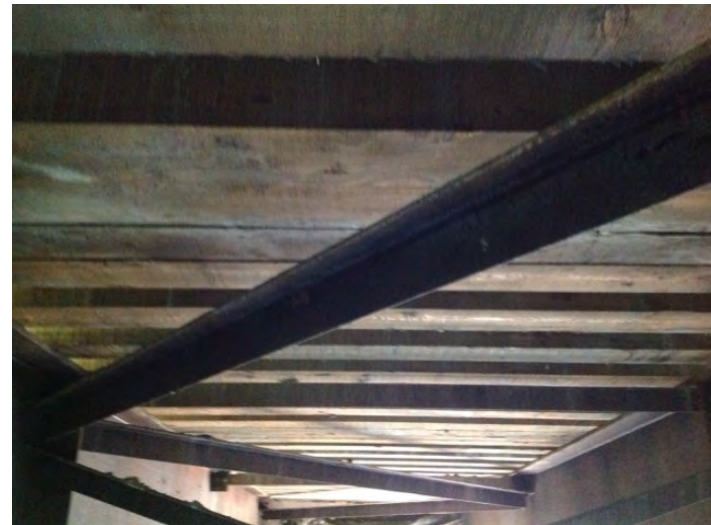
modular panels from underneath

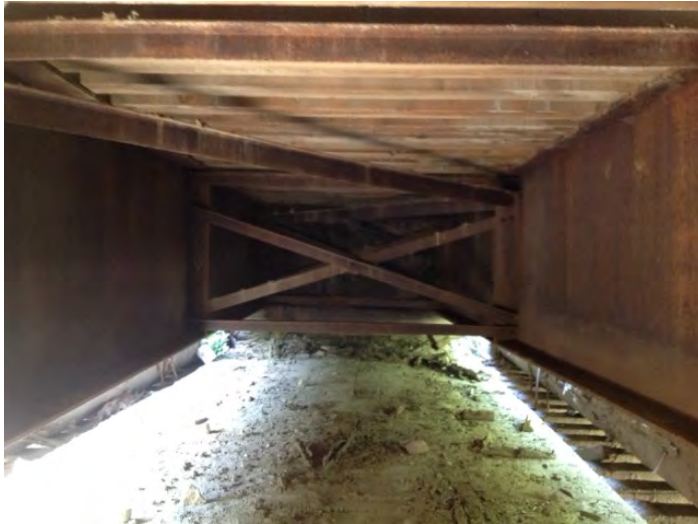
superstructure

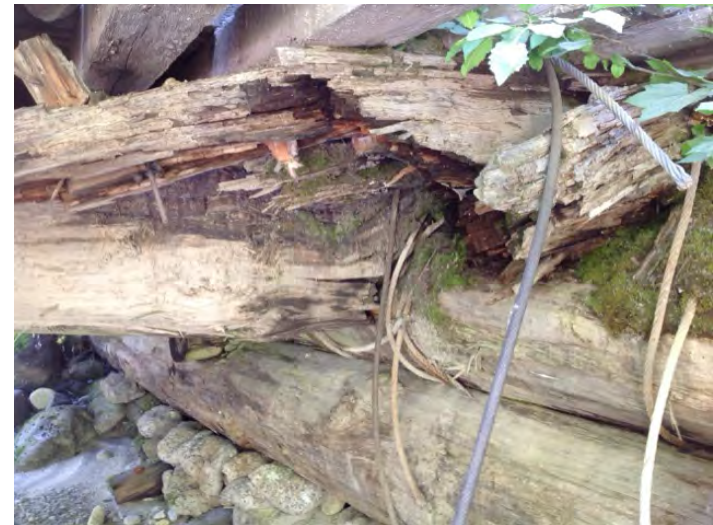
Comments Left Bank stringer structure under steel girder in really poor condition. left bank downstream girder completely sheared and only thing holding it up is the needle beam lashed to structural guardrail. when the stringer falls it may twist and dislodge other stringers and log sill that steel structure bears on

downstream log stringer, left side completely sheared

recommend removing log stringer structure below before it creates a problem for steel girder. replace structure with one that is slightly longer.
