CK-2209

MOWHOKAM EAST 0.1km

2015 Inspection

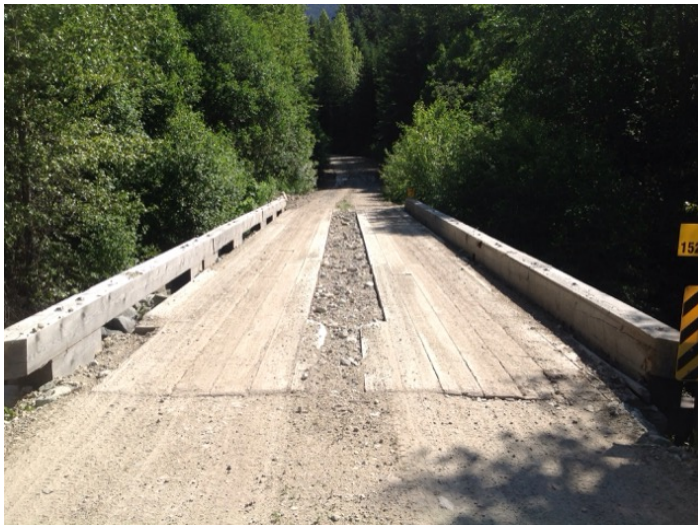
| Running Planks | Fair | some wear at bridge approaches |
| Deck to Girder Bolts | Poor | none |

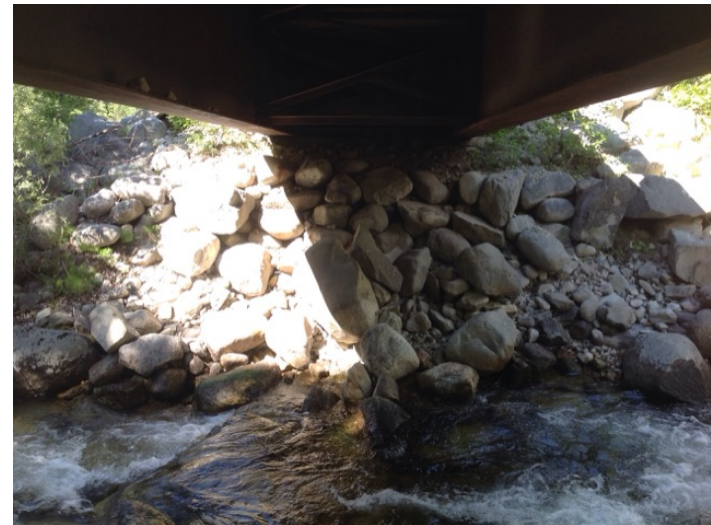
Right Bank Abutment when facing downstream

Riprap Fair rounded and oversteepened

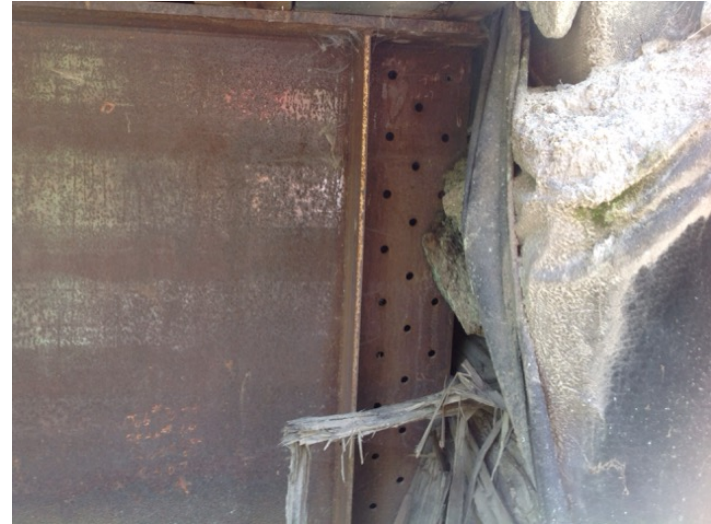
Girders Fair only a section of a longer spliced girder set

Comments    girders might be the other sections from CK-2207

steel girders only a section of planned spliced girder

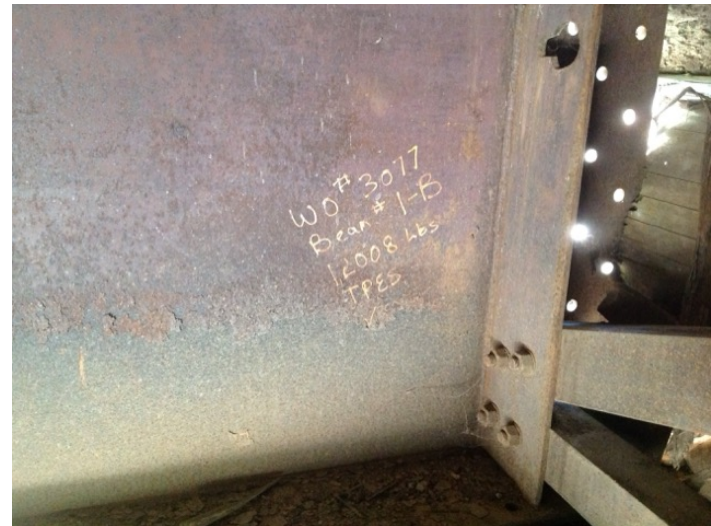
steel weights
