CK-2210

MOWHOKAM EAST 6.51km

2015 Inspection

| Crossing Name | Mowhokam Creek |

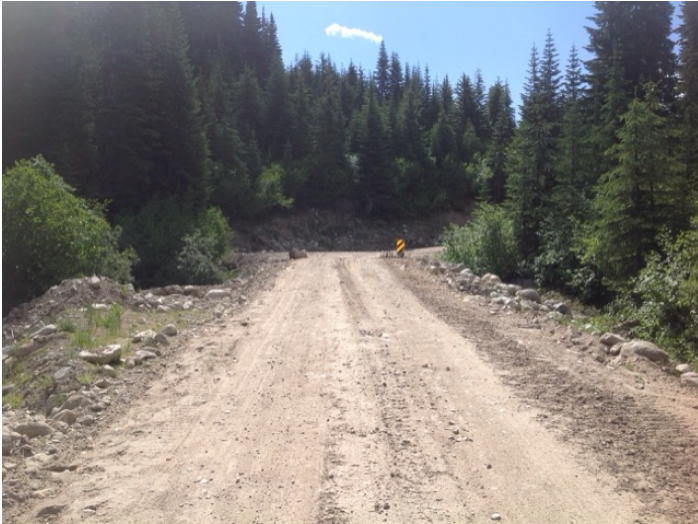
Approach from Left Bank when facing downstream

Bridge Ahead Signs  
Missing ☐ 0 ☐ 1 ☒ 2

Delineator Missing  
Left ☐ 0 ☐ 1 ☒ 2Delineator Missing  
Right ☒ 0 ☐ 1 ☐ 2

Fender Condition Poor none

Post bridge ahead signs replace missing delineators and fenders. Send record drawings and structural drawings to the CEG for an updated load rating. Limit loading to L60 or 54 tonnes until then - please post.

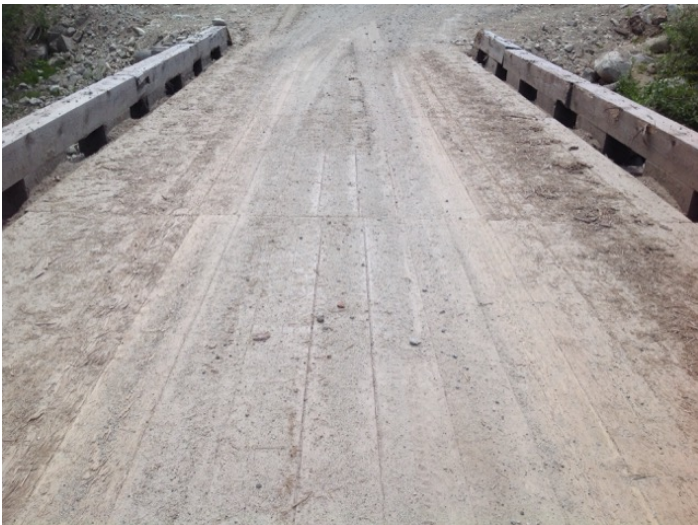
Overall Deck Condition Fair

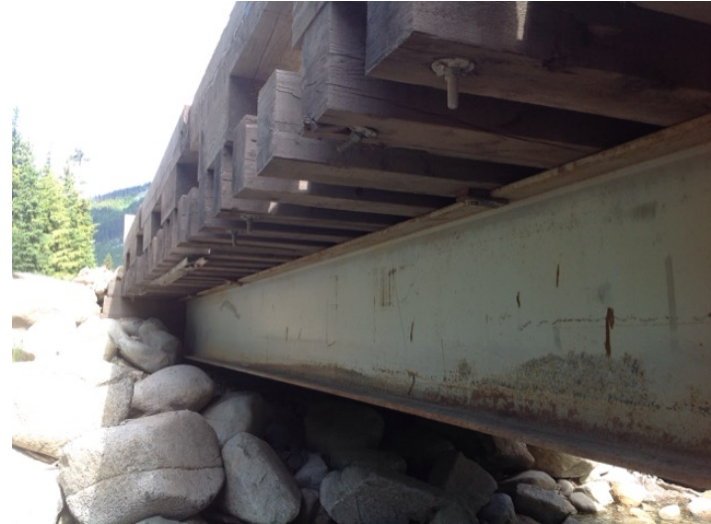
missing some deck clips

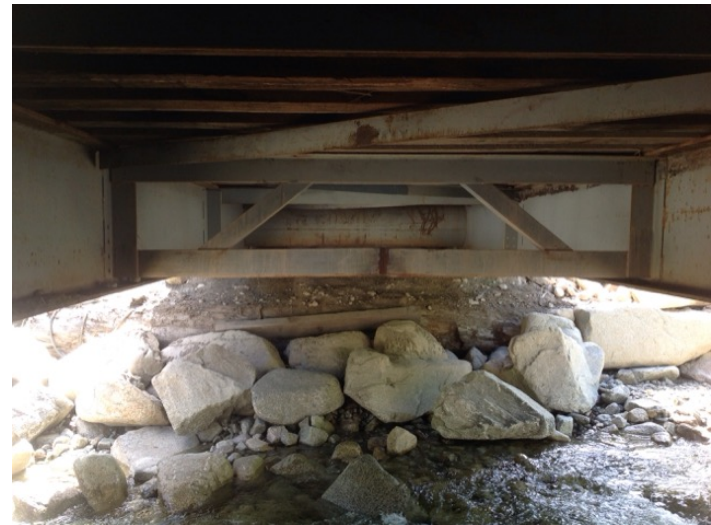
superstructure

Girders Fair painted
