CK-2211

NORTH EMORY CREEK 2.8km

2015 Inspection

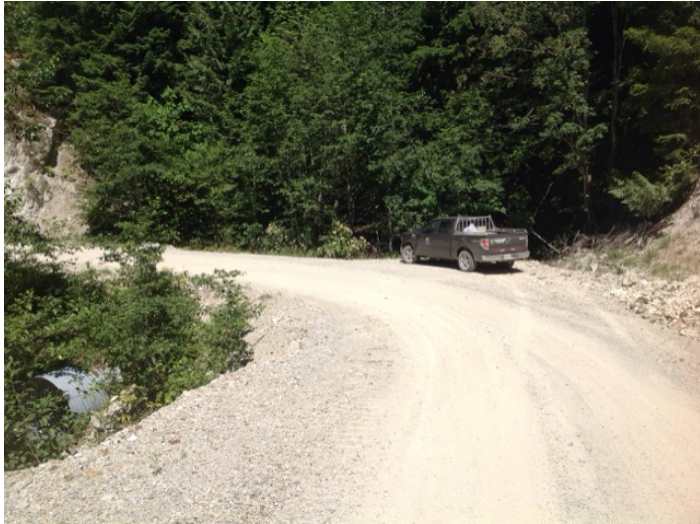
Monitor ravelling fill on the left downstream approach. Present load rating of L75 or 68 tonnes to continue.

left downstream approach ravelling

Approach from Left Bank when facing downstream

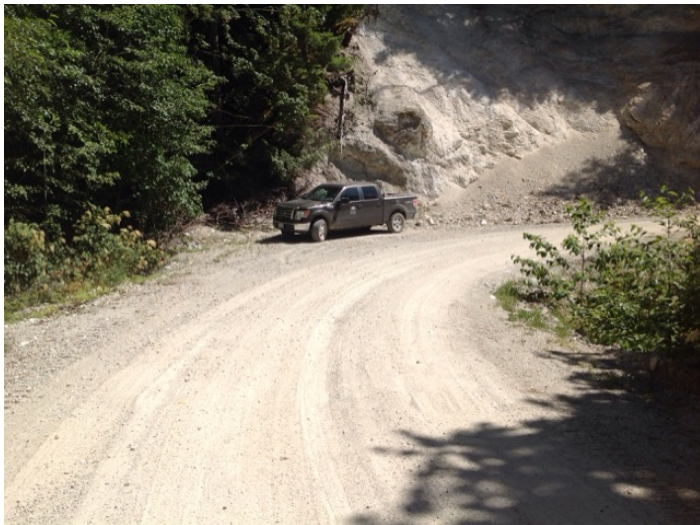
Approach from Right Bank when facing downstream
