## Permanent Bridge Inspection Report

| Structure #: | CK-2213 | Site #: | CK-2213 | Road Name: | PEERS CREEK | Inspection Date: | 2015/10/22 |
| KM: | 0.20 | User km: | 0.20 | Crossing Name: | Coquihalla River | Next Inspection Date: | 2018/10/22 |

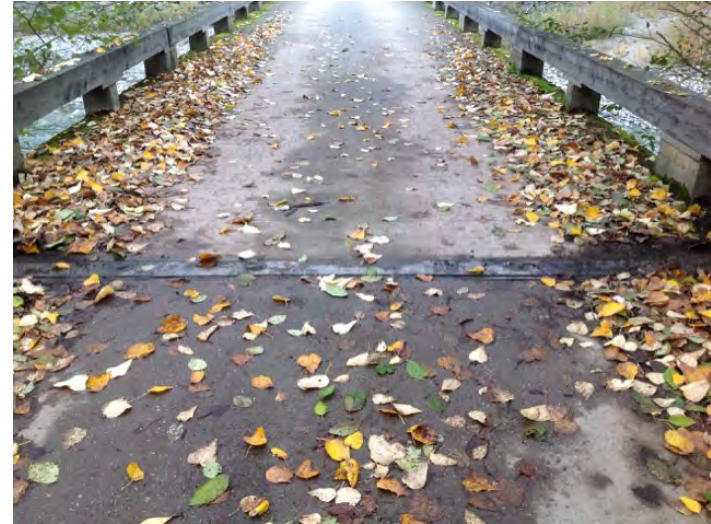
| Deck Joints | Fair | water getting through some joints |

span joints

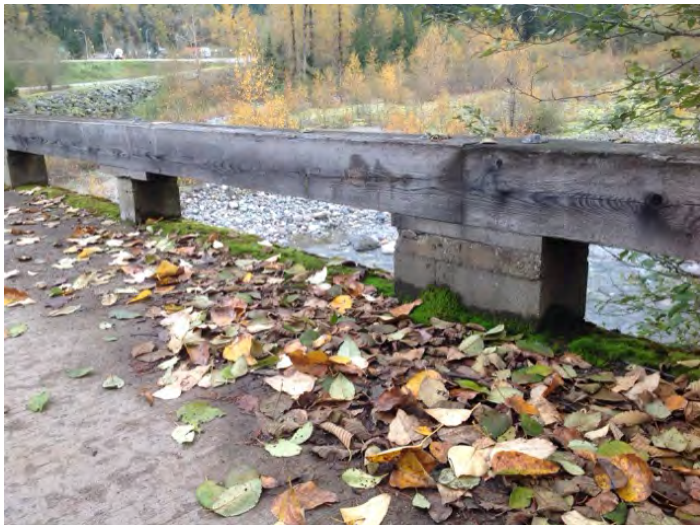
| Curb Rail/Blocks/Posts | Fair | combination of concrete and timber risers - minor deterioration noted on 1 concrete riser |

Guardrail on span 2

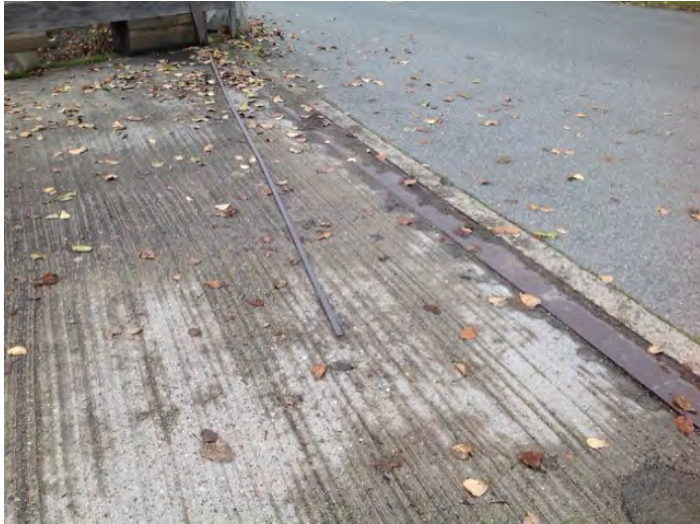
steel separation on span 3 at road surface

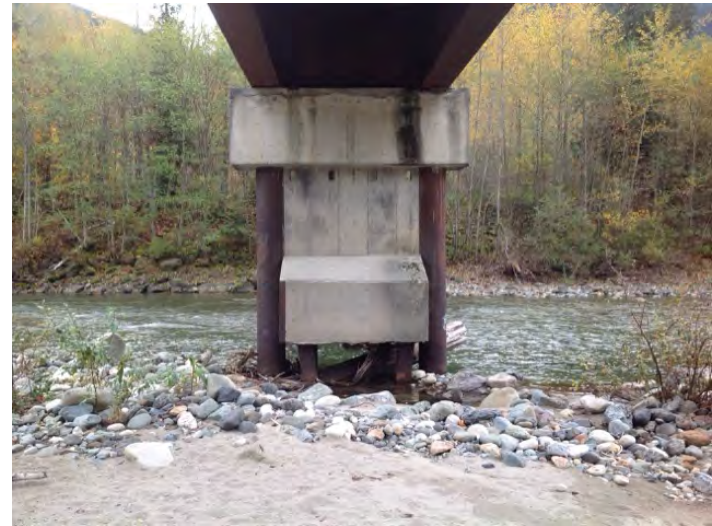
| Bearings | Fair | bearings appear fair, however the concrete cap is in poor condition |
| Caps | Poor | concrete below girder 2 failing |

| | 1 | Required | Medium | \$5,000.00 | repair the spalling concrete and delamination on the pier 2 cap. |

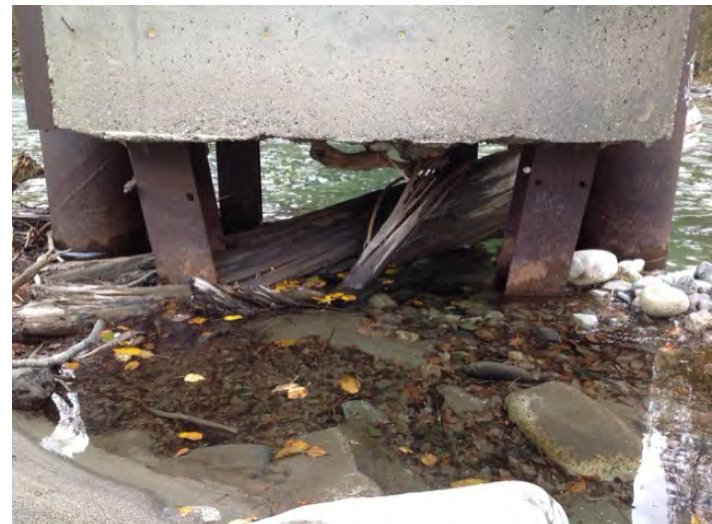
| Piles or Posts | Good | channel degradation has lead to debris accumulations under bottom concrete diaphragm |

| GENERAL | Inspector's Comment: | There is channel degradation under the pier 2 cast in place concrete diaphragm which has lead to debris accumulations between the H-piles. |

log under pier 2

| | 6 | Required | High | \$2,000.00 | remove the debris accumulation from under the pier 2 cast in place concrete diaphragm |

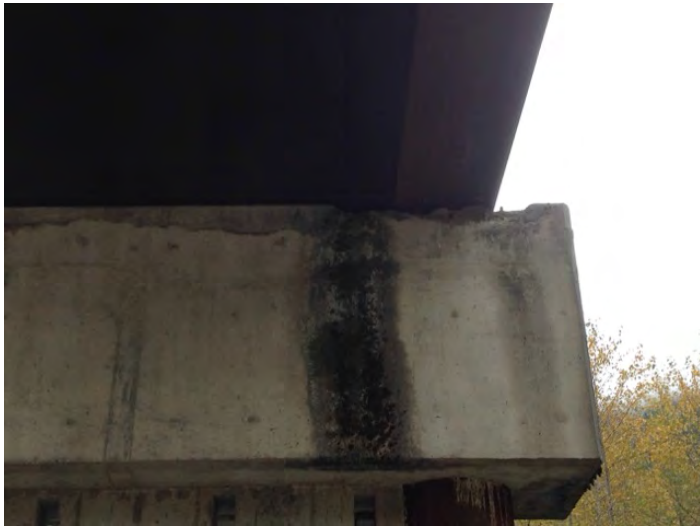
| Caps | Fair | minor spalling around the corners |

pier 2 spalling concrete

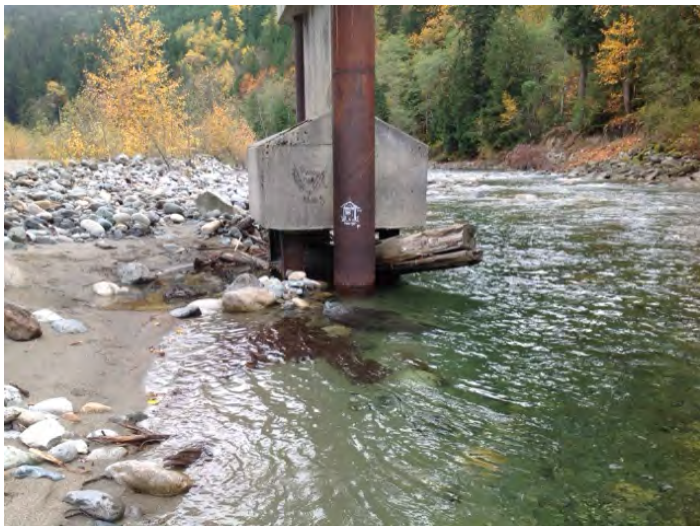
log under pier 2

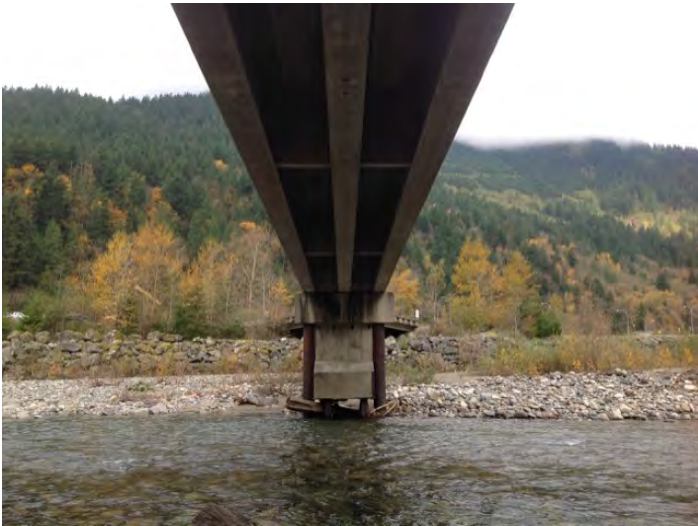
| Diaphragms | Fair | concrete diaphragm at pier 2 is delaminating on woods end face |

span 2 superstructure, pier 2

| | 2 | Required | Medium | \$3,000.00 | Repair the concrete delamination on the span 2 end diaphragm at pier 2 |
