## Permanent Bridge Inspection Report

| Structure #: | CK-2231 | Site #: | CK-2231 | Road Name: | PITT-BUCKLIN | Inspection Date: | 2015/09/23 |
| KM: | 0.80 | User km: | 0.80 | Crossing Name: | Second Canyon Pitt River | Next Inspection Date: | 2016/09/23 |

**2015 Inspection**

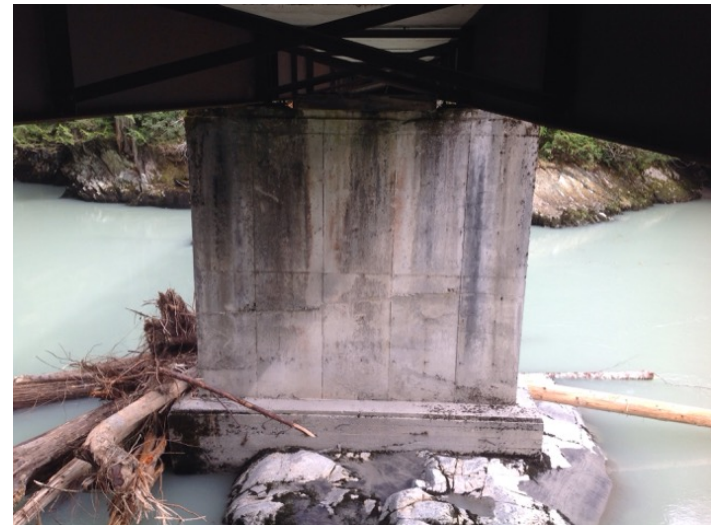
right pier

| Caps | Fair | moss covers the top of the cap | | | | | |

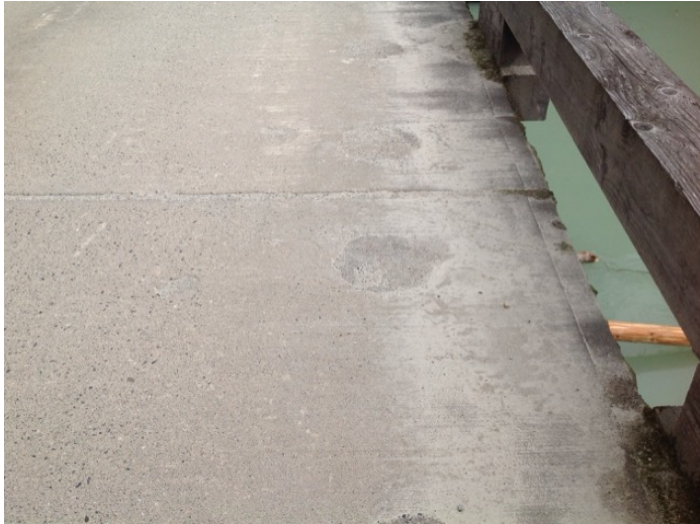
grout pockets - typical

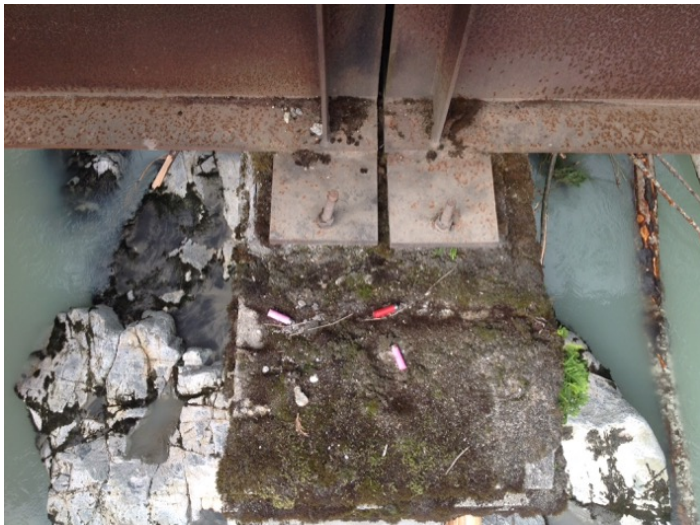
| Bearings | Fair | bearing bolts on downstream end bending | | | | | |

right span downstream pier bearing

| | 4 | bearing bolts on pier 2 | | | | | | | | |

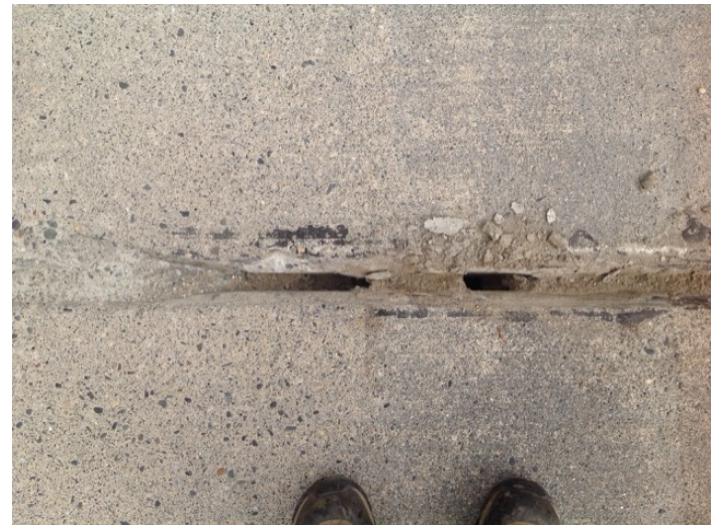
| Deck Joints | Fair | water getting through - monitor |

compression seals on both jump spans missing

| | 3 | deck joints | | | | | | | | |

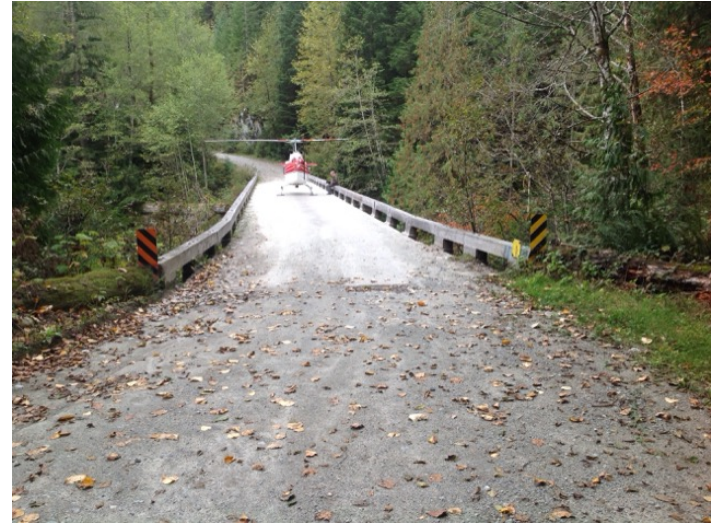
Left Bank Abutment when facing downstream

| | <b>Comment:</b> | left abutment has scour noted | | | | | | | | |

| | 1 | footing scour on left bank | | | | | | | | |

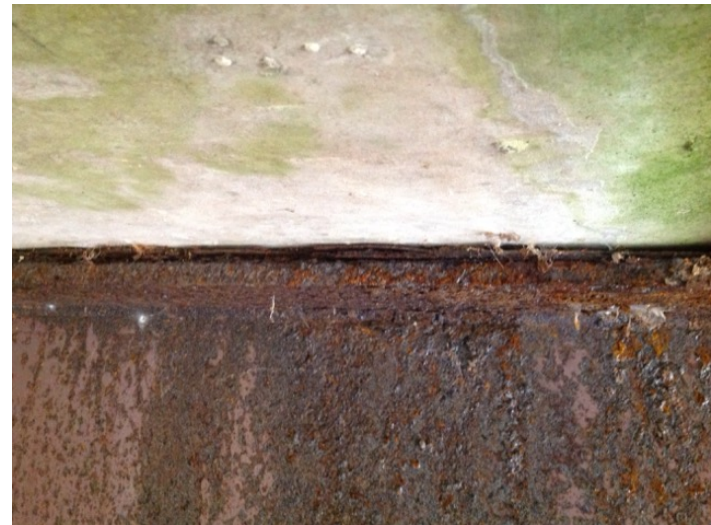
| Girders | Fair | corroding at deck joint locations where water is getting through | | | | | |

top flange corrosion from poor deck joints

| | 2 | corrosion on span 1 girders (left approach) | | | | | | | | |

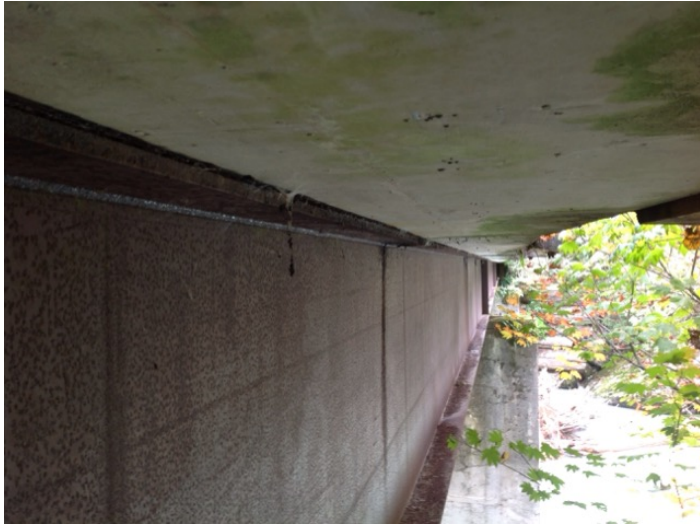
top flange corrosion on left upstream girder - limited to outside of girder

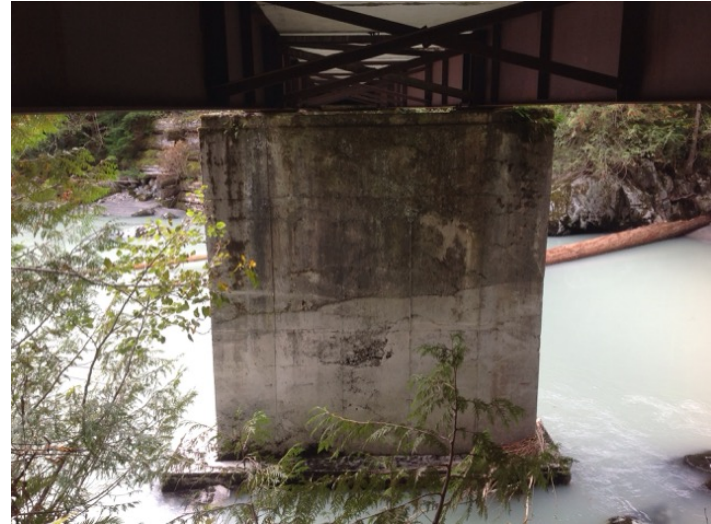
left pier

| Caps | Fair | moss covers the top of the cap |

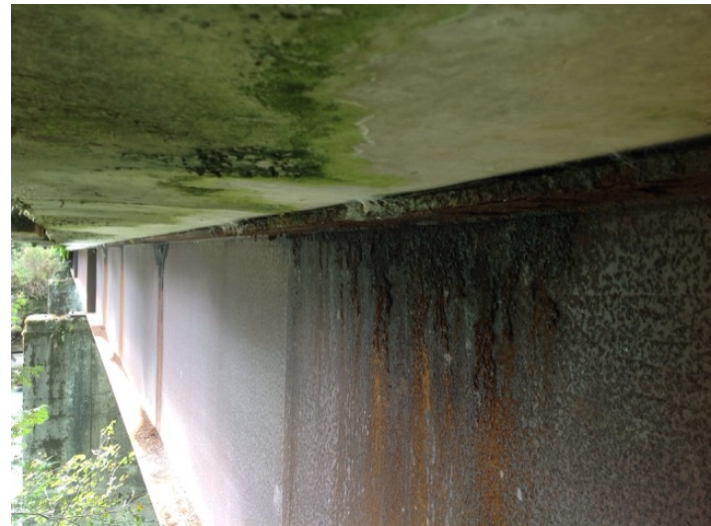
top flange corrosion on left downstream girder
