CK-2234

RUBY CREEK 17km

2015 Inspection

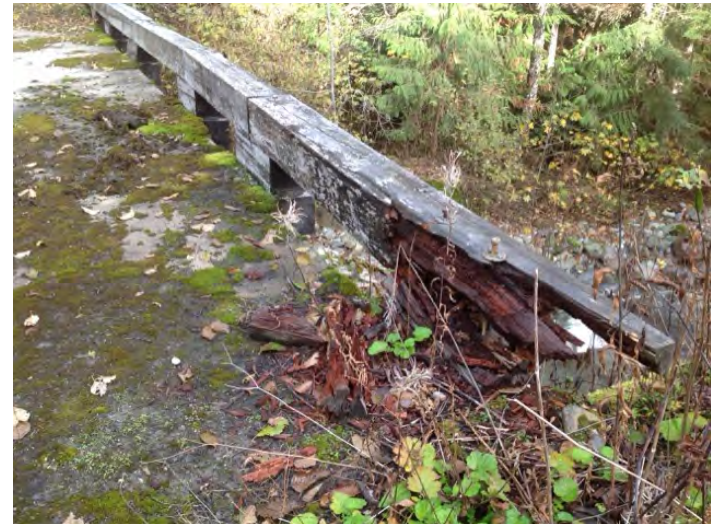
Guard Rail

| Curb Rail/Blocks/Posts | Poor | rotten |
| Overall Deck Condition | Poor | due to rail |

| 1 | Medium | replace guardrail with activity |

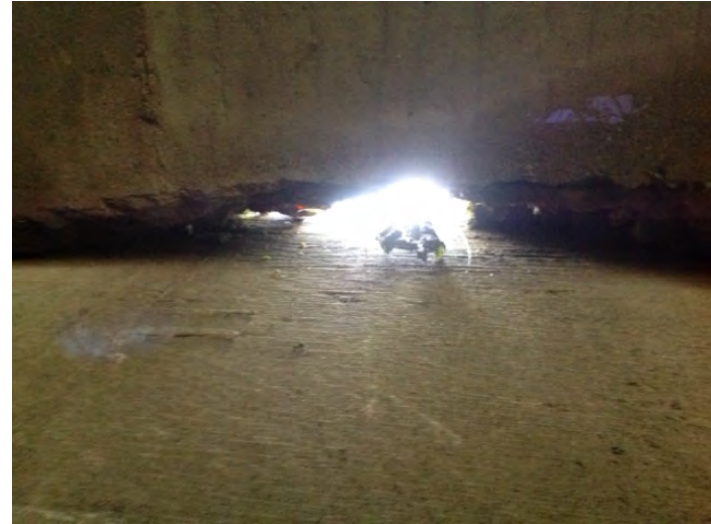
damage to deck panel at downstream left approach

| 4 | Medium | repair damaged panels |

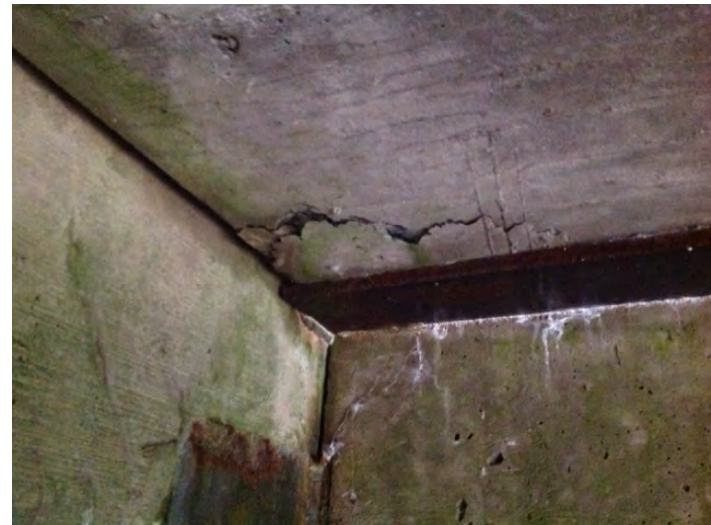
damage to deck panel at downstream right approach
