CK-2239

SOWERBY CREEK 6.5km

2015 Inspection

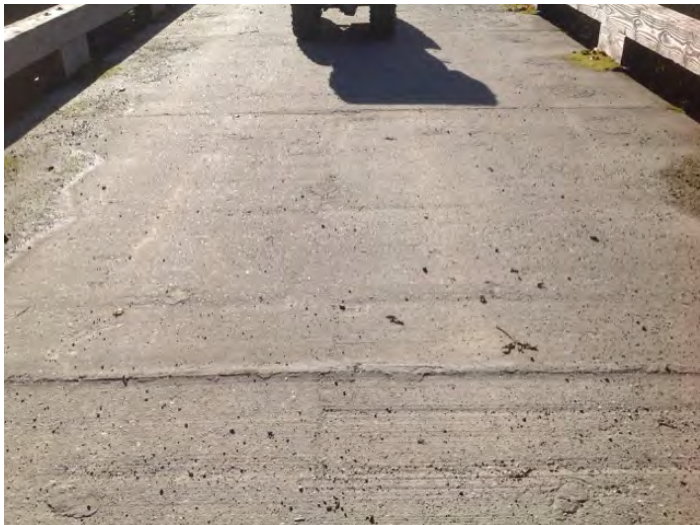
| Deck Joints | Fair | hairline cracks noted on surface |

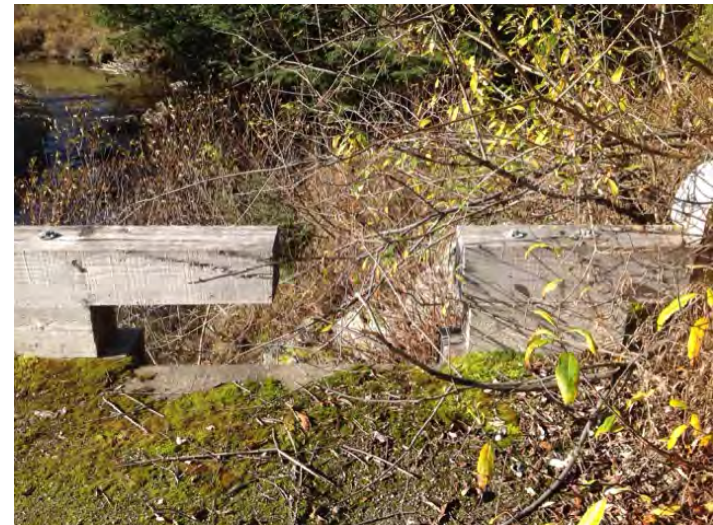
| Curb Rail/Blocks/Posts | Fair | 1 section cut out |

missing section of guardrail

| 3 | Medium | replace missing section of guardrail and place fenders at approaches |
