# BC Ministry of Forests and Range

## Log Stringer Bridge Inspection Report

| Structure #: | CK-2261 | Site #: | CK-2261 | Road Name: | STAVE RIVER | Inspection Date: | 2015/09/23 |
| KM: | 8.50 | User km: | 8.50 | Crossing Name: | Winslow Creek | Next Inspection Date: | 2016/09/23 |

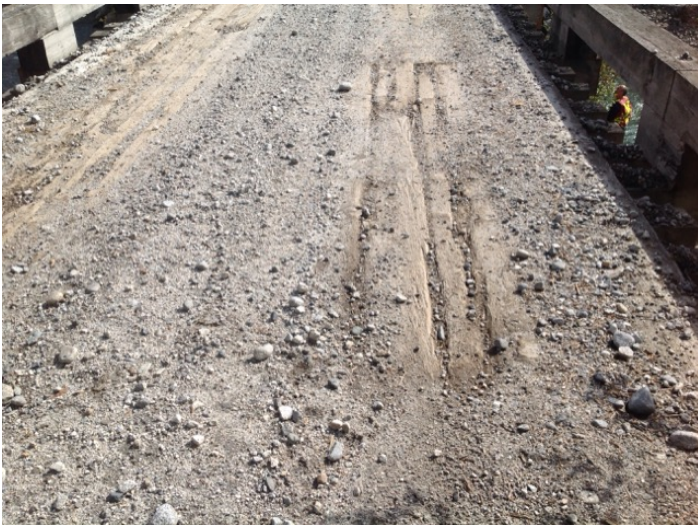
| Running Planks | Fair | fair to poor as wheel path deck planks are wearing |

Deck - wear noted on right span on wheel path

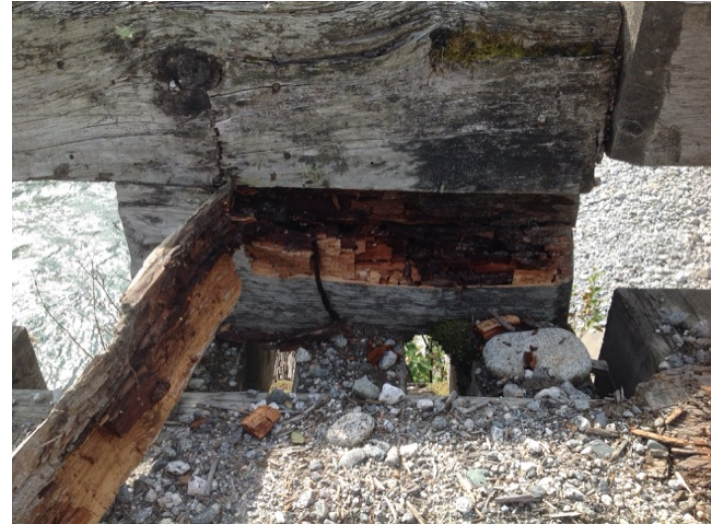
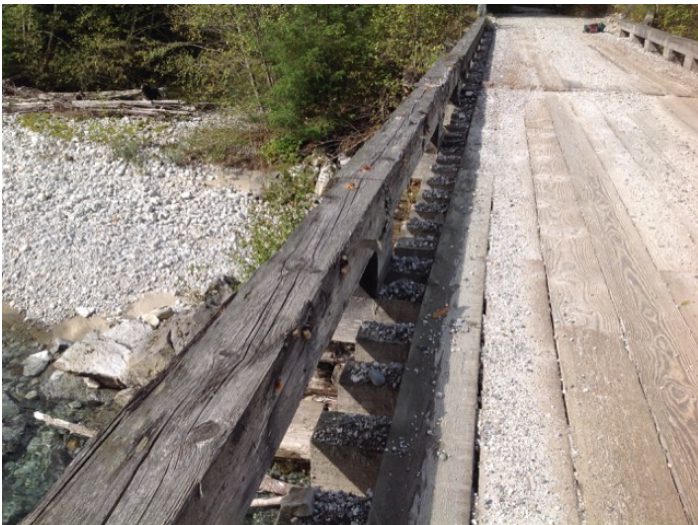
Guard Rail

| Curb Rail/Blocks/Posts | Poor | risers and guardrail in poor condition |

| Curb Rail/Blocks/Posts | Fair | some risers and guardrail in poor shape |

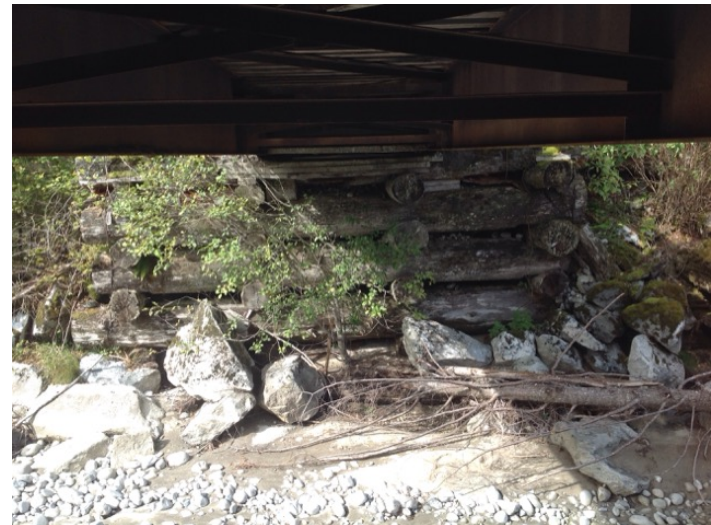
Right Bank Abutment when facing downstream

| Bearings | Poor | top logs crushing |
| Log/Timber Cribbs | Poor | 4x left, 5x right - top logs on both ends are rotting |

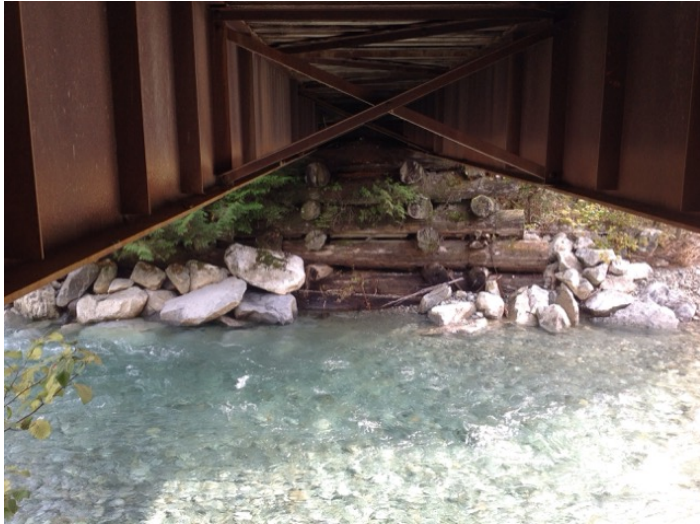
Left Bank Abutment when facing downstream

| Wing Wall | Poor | only left abutment and rotting and slumping |

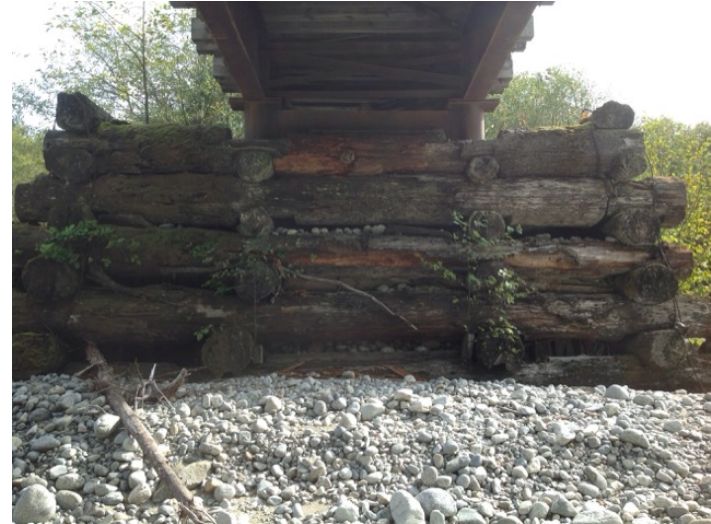
pier

| Bearings | Poor | rotting and crushing logs - approx 80mm difference in deck elevation from upstream to downstream - downstream lower |
| Overall | Poor | top logs in poor condition |

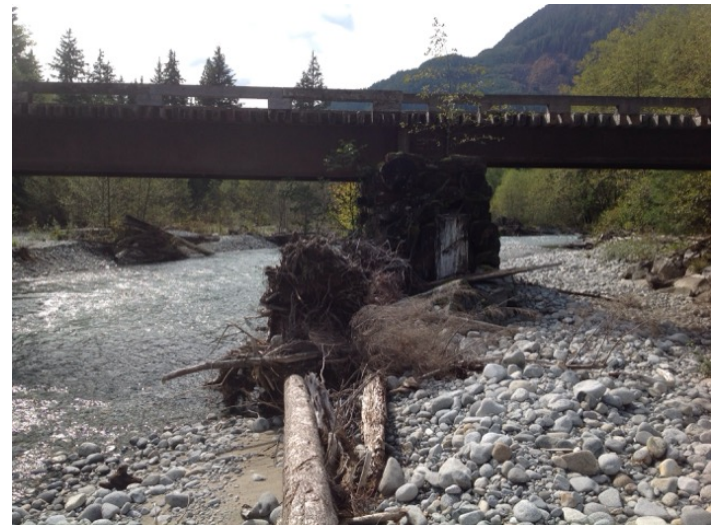
debris accumulation at pier

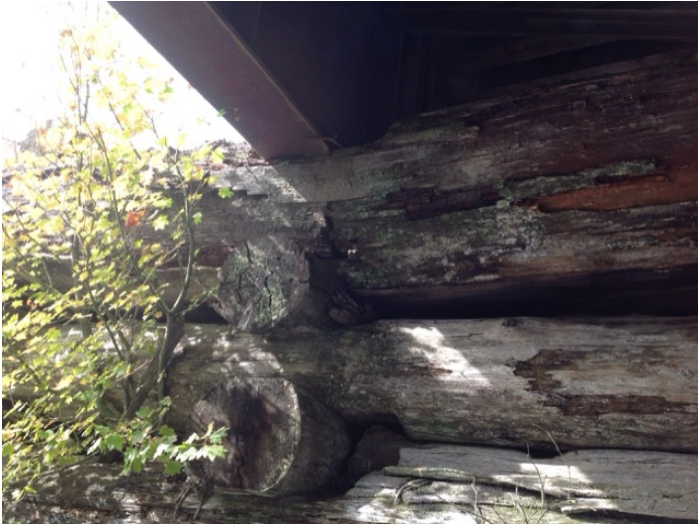
| Caps | Poor | rotting and crushing |
| Cribs | Poor | 5x and rotting |

top crib log in pier
