CK-2262

STAVE RIVER 10.5km

2015 Inspection

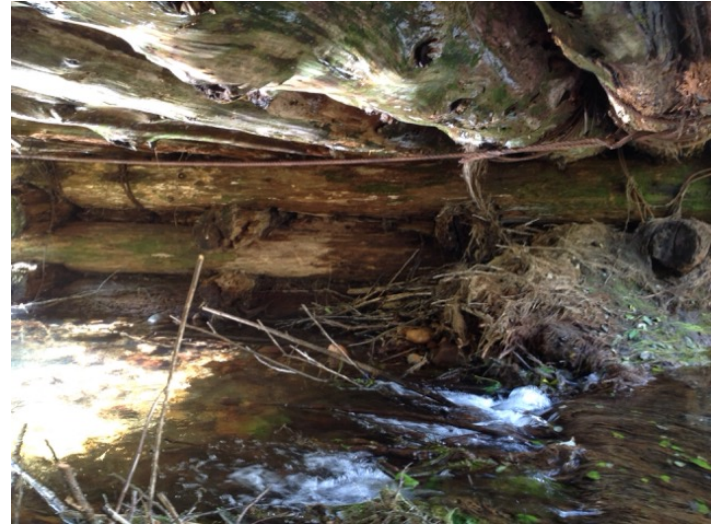
Right Bank Abutment when facing downstream

Log/Timber Cribs Fair fair to poor

Tie Backs Fair fair to poor
