CK-2263

STAVE RIVER 11.4km

2016 Inspection

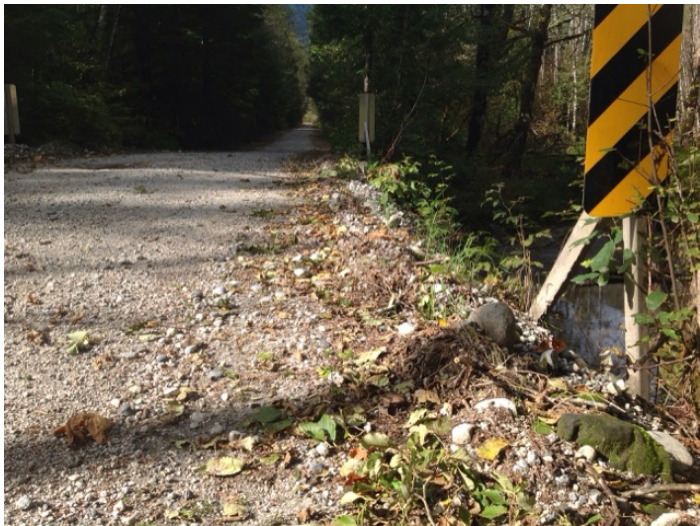
no guard log

| 1 | High | replace missing guard log |

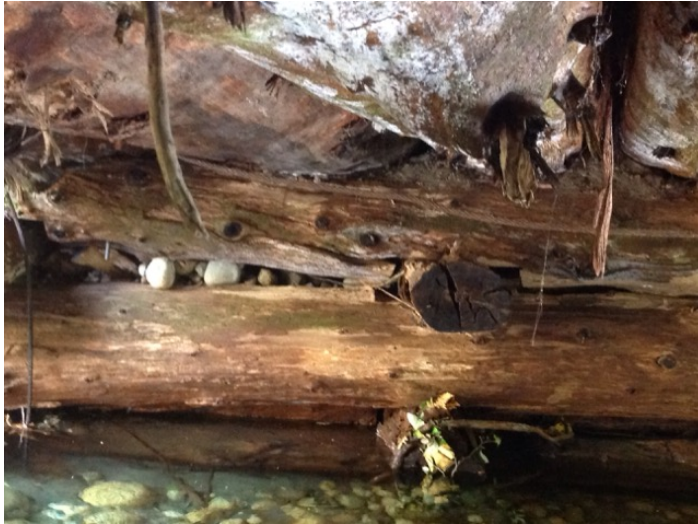
The structure is in relatively poor condition. With rotting and crushing/cracking crib and tieback logs, limit loading to 30 tonnes. Replace the missing curb logs immediately. Replace missing fender logs and post missing bridge ahead signs. Post load rating sign.

top log on left crib cracking horizontally
