CK-2264

STAVE RIVER 13km

2015 Inspection

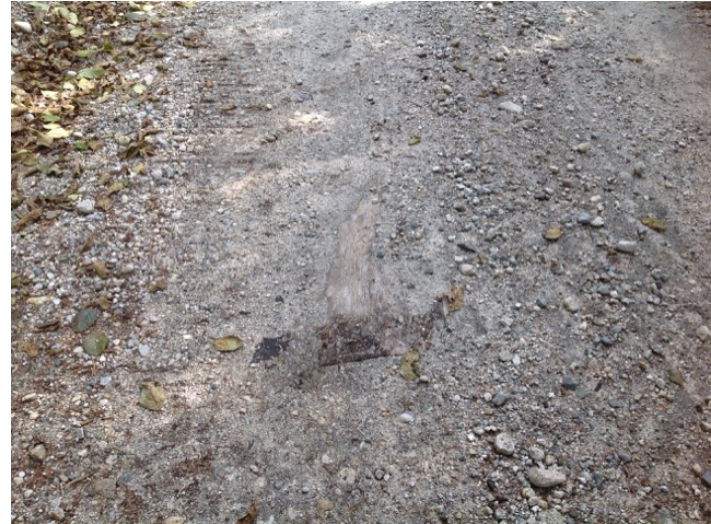
This structure has 2 layers of log stringers and only the bottom layer can properly assessed. The top layer were added in 2012 as a temporary measure in order to facilitate works at the time. The entire structure (crib logs, tiebacks and stringers) has further deteriorated since then. Because the top layer of stringers have not been properly inspected the structure remains down-rated. Present load rating of 30 tonnes to continue. Post load rating sign.

Comments    there are 2 layers of stringers in the bridge

top log stringer exposed

| Repair Item | Priority | Repair Description |
|---|---|---|
| 1 | High | remove gravel deck to properly assess the top row of stringers |

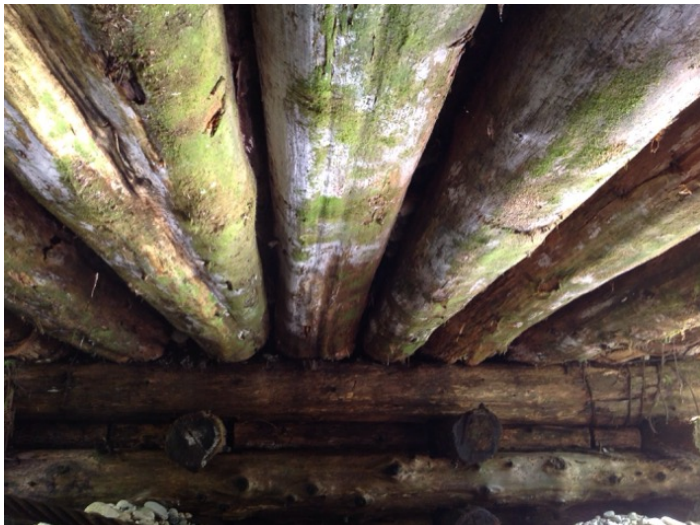
Stringers

| Stringer<br>Number | Needle Beam to Crib (m) | | Diameter<br>(mm) | Needle Diameter (mm) | | | Comment |
|---|---|---|---|---|---|--|---|
| 7 | Cw | Y | 570 | 120 | Poor | | sap and heart rot |
