CK-2265

STAVE RIVER 13.2km

2016 Inspection

| Crossing Name | Side Creek | | |

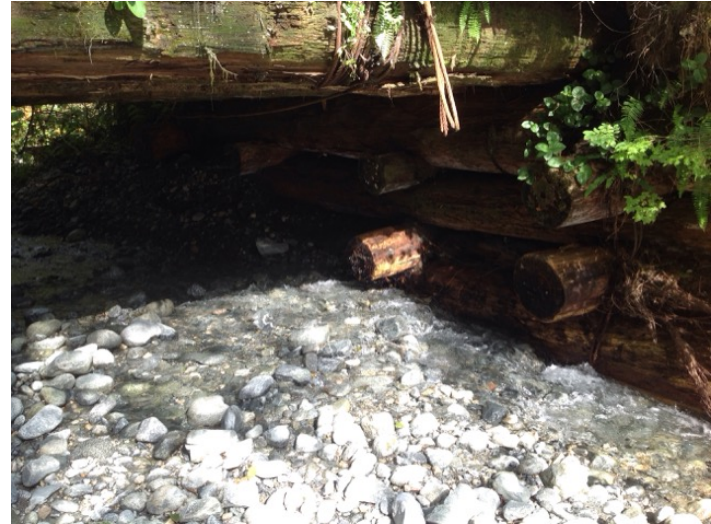
Left Bank Abutment when facing downstream

Log/Timber Cribs Fair 3x left, 2x right

Tie Backs Fair 4x

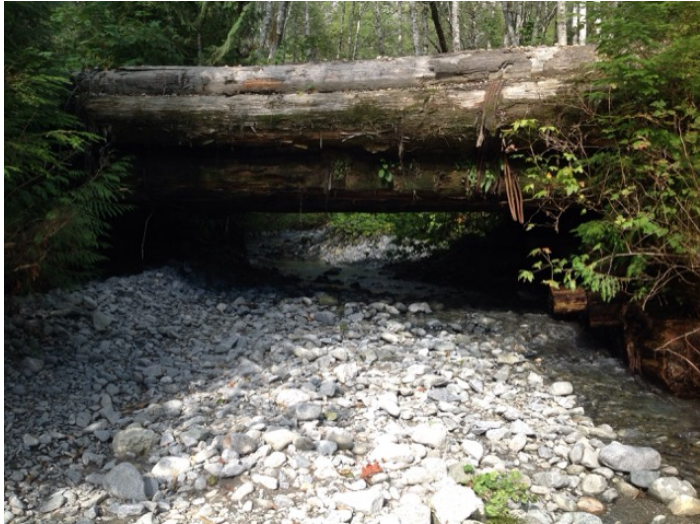
Downstream Profile

This structure has 2 layers of stringers and only the bottom layer can be properly assessed. The top layer were added in 2012 as a temporary measure in order to facilitate works at the time. The entire structure (crib logs, tiebacks and stringers) has further deteriorated since then. Because the top layer of stringers have not been properly inspected the structure remains down-rated. Present load rating of 30 tonnes to continue. Post load rating sign.

| Repair Item | Priority | Repair Description |
|---|---|---|
| 1 | High | remove gravel deck to properly assess top row of stringers |

| 2 | High | post load rating sign |
