CK-2266

STAVE RIVER 16.8km

2015 Inspection

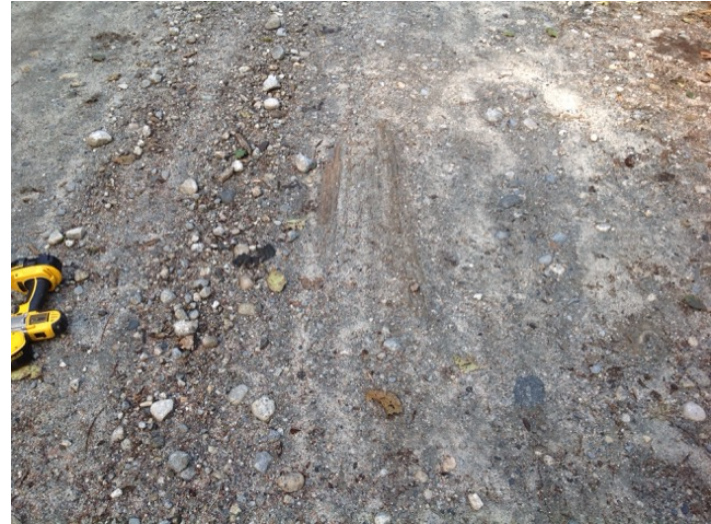
log stringer exposed

1 High remove gravel deck and properly assess top row of stringers
