CK-2267

STAVE RIVER 19km

2015 Inspection

| Crossing Name | Ole Creek | | |

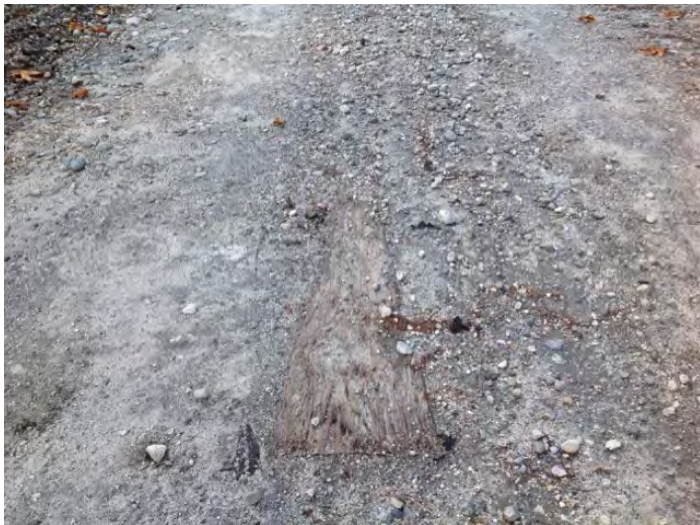
exposed stringer at left approach

| Repair Item | Priority | Repair Description |
|---|---|---|
| 1 | High | dig up gravel deck and properly assess top stringers |

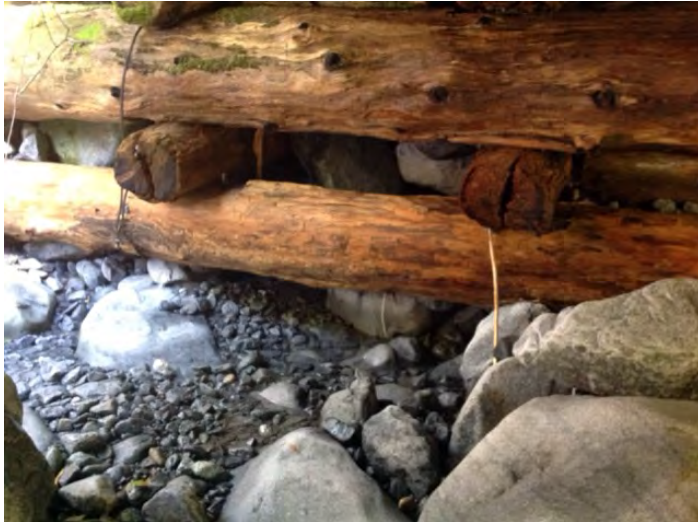
Left Bank Abutment when facing downstream

Bearings Poor undermined crib on left bank

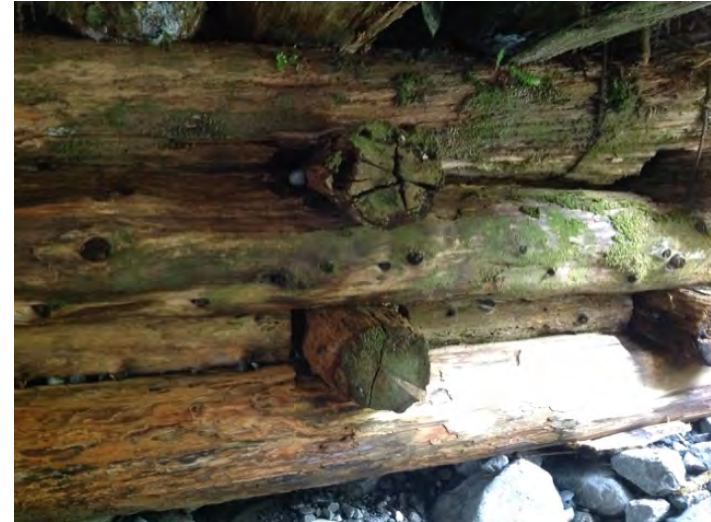
Tie Backs Poor rotting

tiebacks condition

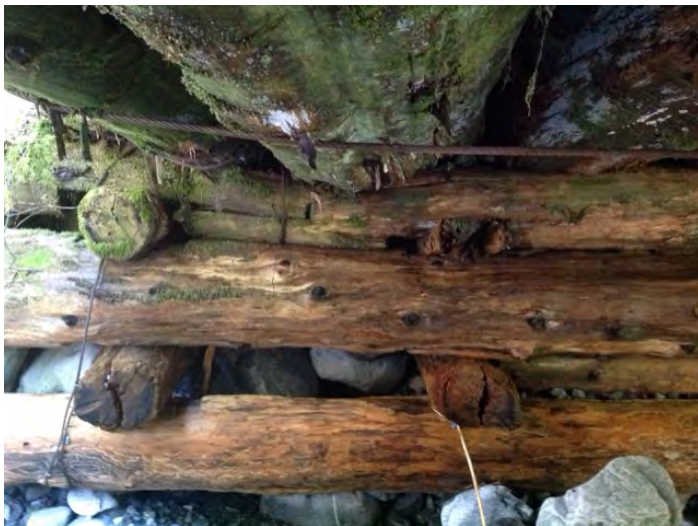
Log/Timber Crib Poor 3x left, 2x right-cracking and splitting top crib log on left bank

left abutment top crib log cracking vertically and horizontally

| Item | Monitor Description | Frequency |
|---|---|---|
| 1 | crib condition | Anually |

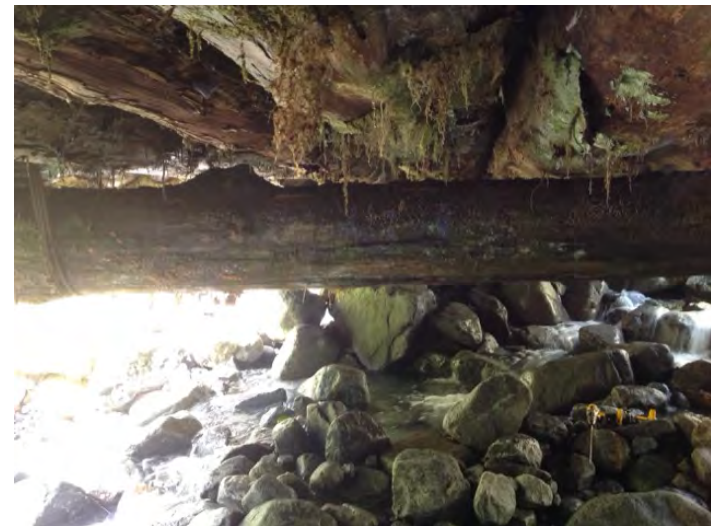
Needle Beam Poor loose

Needle Lashing/  
Shimming Poor loose

needle beam - not functional
