CK-2269

STAVE RIVER 21.6km

2015 Inspection

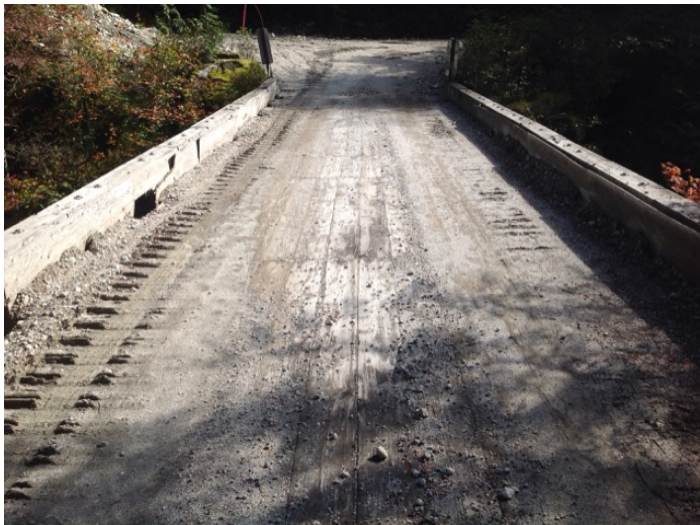
Deck

| Hardware | Fair | fair to poor - loose lashing |

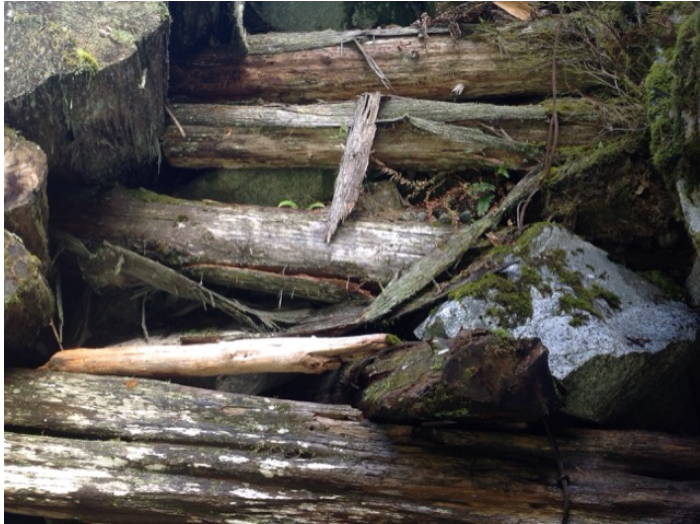
left downstream wing wall

Wing Wall Fair fair to poor

Bearings Fair left downstream abutment has settled and requires monitoring

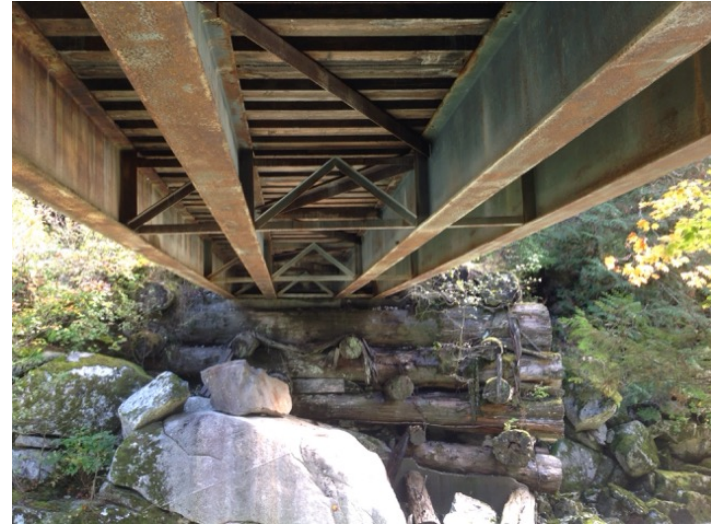
superstructure

4 painted steel I beams

different size then bracing

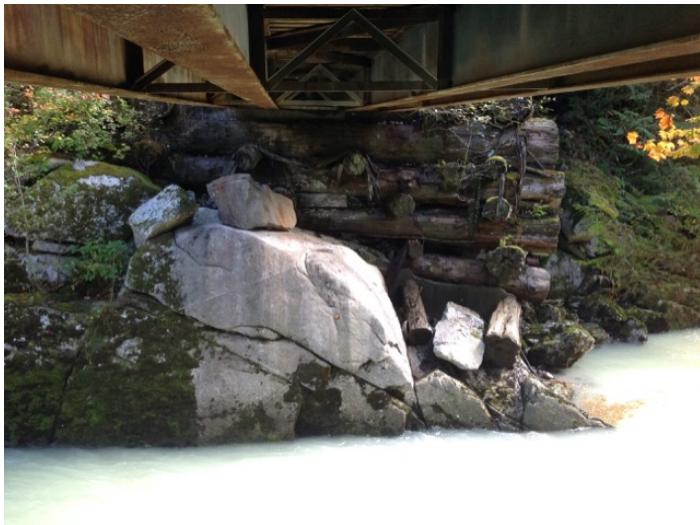
Left Bank Abutment when facing downstream

Post bridge ahead signs and reposition the right approach concrete no post barriers. There hasn't been any change in the left bank abutment noted but it still requires monitoring as it is 29 years old. Present load rating of L75 or 68 tonnes to continue.

monitor left bank abutment

1 left bank abutment

annual
