CK-2270

STAVE RIVER 23.6km

2015 Inspection

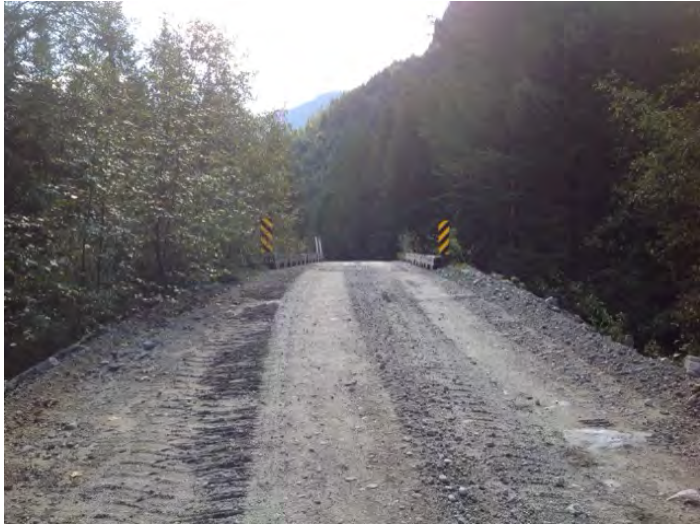
Approach from Left Bank when facing downstream

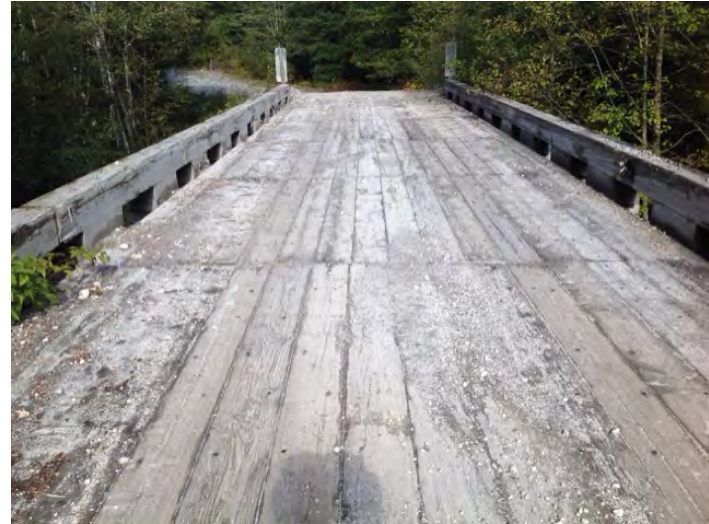
modular deck

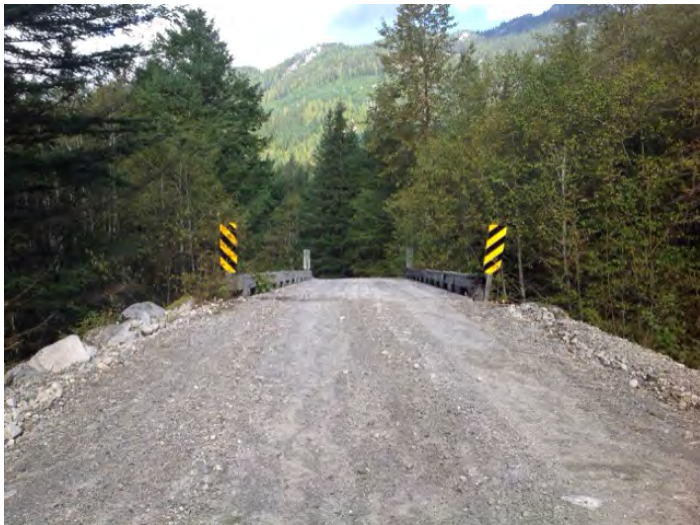
Approach from Right Bank when facing downstream

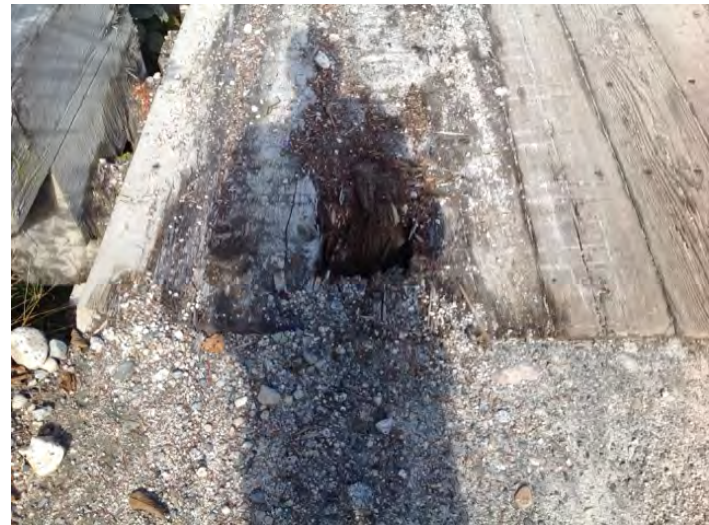
Running Planks Poor outside planks rotting and holes starting to form

holes starting to form in deck

| 1 | High | replace deck |

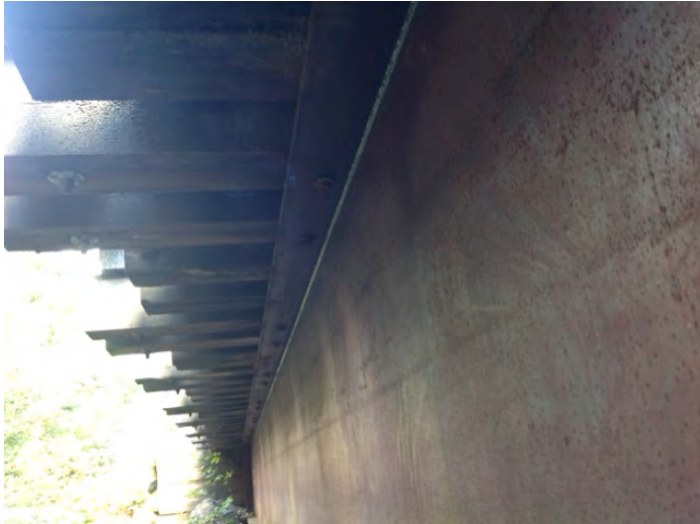
Nails Fair starting to protrude on worn/rotting planks

deck fasteners

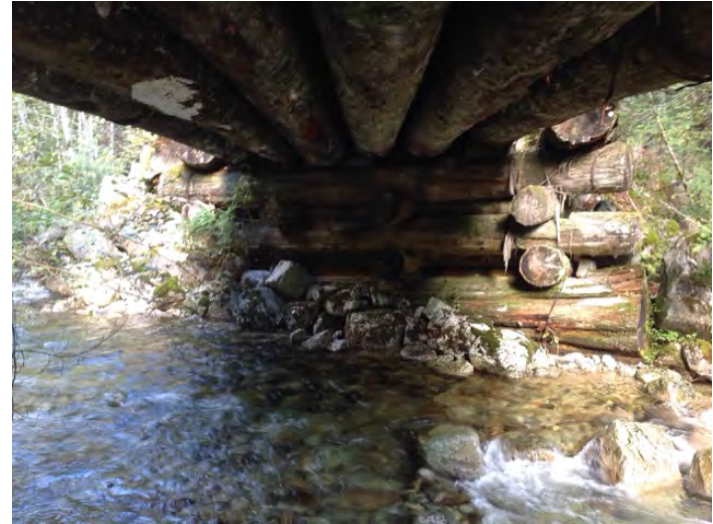
log structure underneath current - left bank

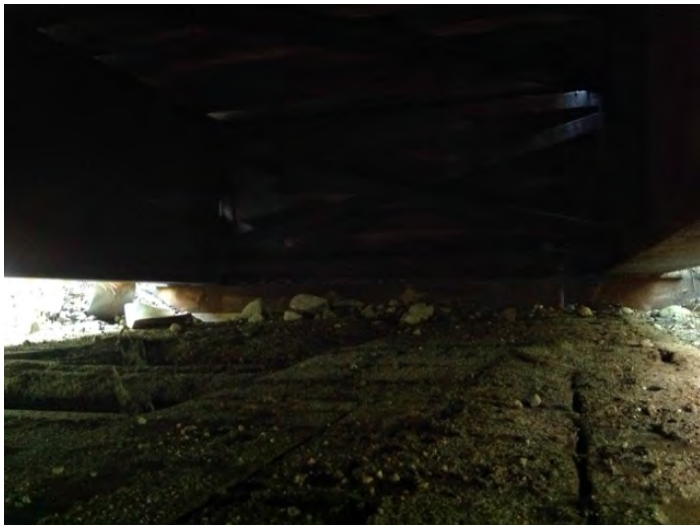
steel girders bearing directly over crib on upstream left bank and downstream right bank

Right Bank Abutment when facing downstream

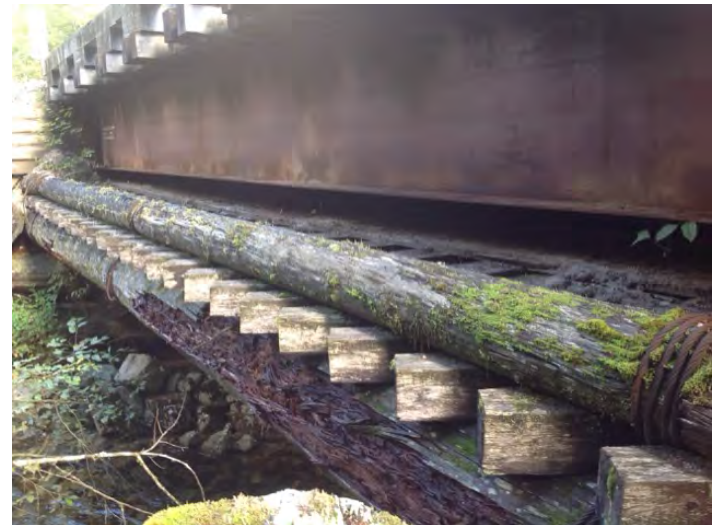
300mm gap between structures

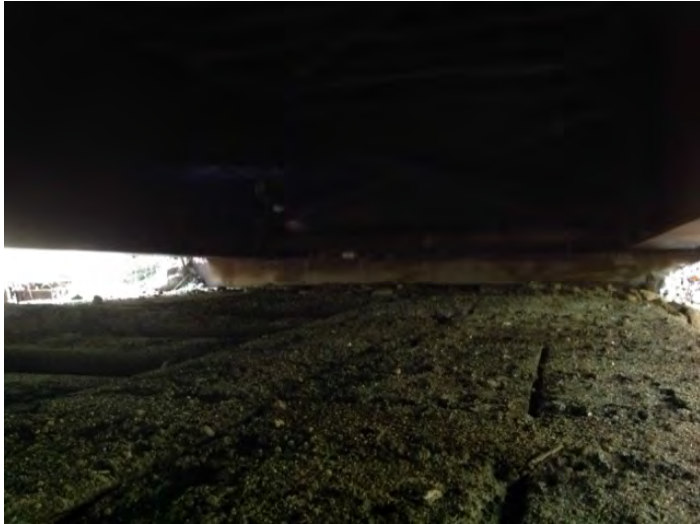
Left Bank Abutment when facing downstream

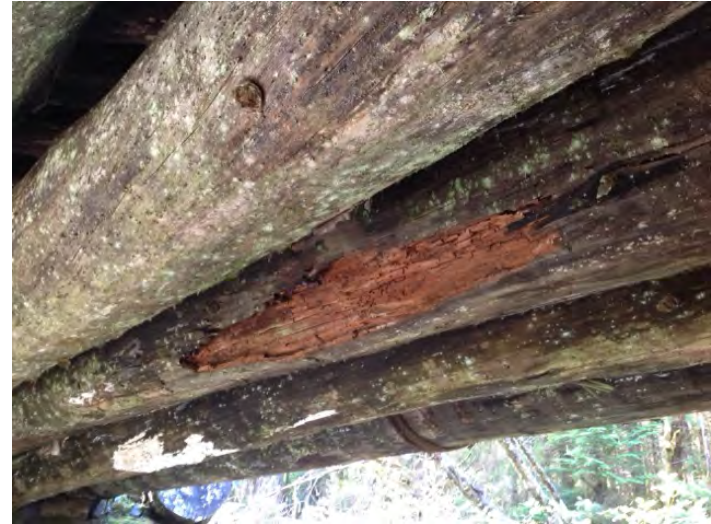
log stringer condition

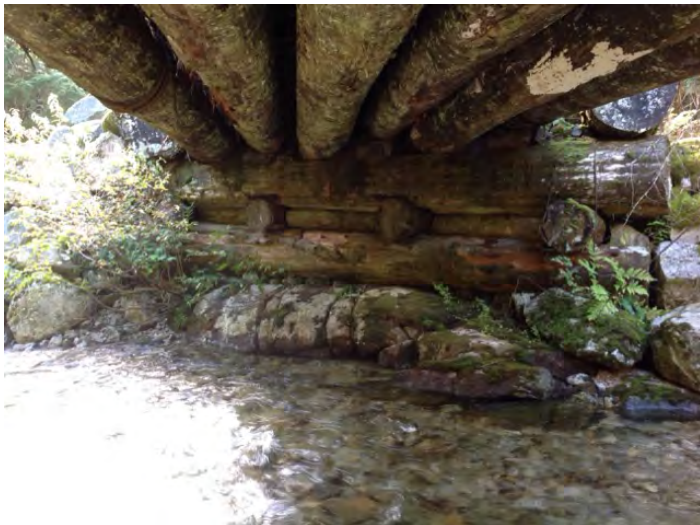
log structure underneath - right bank
