CK-2271

STAVE RIVER 26.2km

2015 Inspection

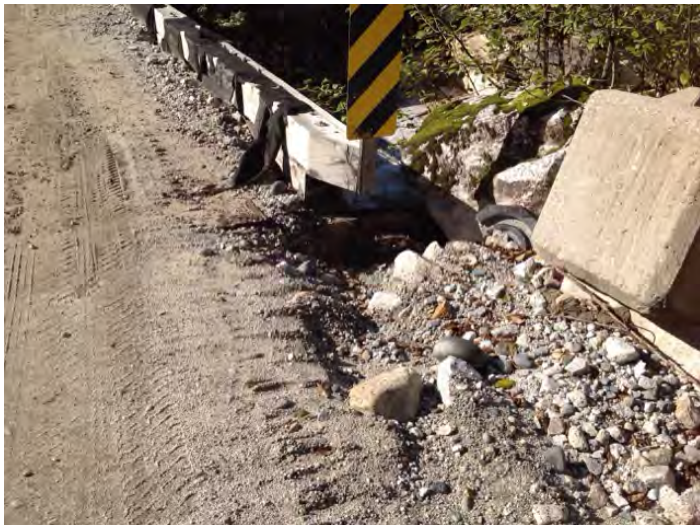
eroding on left approach

eroding fill on left upstream approach

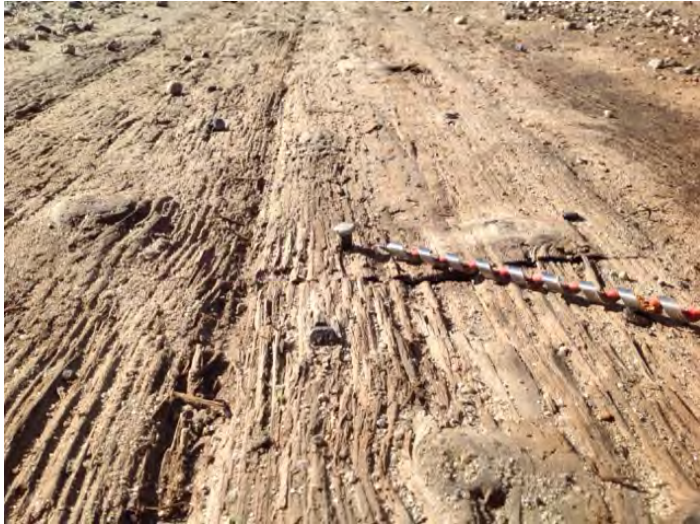
| Nails | Fair - Poor | fair to poor as some are starting to protrude on worn planks |

nails starting to protrude

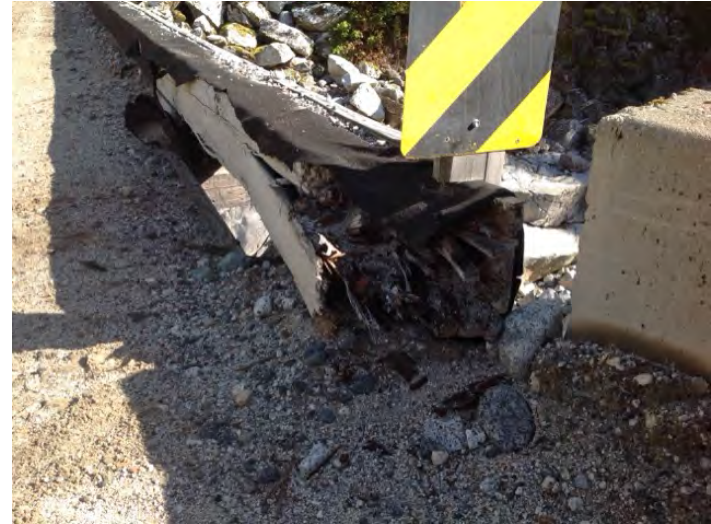
| Curb Rail/Blocks/Posts | Fair | replace damaged section |

guardrail damage

| Repair Item | Priority | Repair Description |
|---|---|---|
| 3 | Medium | replace damaged guardrail section |

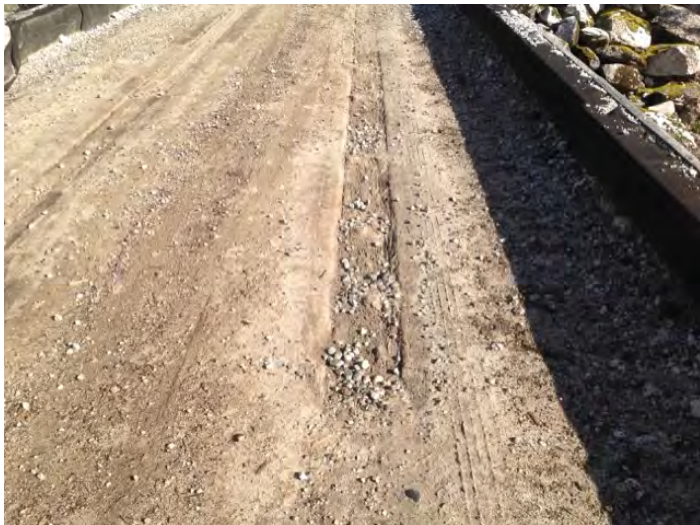
| Running Planks | Fair - Poor | treated planks - wearing on wheel path |

wheel path decking wearing

| Repair Item | Priority | Repair Description |
|---|---|---|
| 2 | High | replace running planks and ensure non-treated wear planks are installed on top |

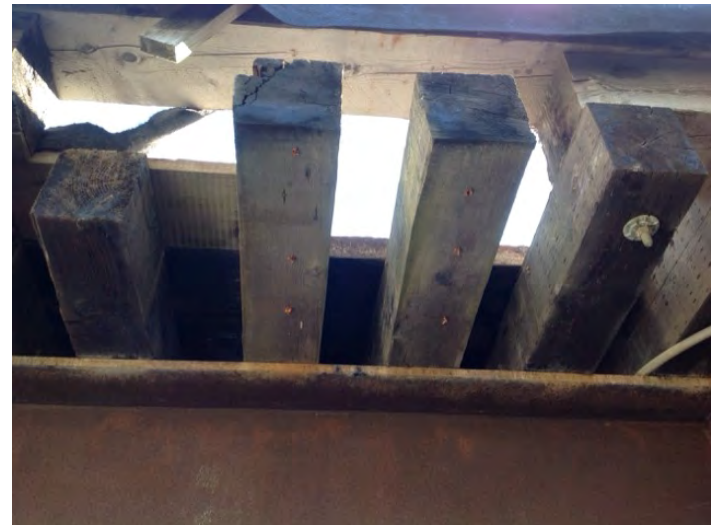
| Ties | Fair | 2 non treated ties have rot - <b>other</b> ties treated and in good shape |

2 non-creosoted ties on right approach - replace

| Repair Item | Priority | Repair Description |
|---|---|---|
| 1 | High | replace 2 rotting ties at right end |

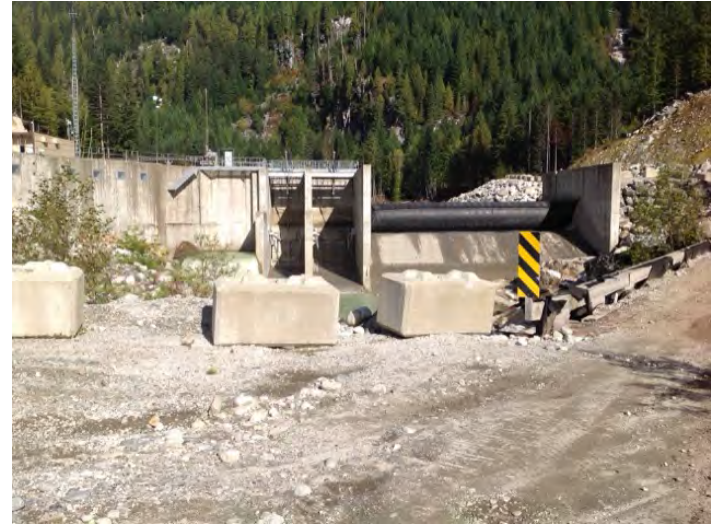
| Comments | dam immediately upstream | | | | |

dam immediately upstream from crossing
