CK-2274

STAVE RIVER 31.6km

2016 Inspection

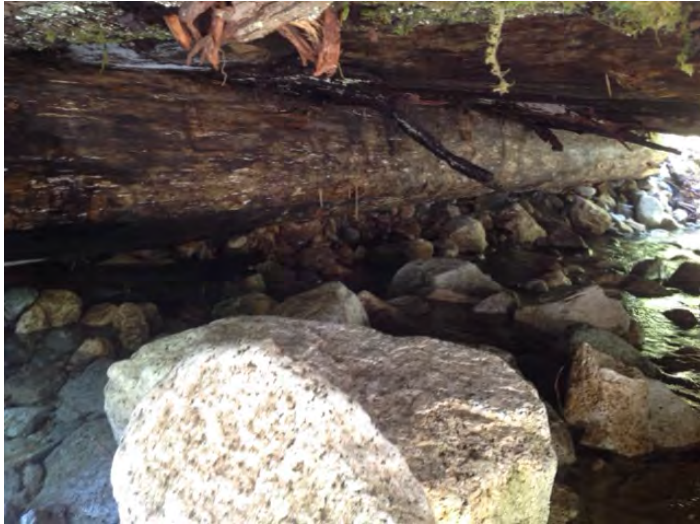
Left Bank Abutment when facing downstream

The left bank sill has been scoured 70% of total length resulting in an uneven bearing surface; therefore limit loading to 30 tonnes. Place bags of sakrete under the sill as a temporary measure to increase the load rating or alternatively completely reinstall the structure ensuring complete bearing and scour protection. Post load rating sign. Monitor the structure.

Bearings Poor left sill scoured 70%

Comments left abutment undermined/scoured and not fully bearing

| Repair Item | Priority | Repair Description |
|---|---|---|
| 1 | High | place bags of sakrete under left sill for proper bearing or completely reinstall for a higher load rating |

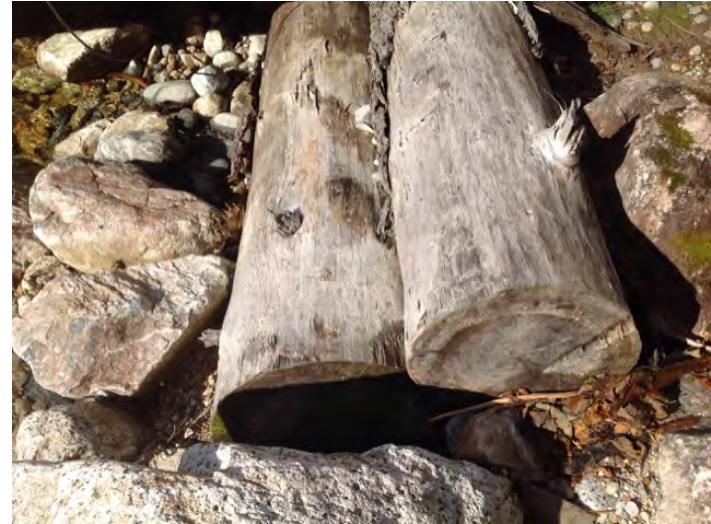
right sill configuration - upstream

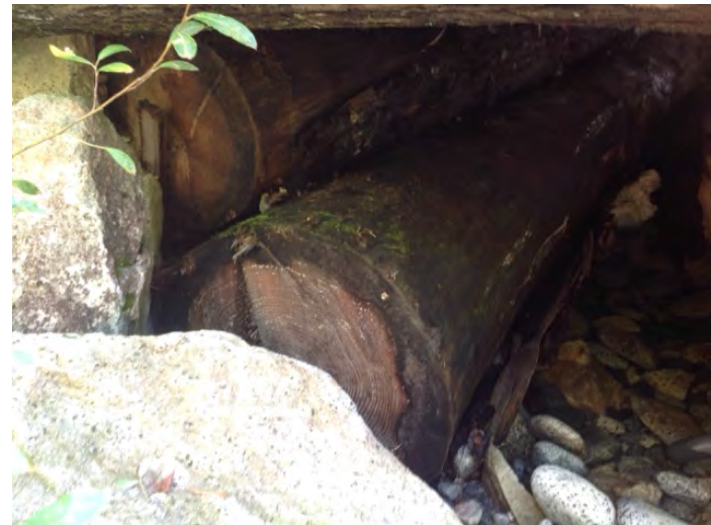
right sill configuration - downstream
