CK-2279

SUMALLO RIVER 4.7km

2015 Inspection

| Crossing Name | Tearse Creek (structure #11) |

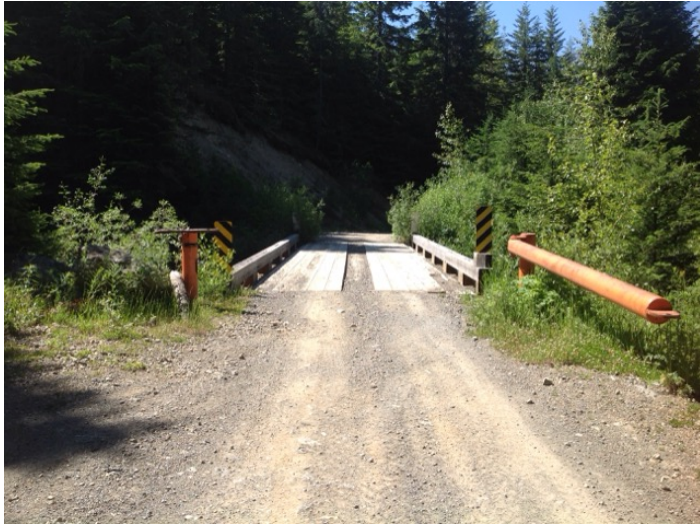
Approach from Right Bank when facing downstream

Brushing Required Y

Fender Condition Poor missing

Posted Load Rating not posted

Brush approaches and post bridge ahead signs. Present load rating of L60 or 54 tonnes to continue.

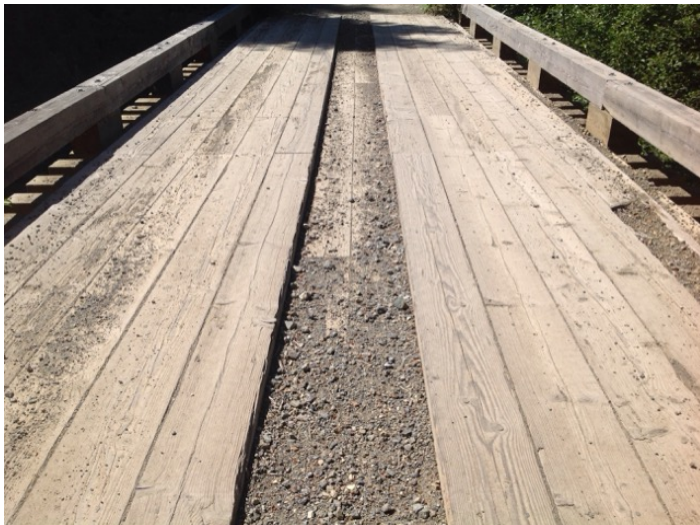
Overall Deck Condition Good

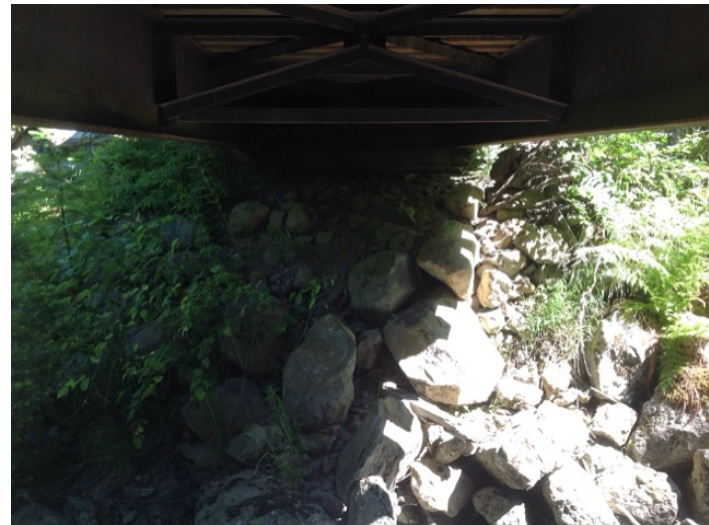
Right Bank Abutment when facing downstream

Caps or Sills Fair single log sills

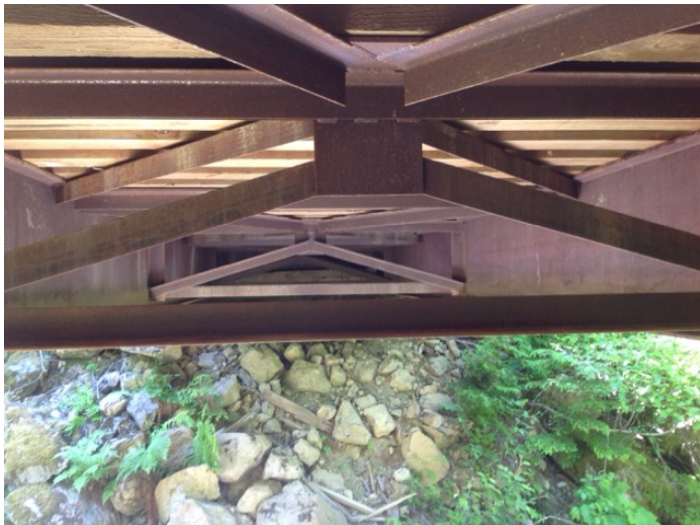
superstructure

Girders Good

Diaphragms Good 4 bays, welded
