CK-2284

TSILEUH CREEK 4.4km

2016 Inspection

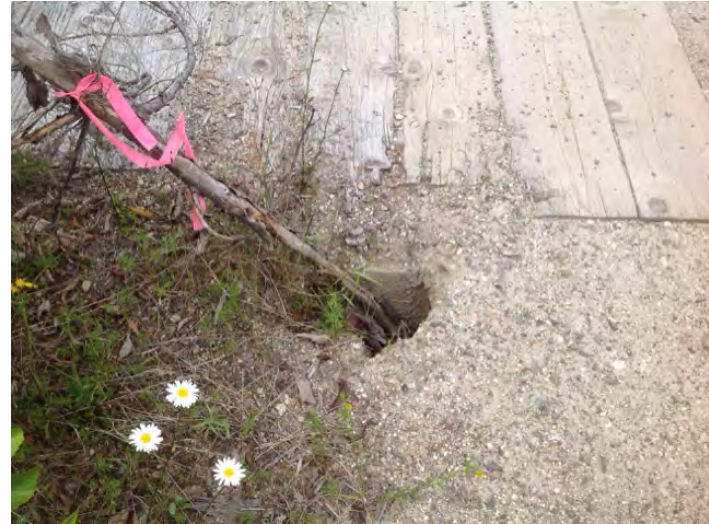
Fill Fair failing behind right abutment ballast wall

failing fill on right approach

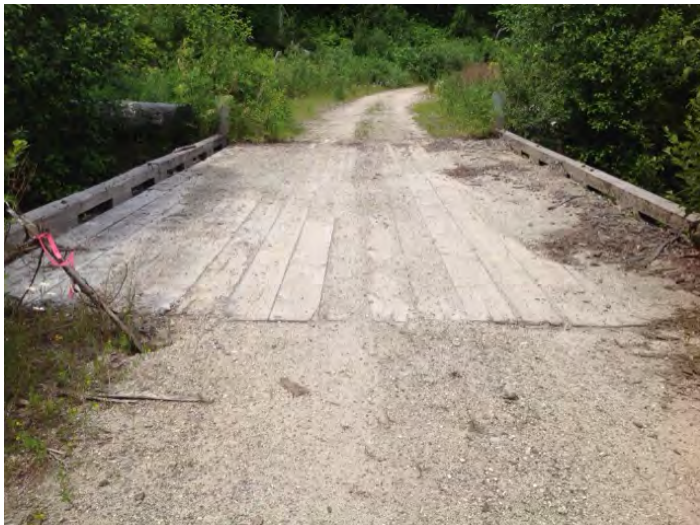
| Overall Deck Condition | Poor | due to age and condition |

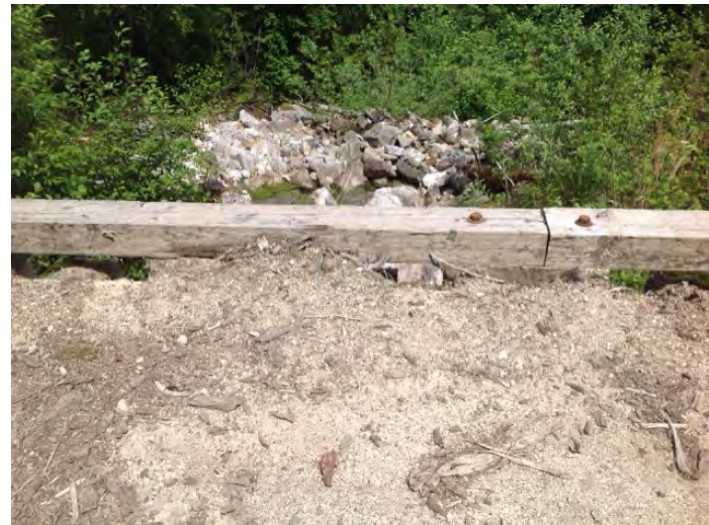
| Curb Rail/Blocks/Posts | Poor | too low |

guardrail too low

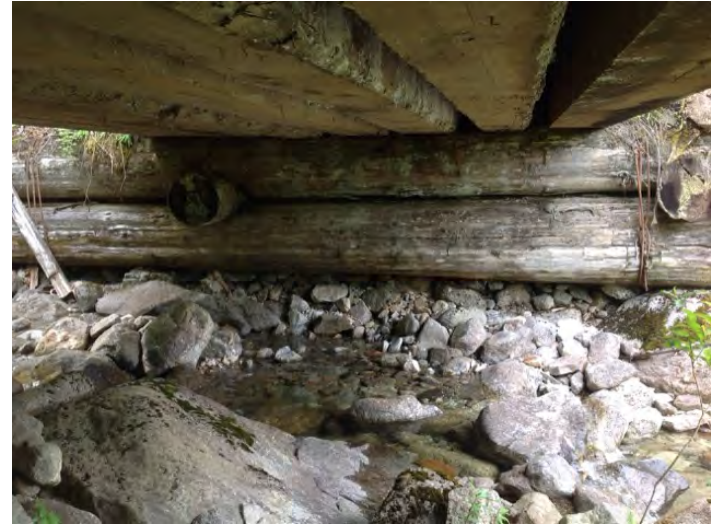
Left Bank Abutment when facing downstream

Bearings Poor scoured crib on left bank

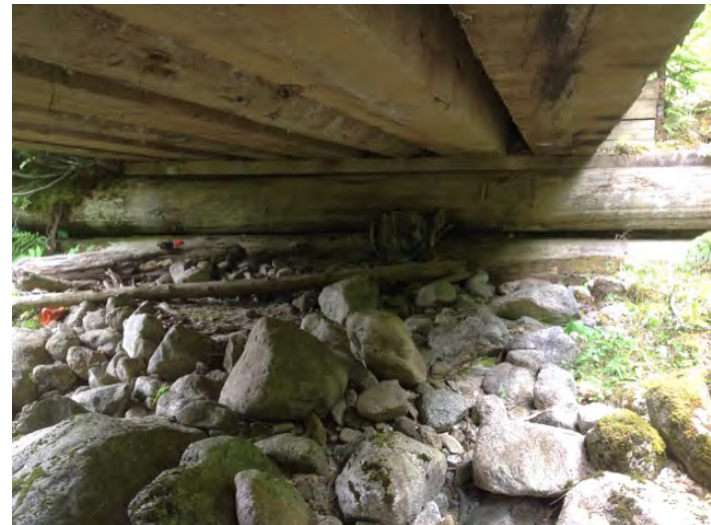
Right Bank Abutment when facing downstream

Caps or Sills Fair treated timber on right abutment on top of crib

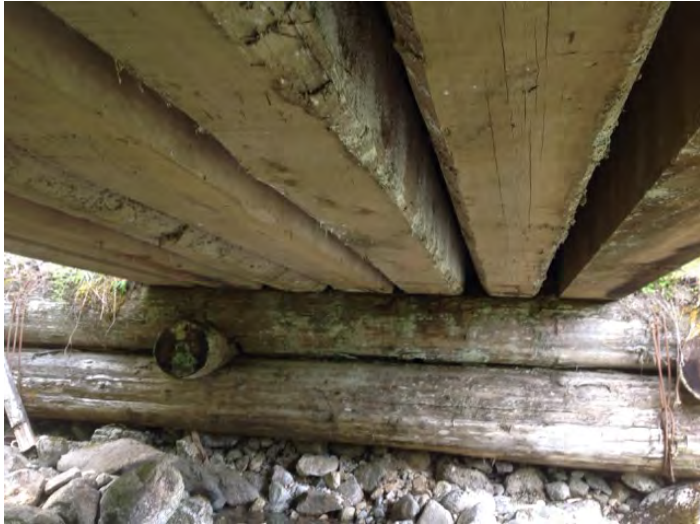
Stringers

| Stringer<br>Number | Needle Beam to Crib (m) | | Diameter<br>(mm) | Needle Diameter (mm) | | | Comment |
|---|---|---|---|---|---|--|---|
| 3 | Fd | Y | 610 | 150 | Poor | | powder for shavings |
