CK-2300

UZTLIUS CREEK 13.4km

2015 Inspection

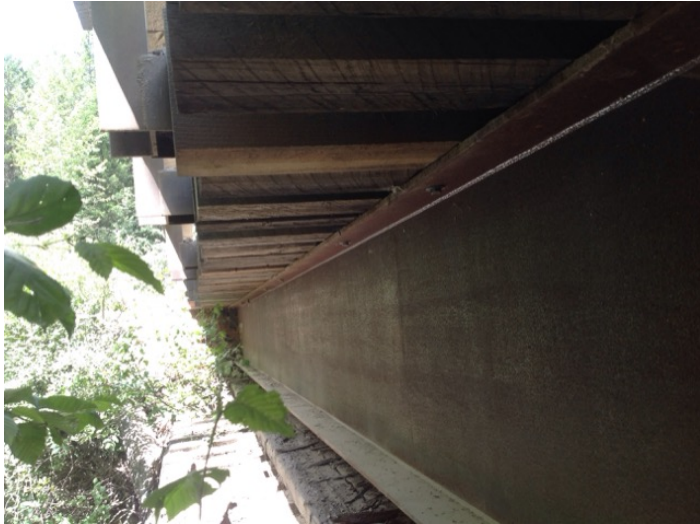
deck to girders bolts

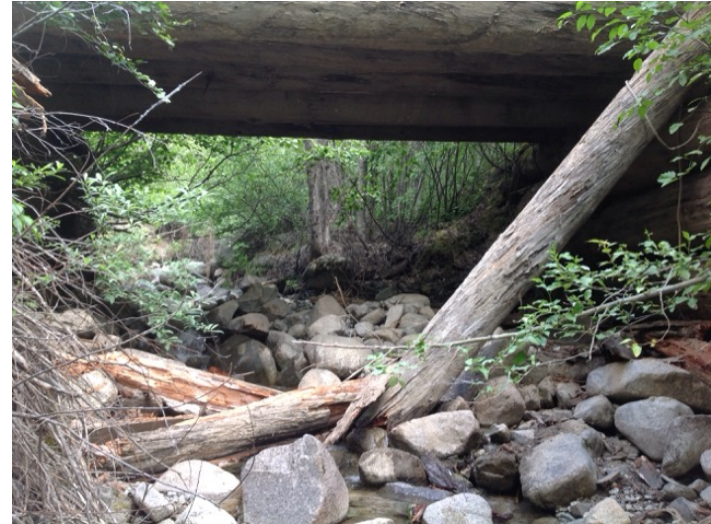
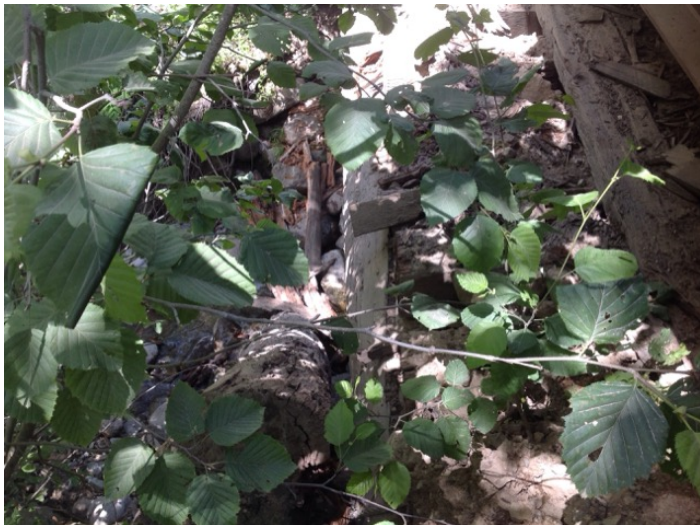
Comments other log stringers drilled and much rot detected, with 1 stringer failing I suspect others will start to fail soon. because the log sill for the steel girder is very close to crib the structure may be compromised when the other stringers start to fail. recommend removing log stringers and replacing abutments prior to this happening.

log stringer failure

Due to the rotting log stringers underneath the steel girders and the proximity of them to the sills I recommend removing the log stringers before the steel girders are compromised. Remove the log stringers and old log crib and replace. Limit loading to 40 tonnes until the structure has been replaced. Post load rating sign.
