CK-2312

WEAVER LAKE 2.6km

2015 Inspection

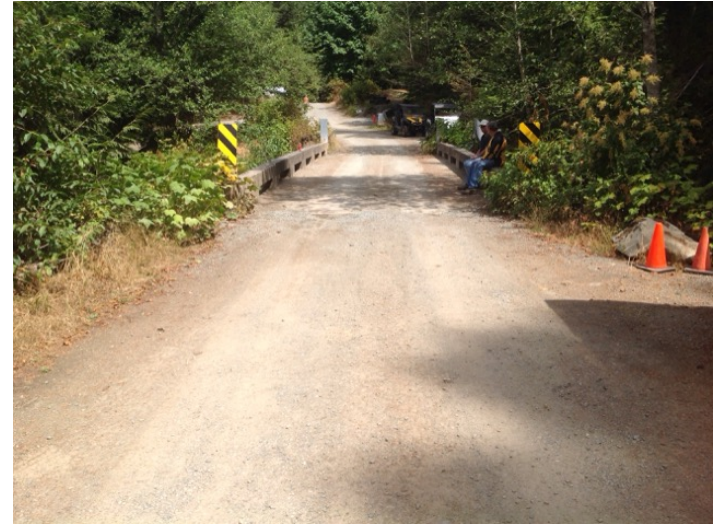
Approach from Right Bank when facing downstream

Fender Condition Fair missing right approach

Replace the RH delineator (with a proper RH) at the right approach. Replace missing fender log. Guardrail nearing the end of its industrial life. Present load rating of L60 or 54 tonnes to continue.

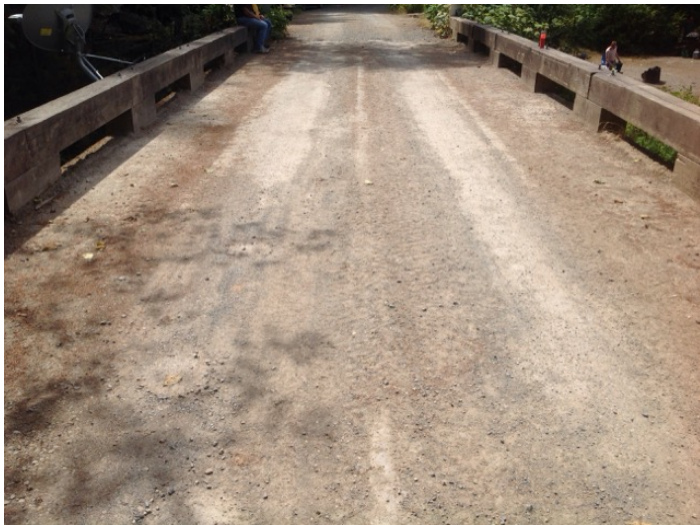
Overall Deck Condition Fair

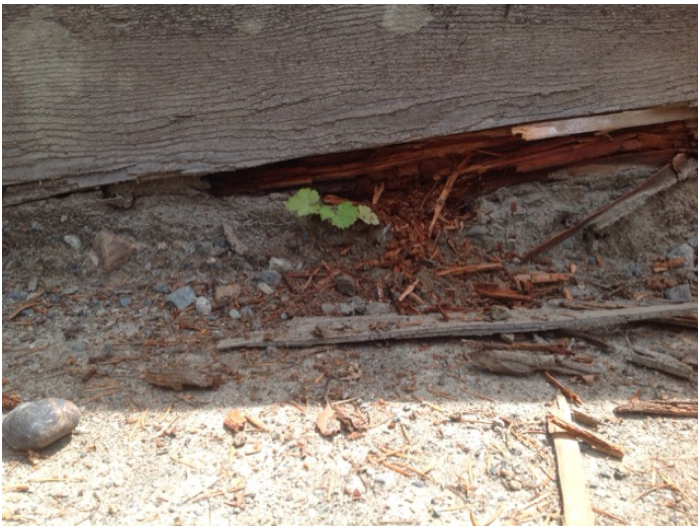
Risers starting to rot from bottom up - 25%

riser rot - only on ones with sediment accumulations on
