CK-2315

WRAY-BERKEY CREEK 4.2km

2015 Inspection

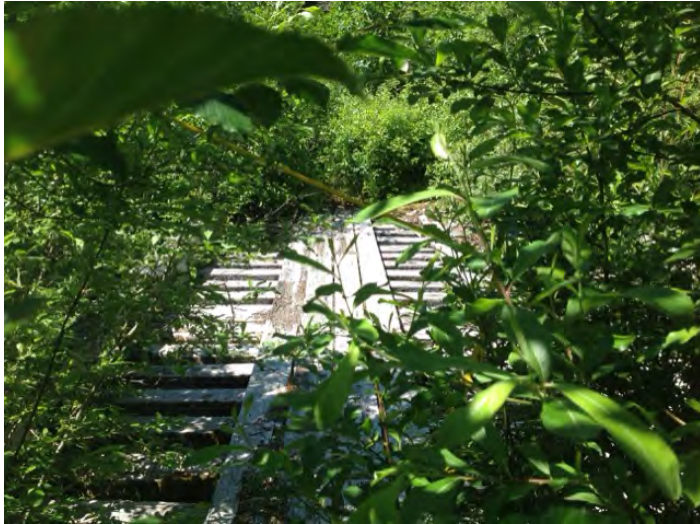
Approach from Right Bank when facing downstream

Posted Load Rating not posted but road extremely grown over - no vehicle access

Road Surface Poor grown over

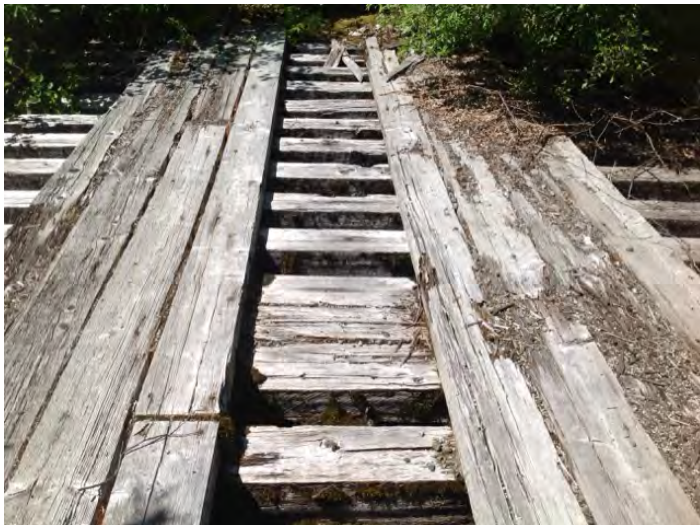
| Running Planks | Poor | rotten |
| Ties | Poor | rotten |
| Nails | Poor | protruding |
| Curb Rail/Blocks/Posts | Poor | rotten |
| Overall Deck Condition | Poor | replace entire structure prior to use |

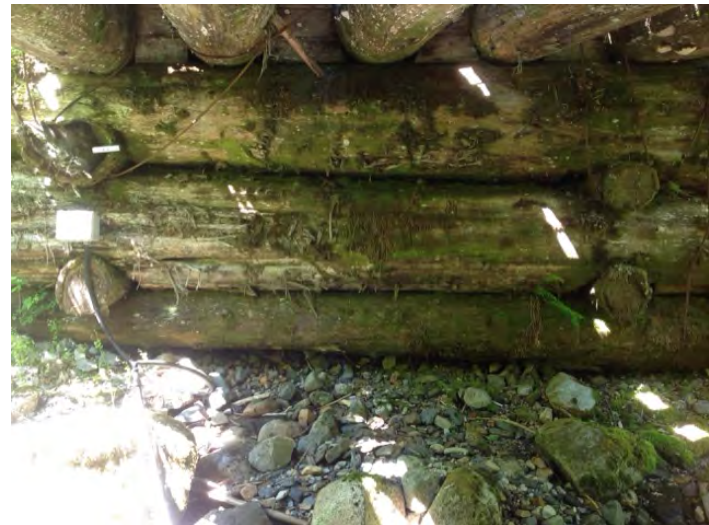
Left Bank Abutment when facing downstream

Ballast Wall Poor rotten on left bank, non existent on right bank
