CK-2319

GARNET CREEK 10.1km

2015 Inspection

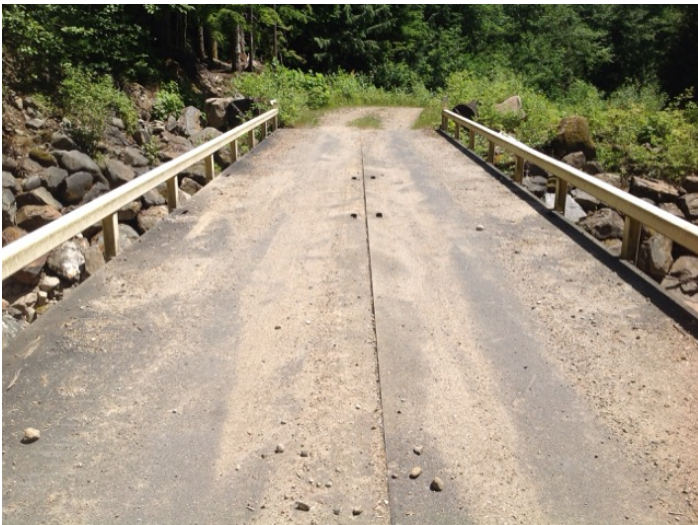
| Overall Deck Condition | Good |
