CK-2327

STAVE RIVER 0km

2015 Inspection

| Structure Class | Temporary Bridge |

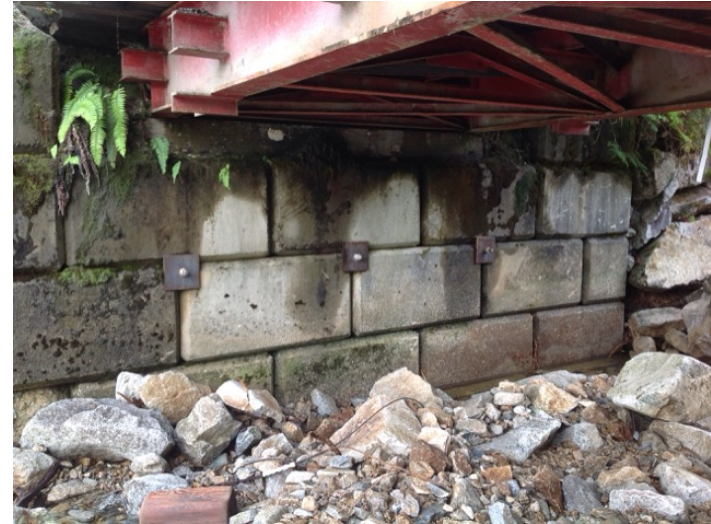
Right Bank Abutment when facing downstream

Concrete Fair lock blocks

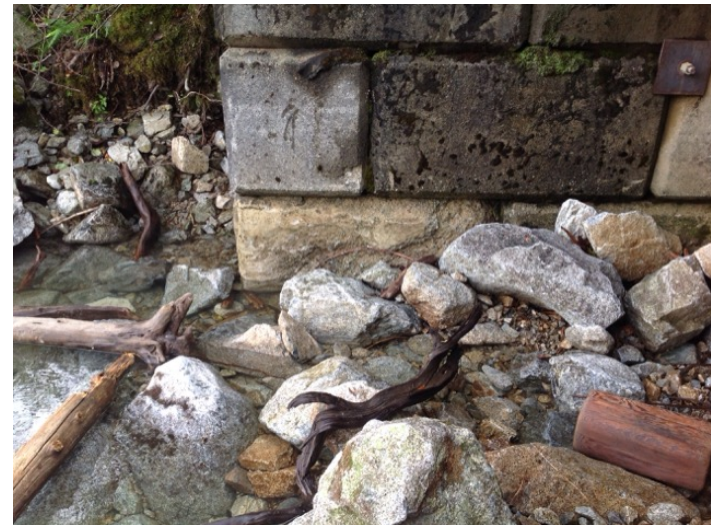
right bank downstream luck block spalling

Place log fenders at both approaches and post bridge ahead signs. Continuously monitor the spalling lock block on the right bank, downstream bottom row. Present load rating of L75 or 68 tonnes to continue.

| Item | Monitor Description | Frequency |
|---|---|---|
| 1 | spalling concrete lock block - downstream bottom row on right bank abutment | annual |

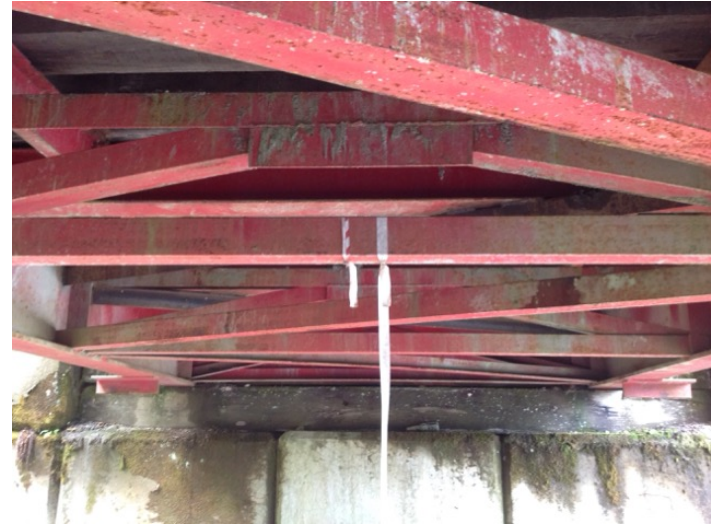
superstructure

Girders Fair painted
