CK-2338

STAVE RIVER 12.2km

2015 Inspection

| Structure Class | Major Culvert | | |

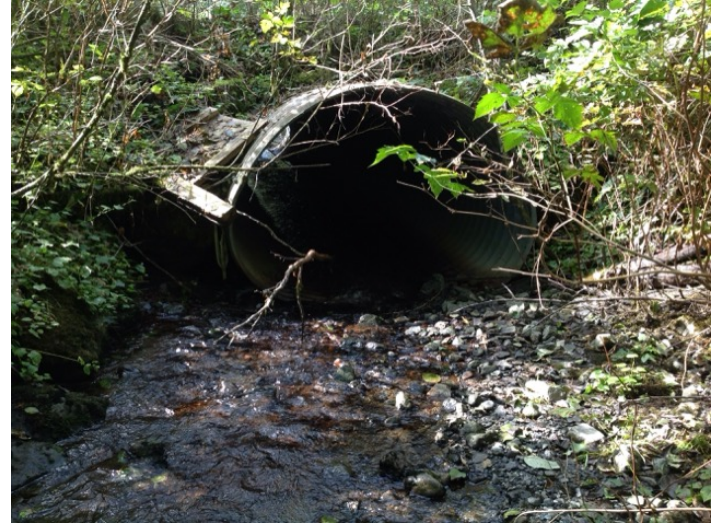
| Inlet | Good | |

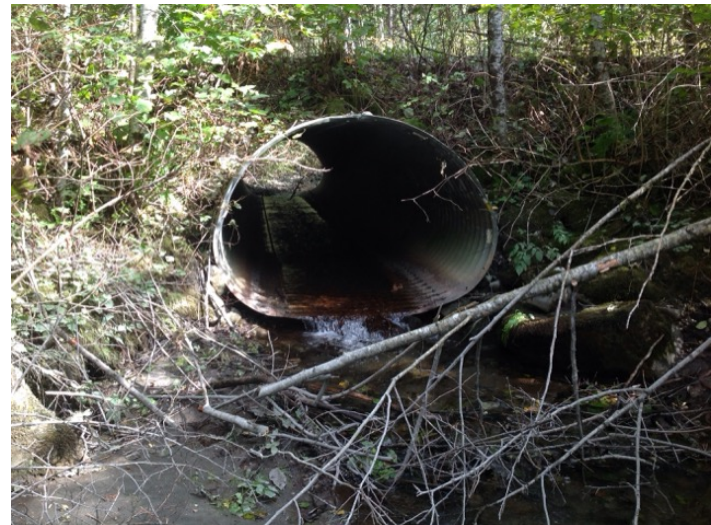
| Outlet | Good | |
